## Annual Inspection

Bockhampton

Bockhampton Lane, Lower Bockhampton, Dorset, DT2  
8PZ

Inspection Ref: 1509630

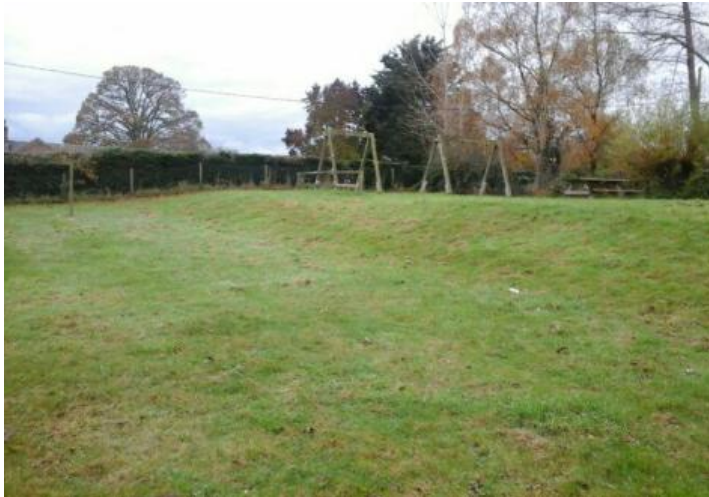
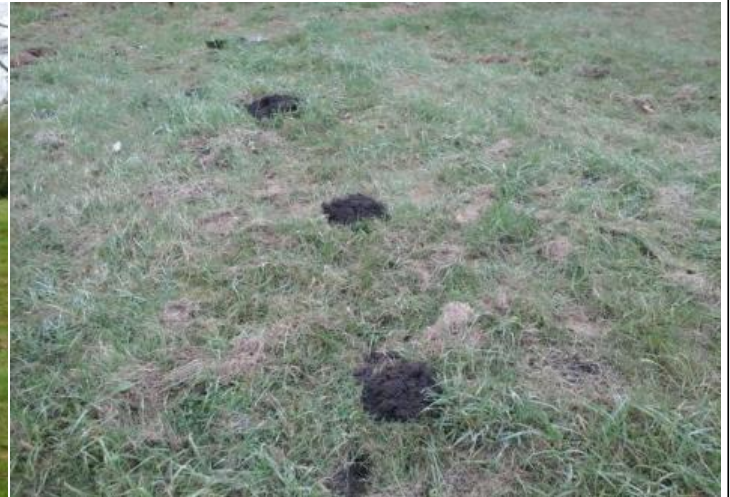
### 8 - Low Risk (Finding 1)

There are a number of molehills within the area and these may present unforeseen hazards for users - Remove moles by appropriate means, reinstate surfaces to level and maintain the area

**Finding:** There are a number of molehills within the area and these may present unforeseen hazards for users

**Action:** Remove moles by appropriate means, reinstate surfaces to level and maintain the area

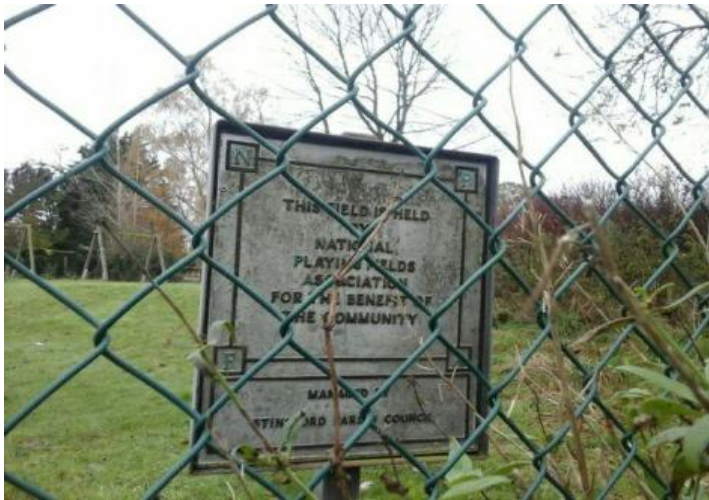
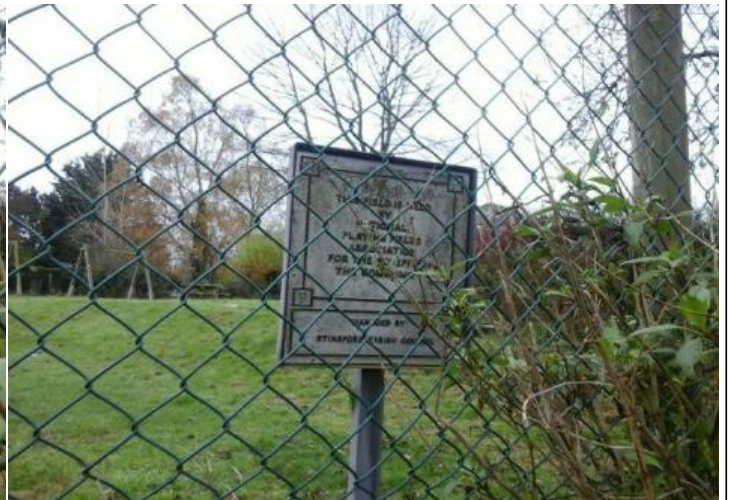
**i** 5 - Very Low Risk (Finding 1)

BS EN 1176 Part 7 recommends that signage shall include emergency contact details and contact details of owner / operator for reporting maintenance issues - Provide additional information

**Finding:** BS EN 1176 Part 7 recommends that signage shall include emergency contact details and contact details of owner / operator for reporting maintenance issues  
**Action:** Provide additional information

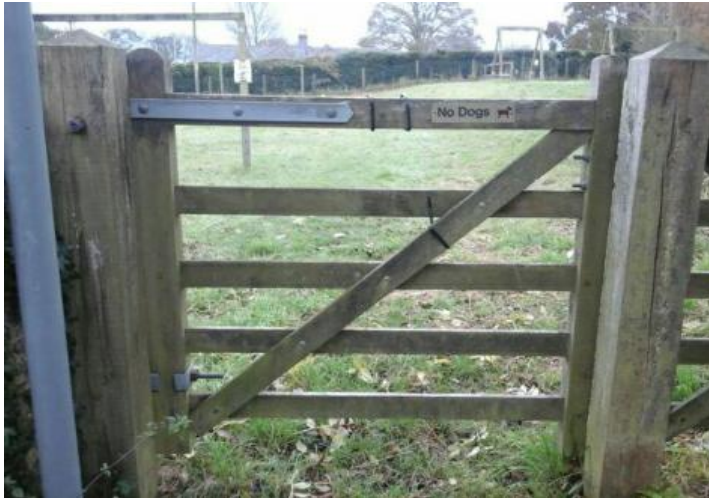
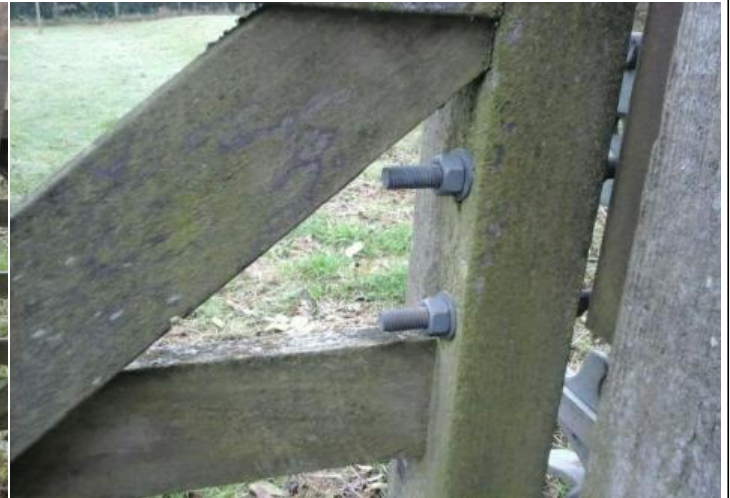
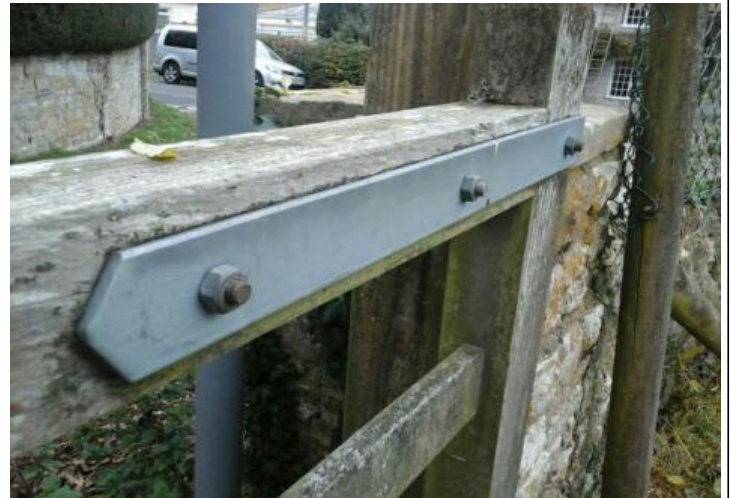
**i** 8 - Low Risk (Finding 1)

There are projecting bolt thread(s) present - Remove excess thread length and deburr or provide cap

**Finding:** There are projecting bolt thread(s) present

**Action:** Remove excess thread length and deburr or provide cap

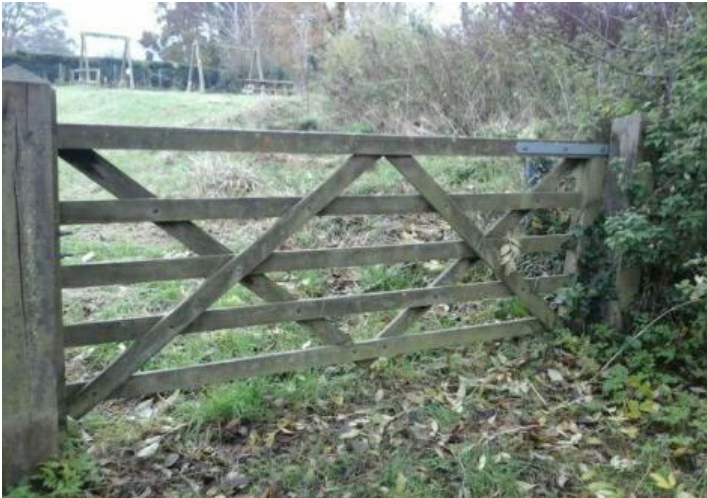
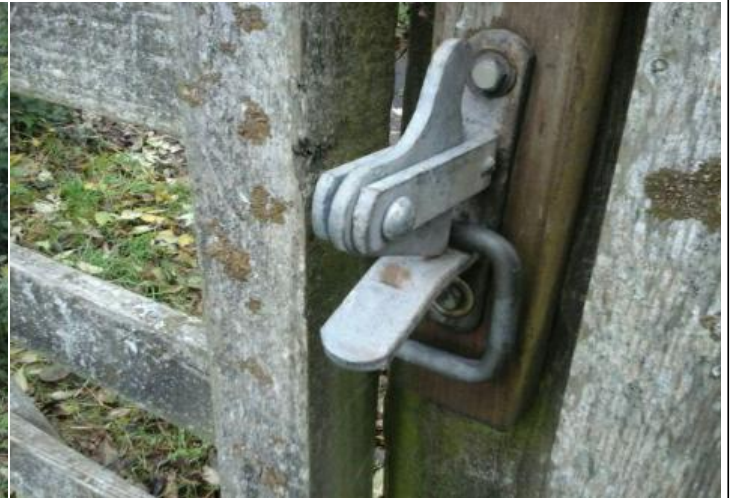
**i 6 - Low Risk (Finding 1)**

There is no padlock on the maintenance gate - Provide a padlock to secure the gate

**Finding:** There is no padlock on the maintenance gate

**Action:** Provide a padlock to secure the gate

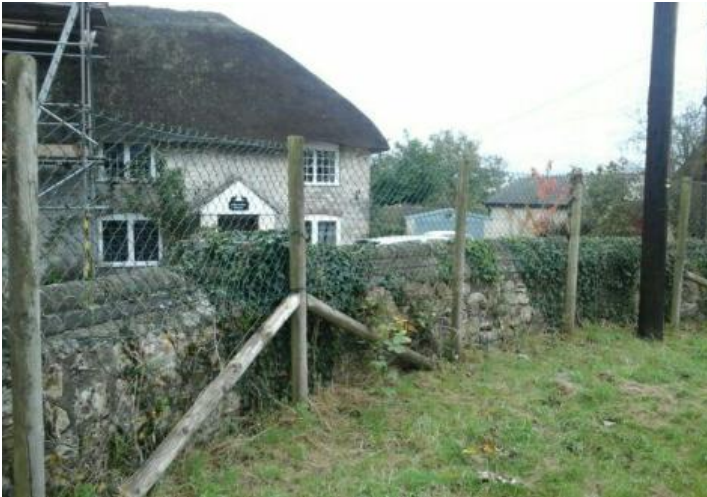
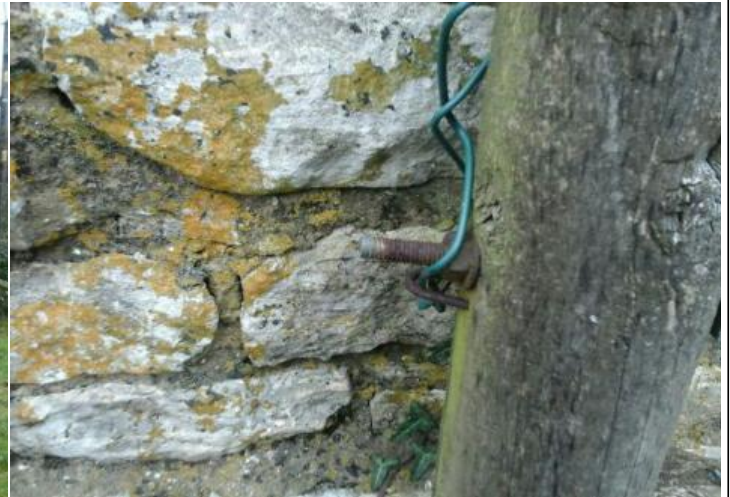
**i 8 - Low Risk (Finding 1)**

There are projecting bolt thread(s) present - Remove excess thread length and deburr or provide cap

**Finding:** There are projecting bolt thread(s) present

**Action:** Remove excess thread length and deburr or provide cap

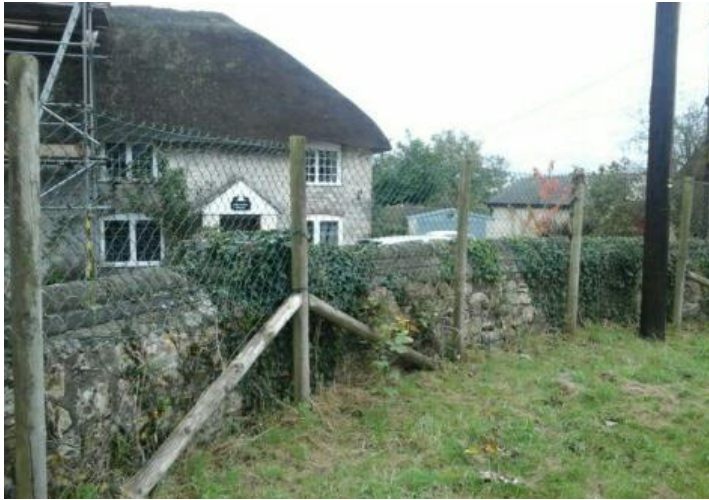
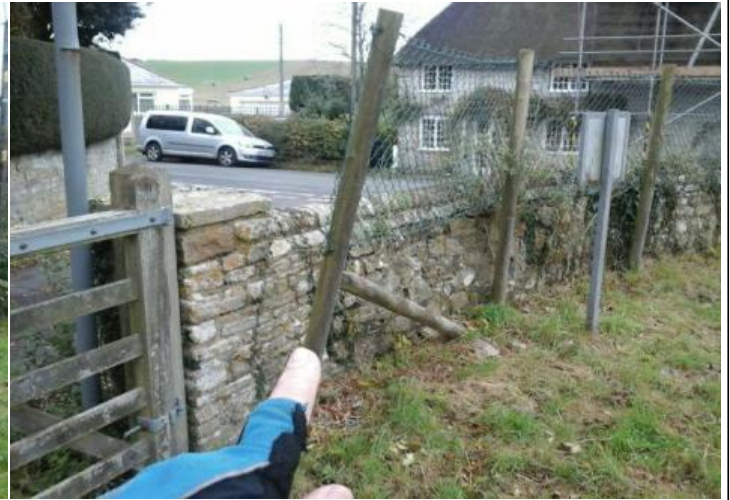
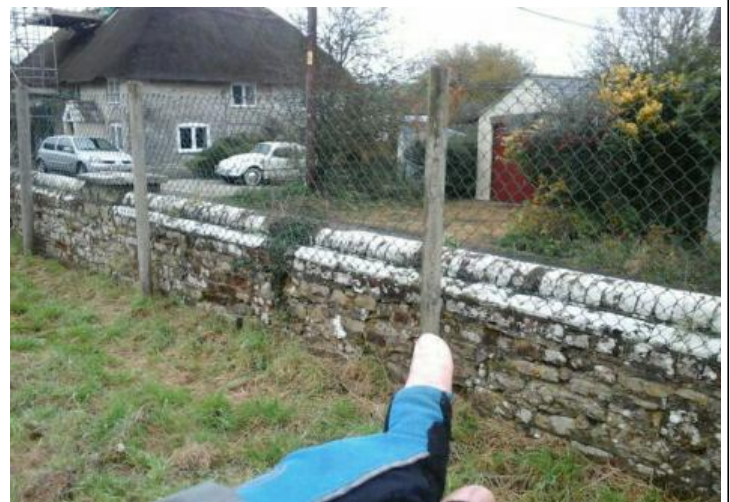
**i** 8 - Low Risk (Finding 2)

Numerous posts have rotted at ground level - Replace posts

**Finding:** Numerous posts have rotted at ground level

**Action:** Replace posts

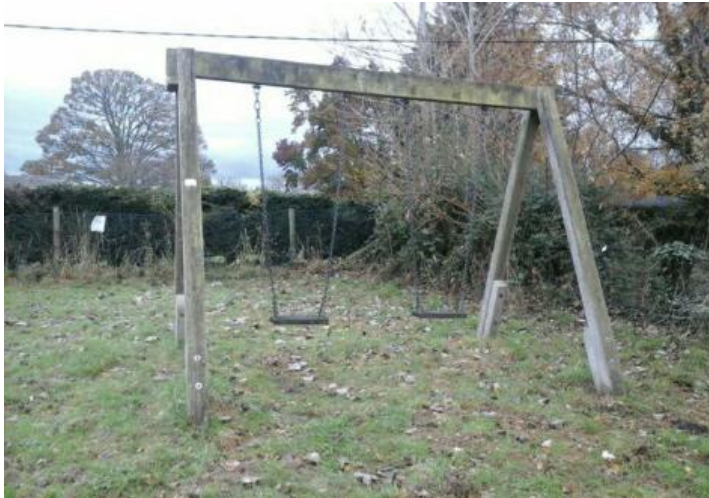
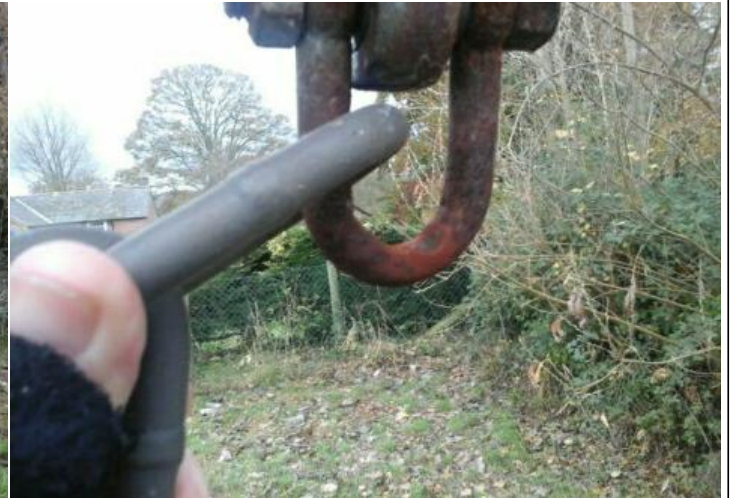
**i** 6 - Low Risk (Finding 1)

There is some wear to the shackles. - Monitor for any further deterioration and replace when 40% worn

**Finding:** There is some wear to the shackles.

**Action:** Monitor for any further deterioration and replace when 40% worn

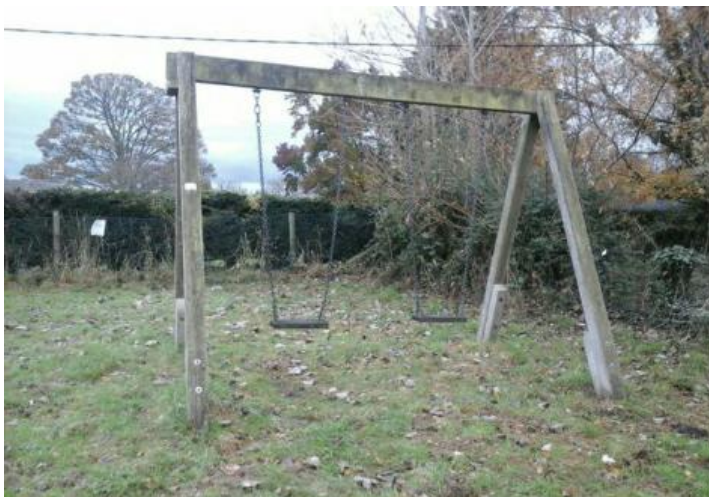
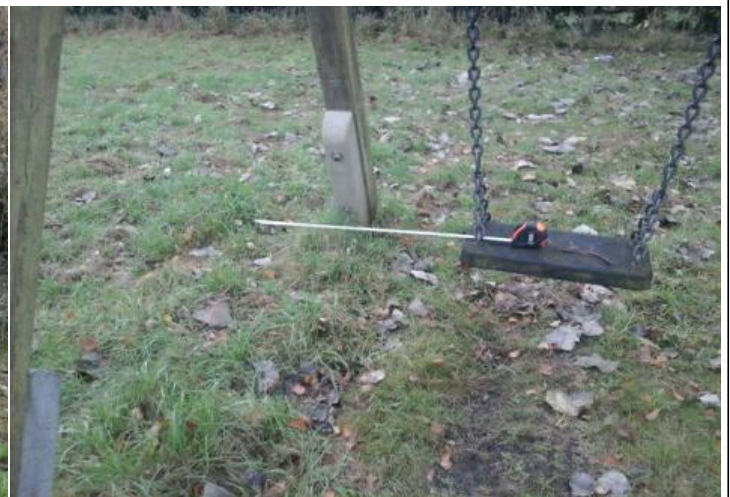
**i** 4 - Very Low Risk (Finding 2)

The seats are too close to the frame as defined in BS EN 1176 Part 2; this is a low risk failure and no remedial action is required - Monitor - No remedial work recommended

**Finding:** The seats are too close to the frame as defined in BS EN 1176 Part 2; this is a low risk failure and no remedial action is required

**Action:** Monitor - No remedial work recommended

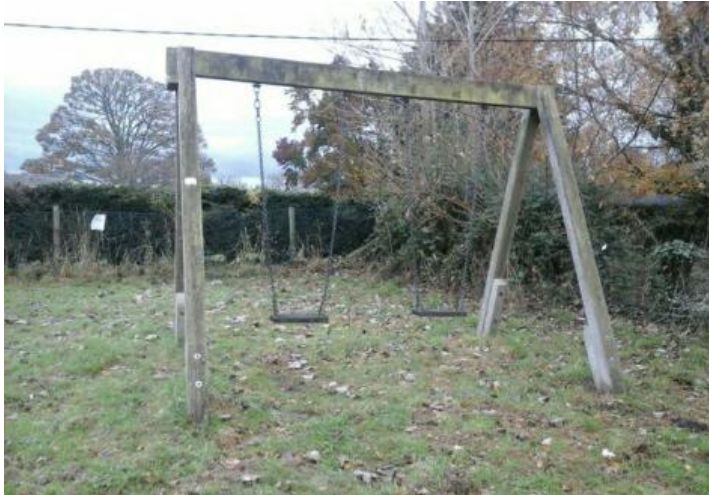
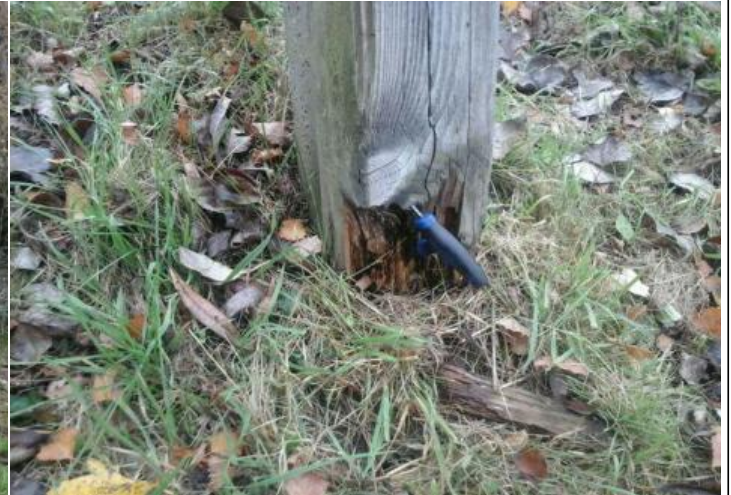
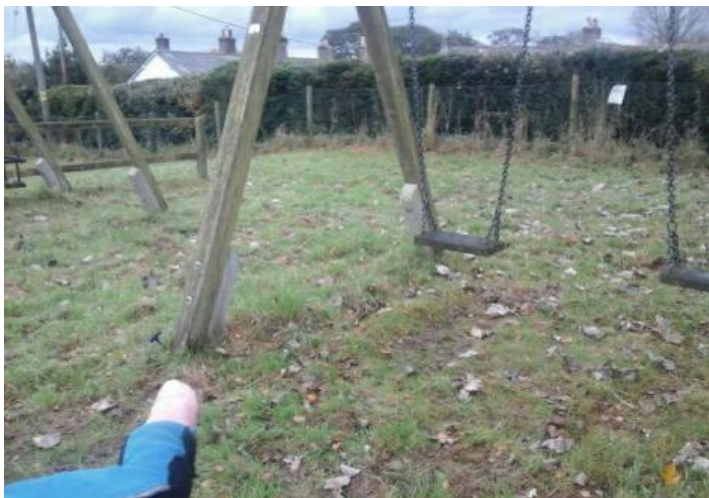
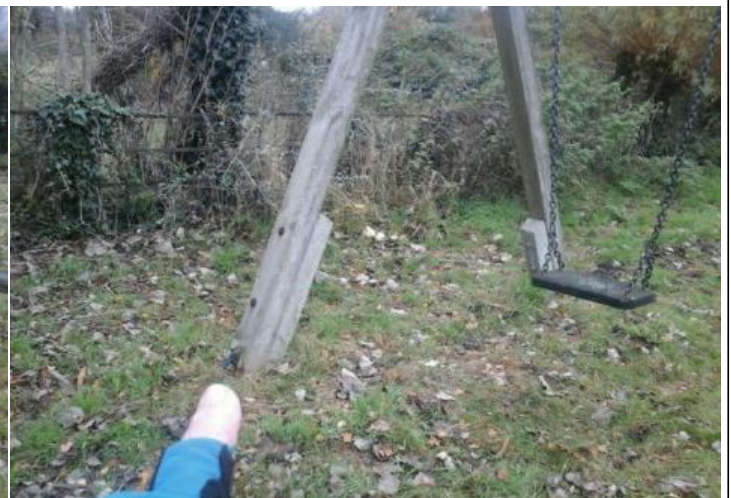
**!** 12 - Moderate Risk (Finding 3)

There are areas or parts of the timber on the structure that have rotted - Replace all affected timbers

**Finding:** There are areas or parts of the timber on the structure that have rotted

**Action:** Replace all affected timbers

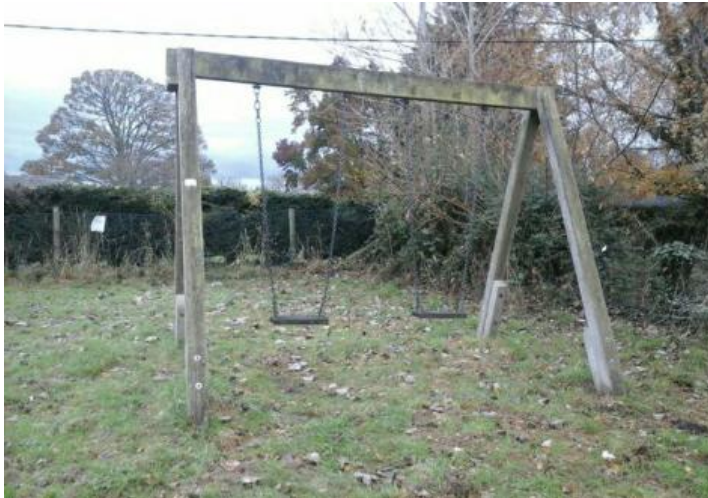
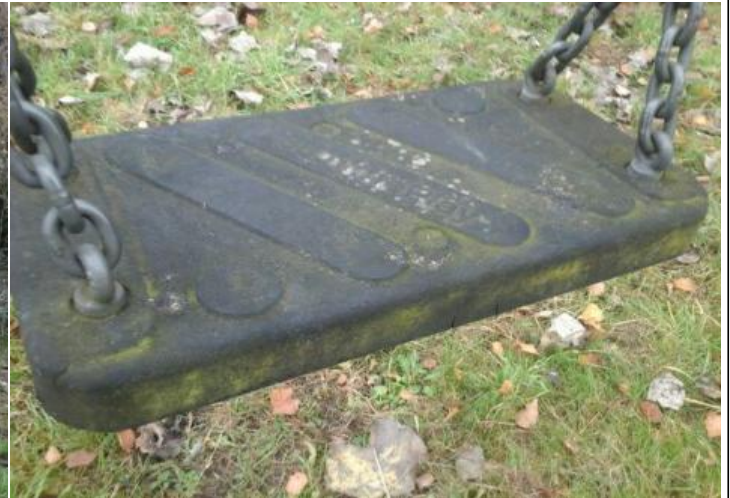
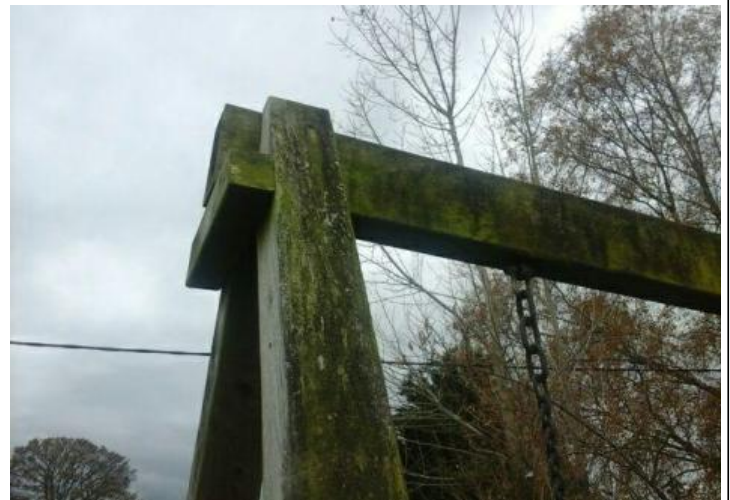
**i** 8 - Low Risk (Finding 4)

There is algae or moss on the surface of the equipment - Clean and treat appropriately

**Finding:** There is algae or moss on the surface of the equipment

**Action:** Clean and treat appropriately

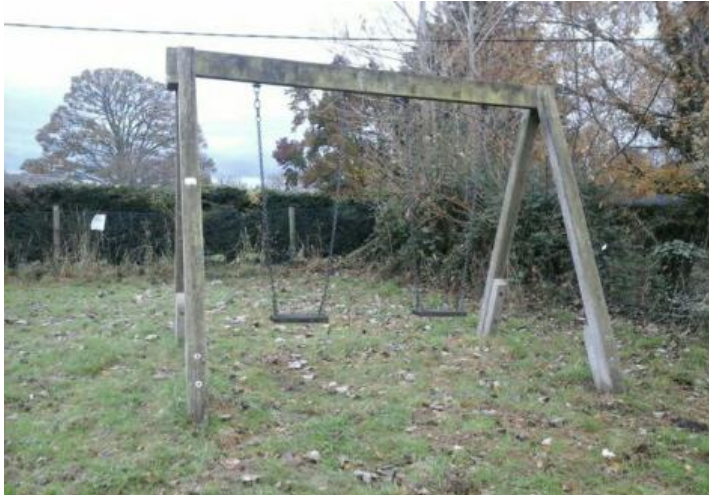
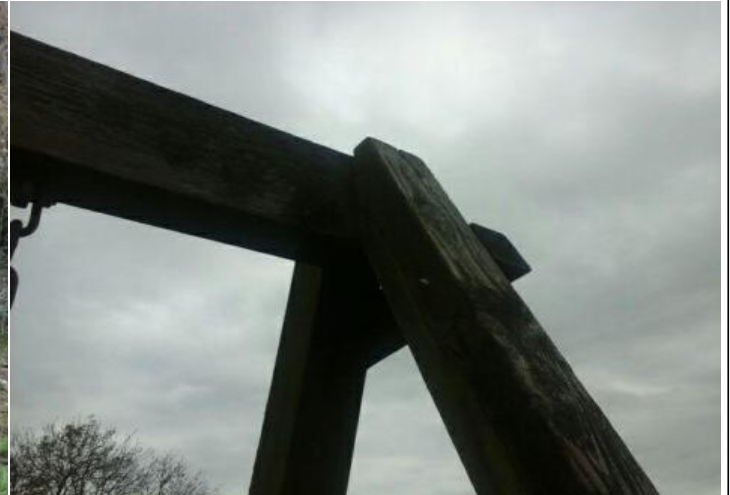
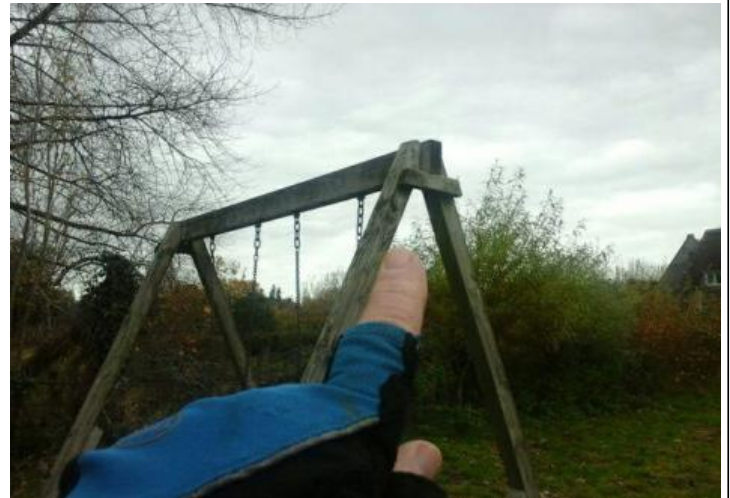
**!** 12 - Moderate Risk (Finding 5)

A number of fixing(s) have worked loose, the cross bar moves when in use - Secure all loose fixings

**Finding:** A number of fixing(s) have worked loose, the cross bar moves when in use  
**Action:** Secure all loose fixings

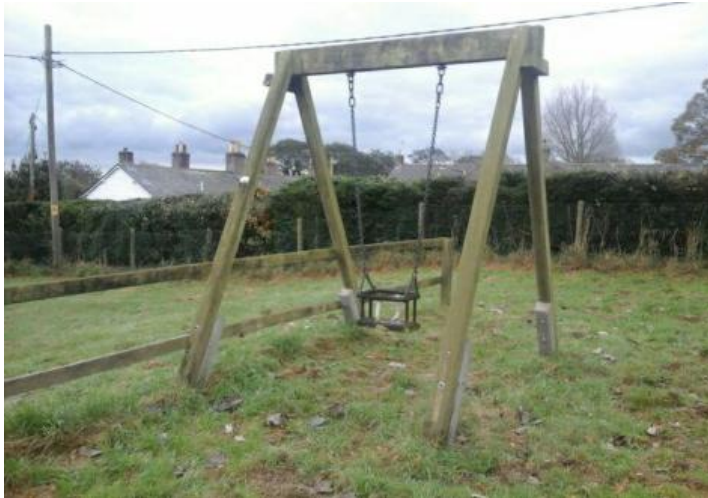
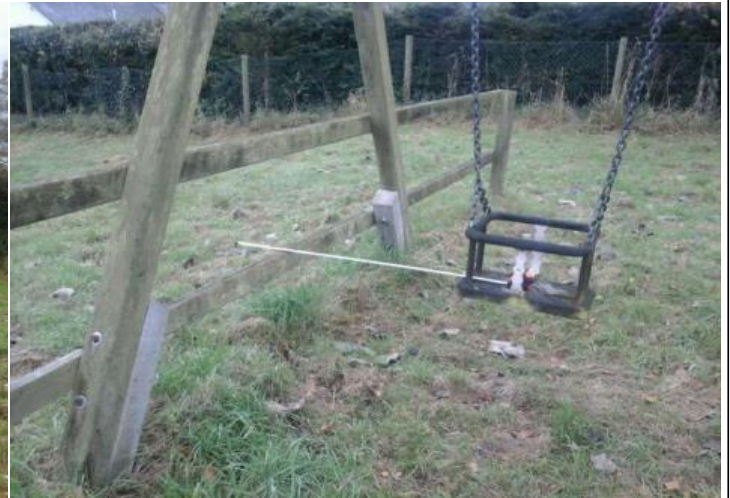
**i** 6 - Low Risk (Finding 1)

BS EN 1176 Part 2: Annex A makes a recommendation that fences or enclosures should be up to 1.50m from the edges of the swing seat to the sides, and subject to risk assessment, from the edge of the impact area. This is however, a low risk finding and no remedial action is recommended. - Monitor - No remedial work recommended

**Finding:** BS EN 1176 Part 2: Annex A makes a recommendation that fences or enclosures should be up to 1.50m from the edges of the swing seat to the sides, and subject to risk assessment, from the edge of the impact area. This is however, a low risk finding and no remedial action is recommended.

**Action:** Monitor - No remedial work recommended

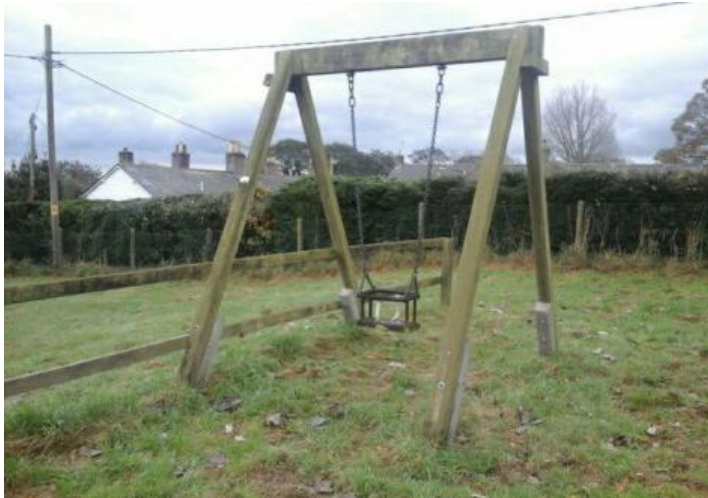
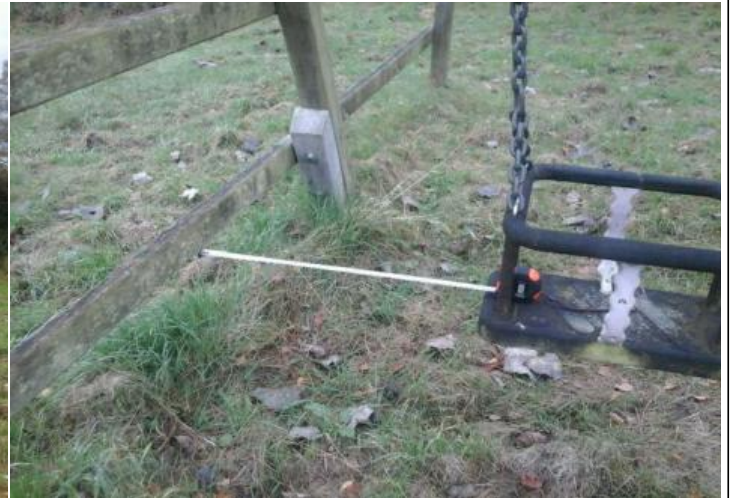
**i** 4 - Very Low Risk (Finding 2)

The seats are too close to the frame as defined in BS EN 1176 Part 2; this is a low risk failure and no remedial action is required - Monitor - No remedial work recommended

**Finding:** The seats are too close to the frame as defined in BS EN 1176 Part 2; this is a low risk failure and no remedial action is required

**Action:** Monitor - No remedial work recommended

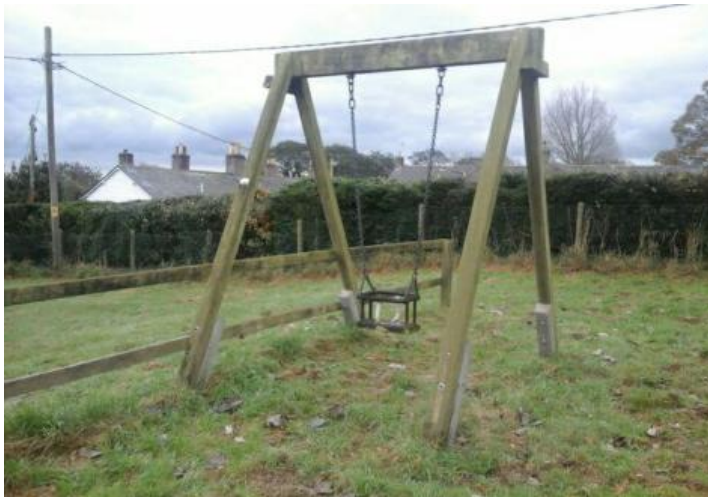
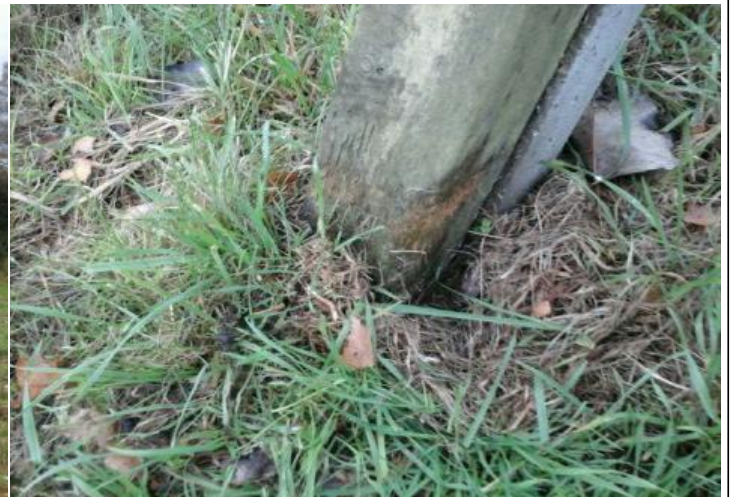
**i** 6 - Low Risk (Finding 3)

There is some strimmer / machinery damage apparent on the posts, this can penetrate the preservative applied to the timber and accelerate the rotting process - Monitor for any deterioration (rot) and replace as required

**Finding:** There is some strimmer / machinery damage apparent on the posts, this can penetrate the preservative applied to the timber and accelerate the rotting process

**Action:** Monitor for any deterioration (rot) and replace as required

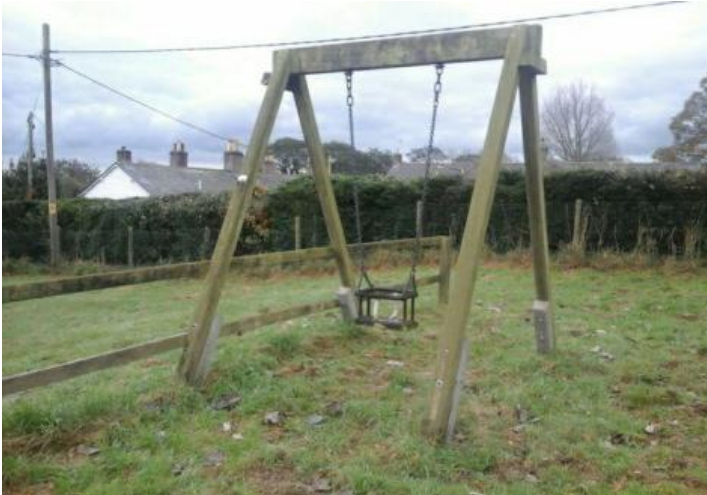
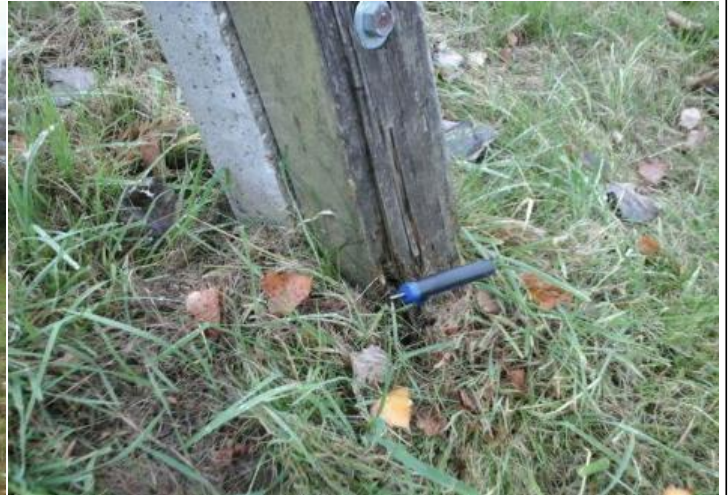
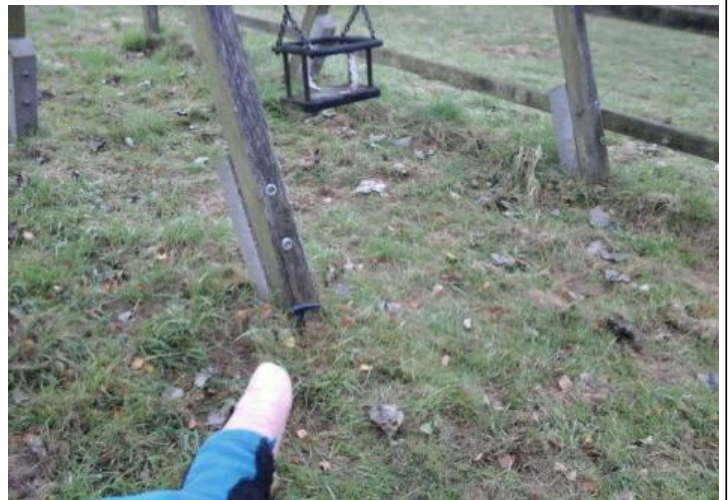
**!** 12 - Moderate Risk (Finding 4)

There are areas or parts of the timber on the structure that have rotted - Replace all affected timbers

**Finding:** There are areas or parts of the timber on the structure that have rotted

**Action:** Replace all affected timbers

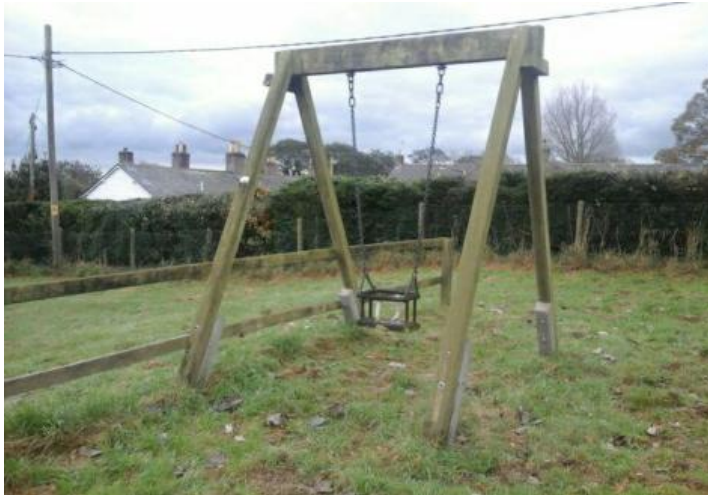
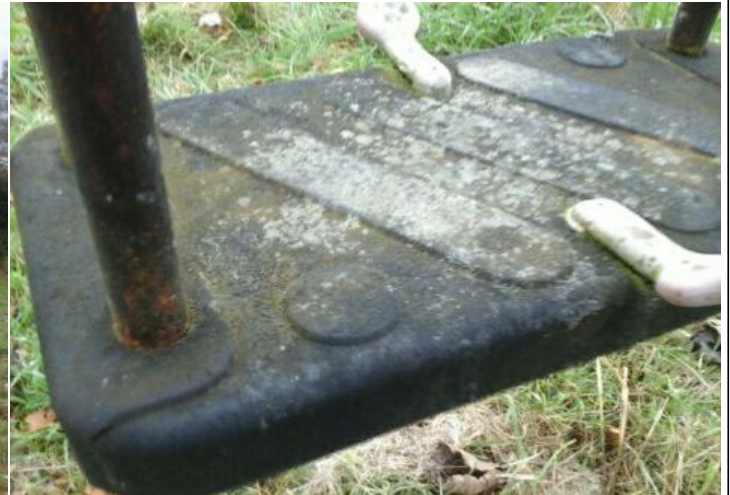
**i 8 - Low Risk (Finding 5)**

There is algae or moss on the surface of the equipment - Clean and treat appropriately

**Finding:** There is algae or moss on the surface of the equipment

**Action:** Clean and treat appropriately

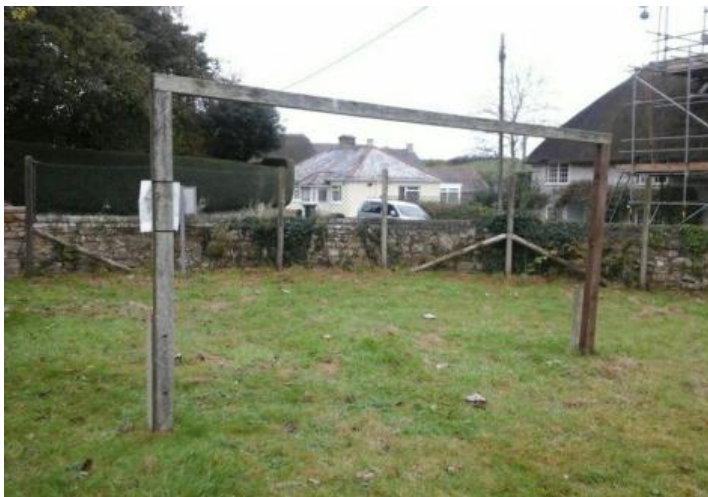
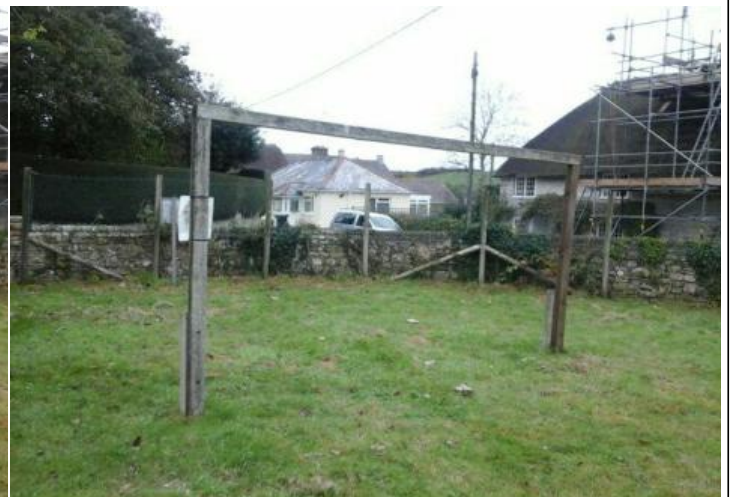
**i 0 - Risk Assessment not Undertaken (Finding 1)**

NB: We have undertaken a maintenance inspection only of the football goal(s); full load testing falls outside the scope of our inspection. - Implement load testing as required

**Finding:** NB: We have undertaken a maintenance inspection only of the football goal(s); full load testing falls outside the scope of our inspection.

**Action:** Implement load testing as required

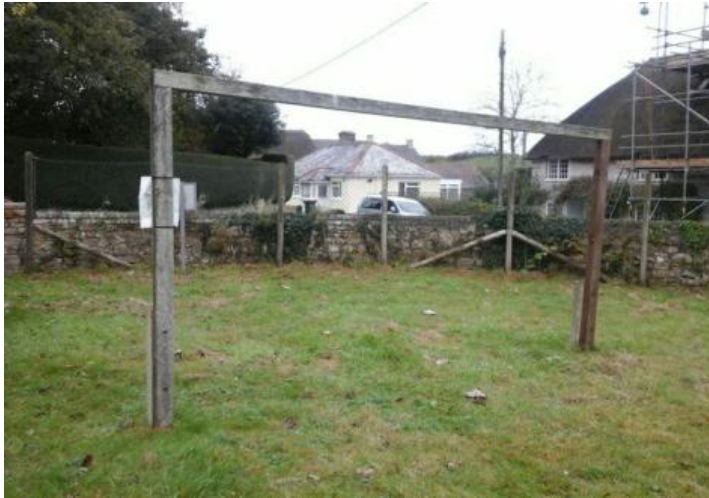
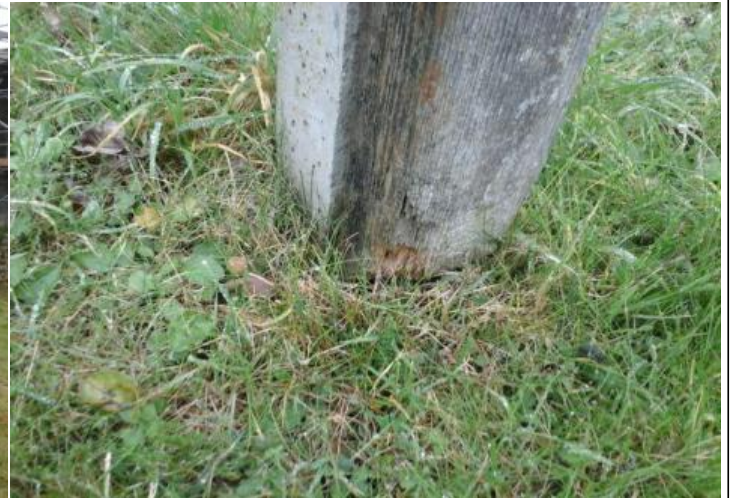
**i** 6 - Low Risk (Finding 2)

There is some strimmer / machinery damage apparent on the posts, this can penetrate the preservative applied to the timber and accelerate the rotting process - Monitor for any deterioration (rot) and replace as required

**Finding:** There is some strimmer / machinery damage apparent on the posts, this can penetrate the preservative applied to the timber and accelerate the rotting process

**Action:** Monitor for any deterioration (rot) and replace as required
