# the **play** inspection company

## Annual Inspection

Bockhampton

Bockhampton Lane, Lower Bockhampton, Dorset, DT2  
8PZ

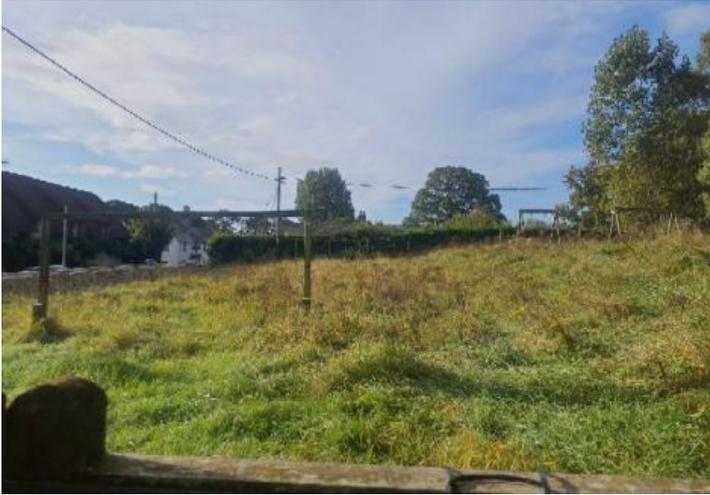
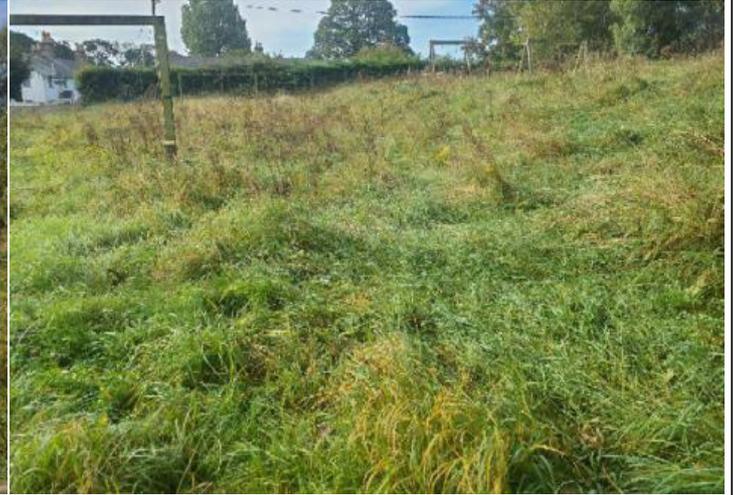
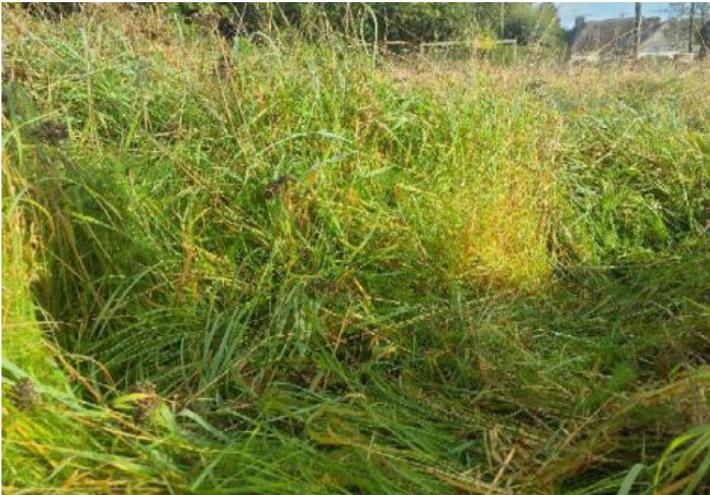
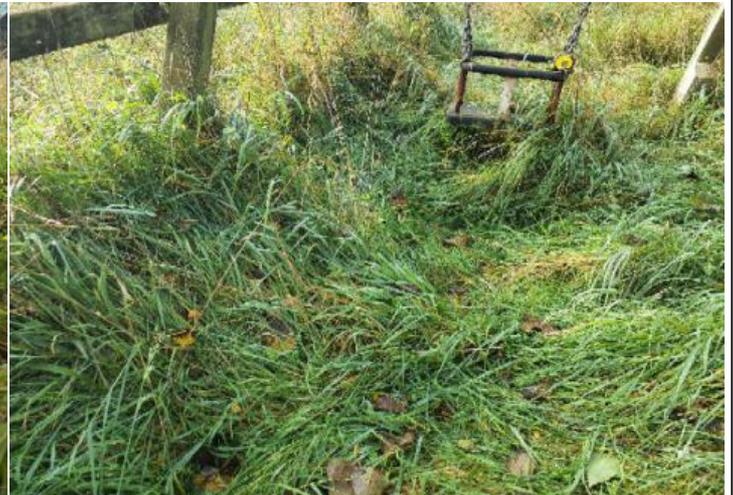
**Finding:** The grass is overgrown within the play area and may hide hazards

**Action:** Reduce the length of grass to an acceptable height and maintain

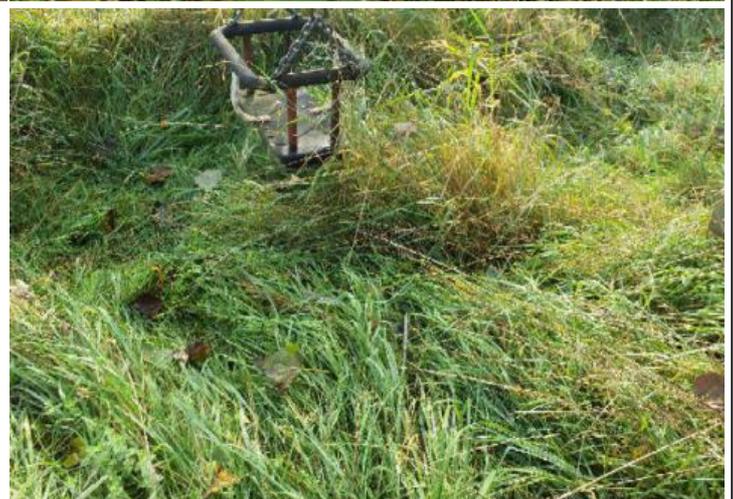
**Finding:** The inspector was unable to check the surfacing below the items due to the sheer volume of vegetation

**Action:** Check surfacing when the vegetation has been removed

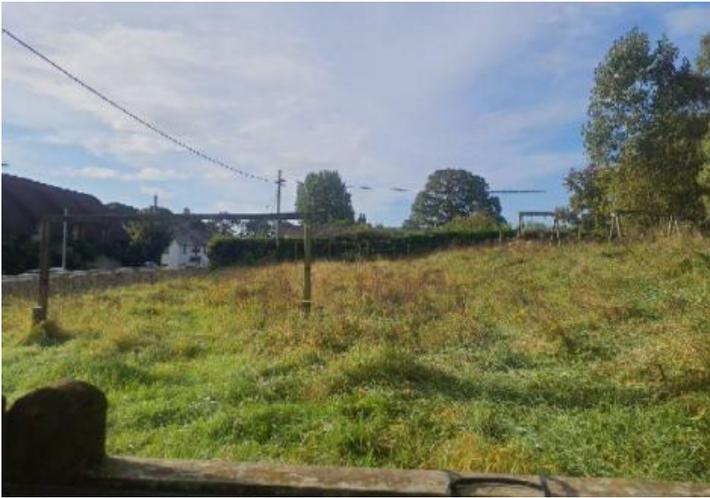
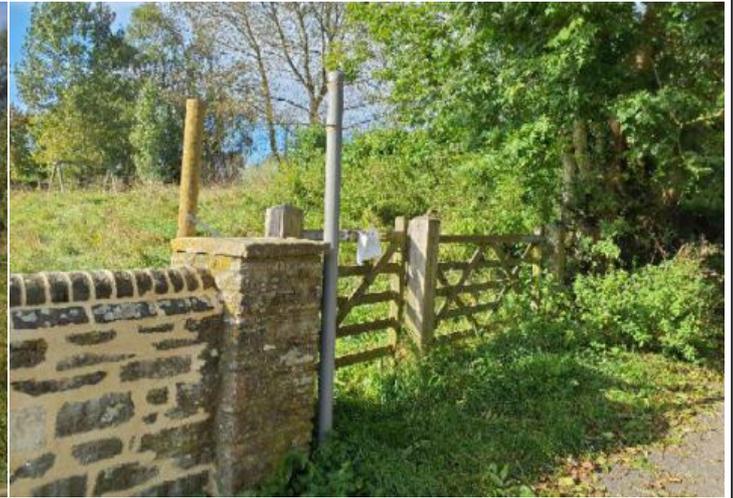
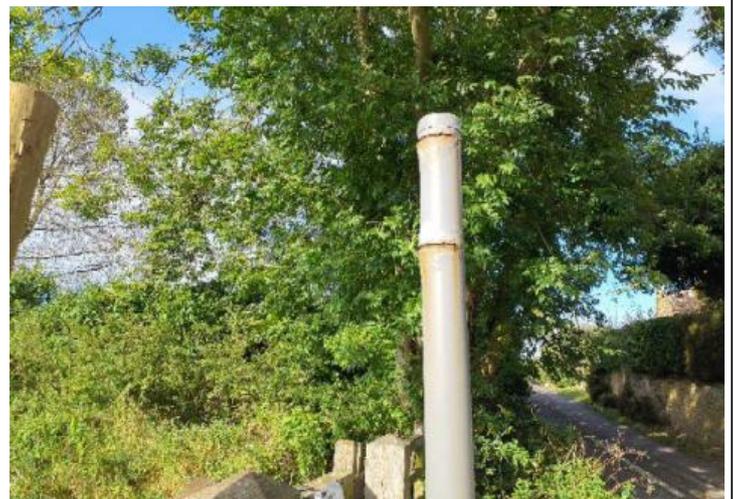
**Finding:** There are redundant / damaged posts

**Action:** Remove

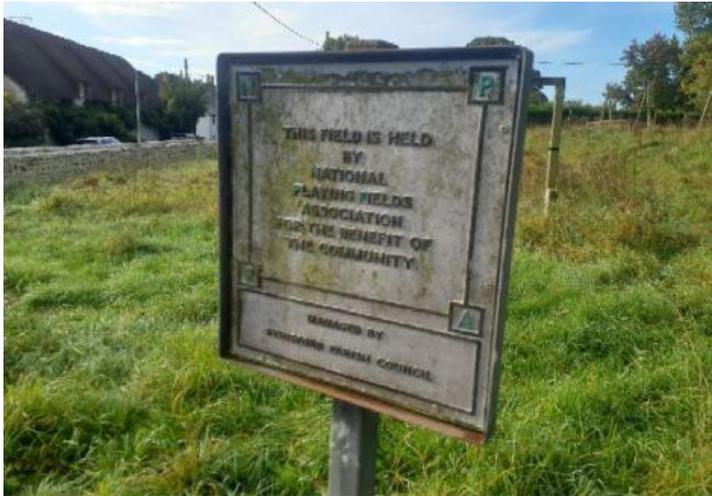
**Finding:** It is recommended that signage, with information including the site address, contact information for maintenance issues and emergency contact details are provided for the facility

**Action:** Provide in accordance with the recommendations

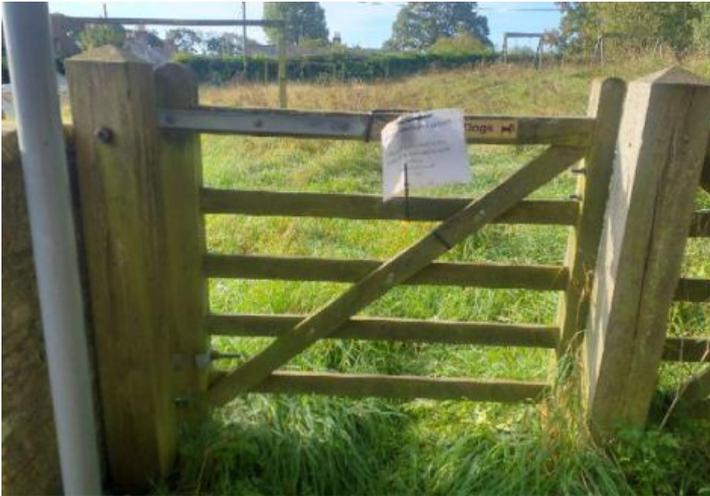
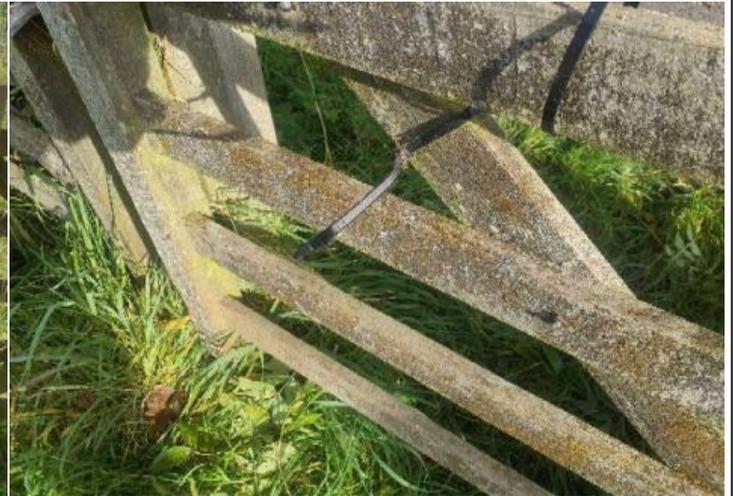
**Finding:** Cable ties have been used on the item and there are sharp projecting ends

**Action:** Remove if not required or replace with a more appropriate alternative fixing method if used as a fixing

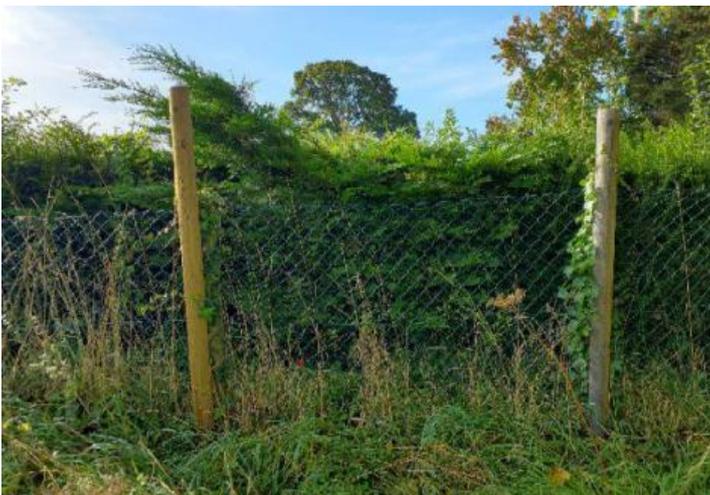
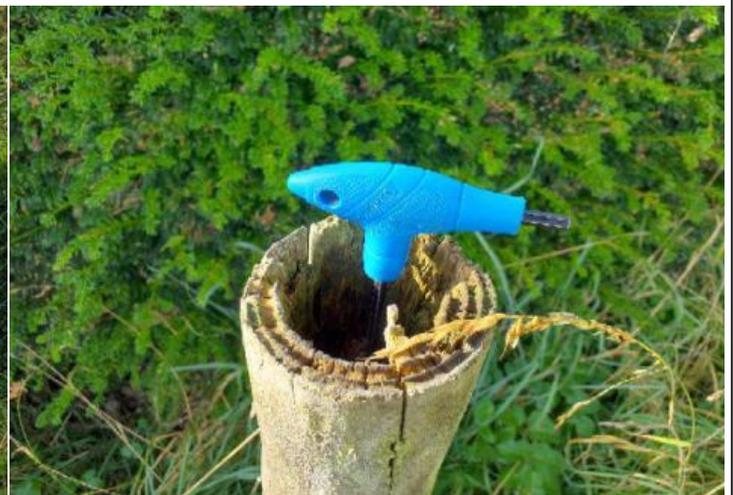
**Finding:** There are areas or parts of the timber on the structure that have rotted

**Action:** Replace all affected timbers

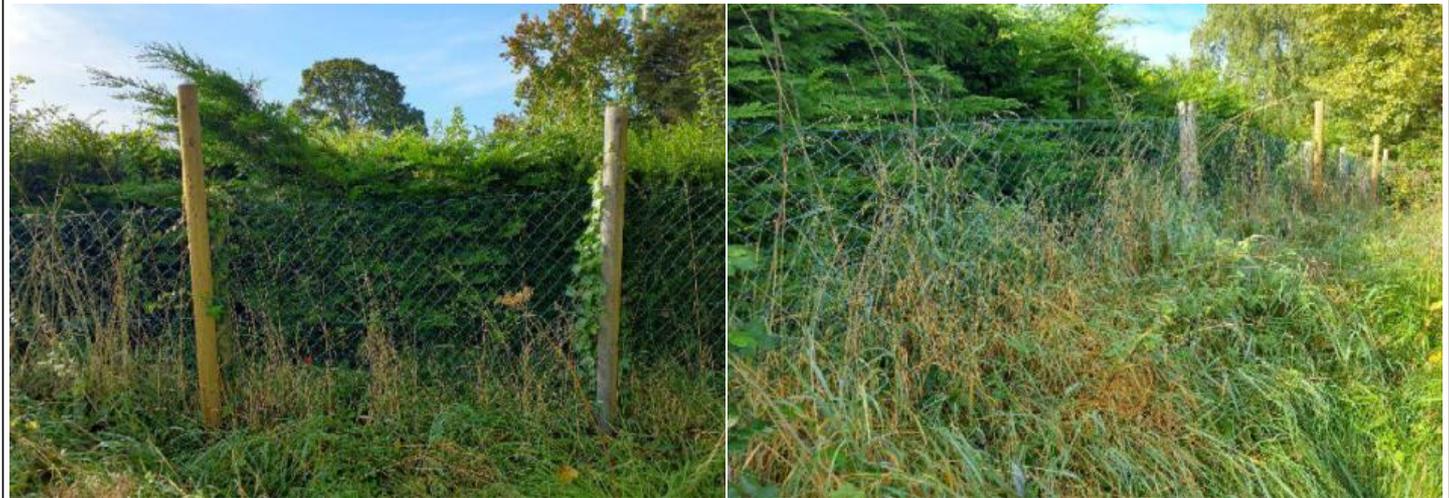
<b>Finding:</b> There are a number of loose posts around the fence	<b>Action:</b> Monitor for any further deterioration and reset as required
--	--

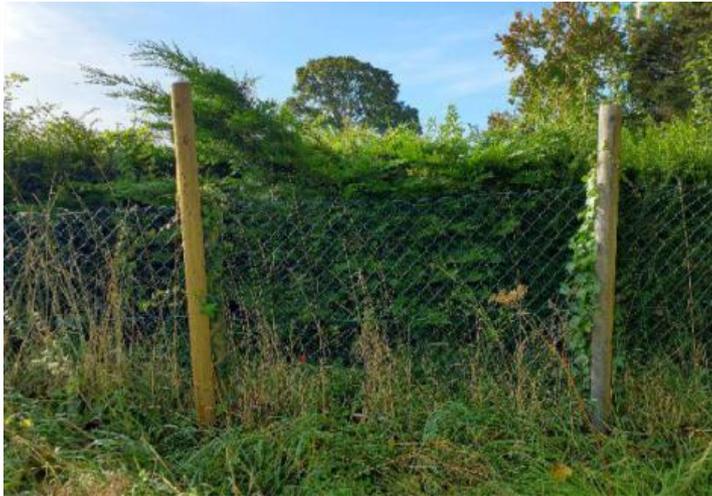
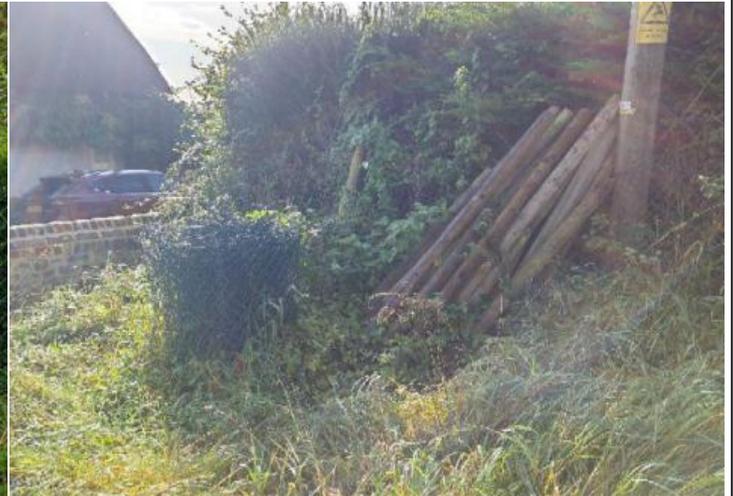
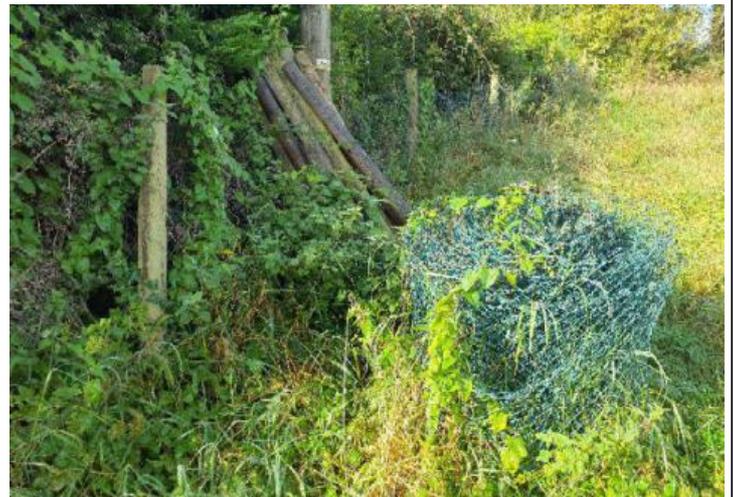
**Finding:** Loose timber posts and mesh (fencing materials) are being stored in the area

**Action:** Remove

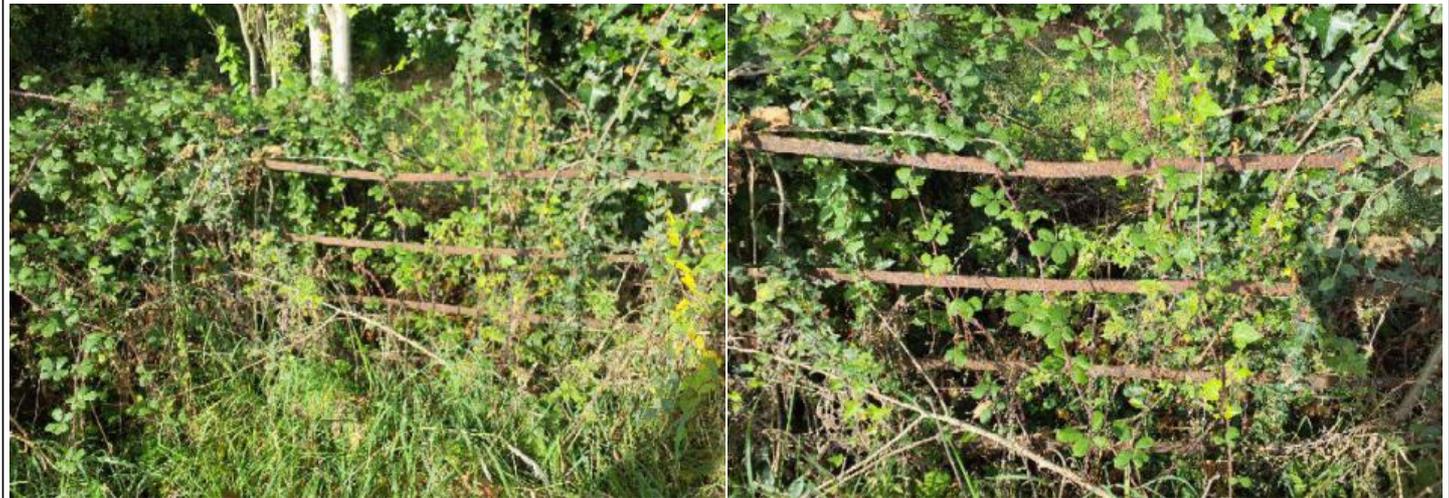
<b>Finding:</b> The paintwork on this item has been damaged or worn exposing the metal underneath which is rusting / corroding	<b>Action:</b> Treat affected areas and repaint
--	---

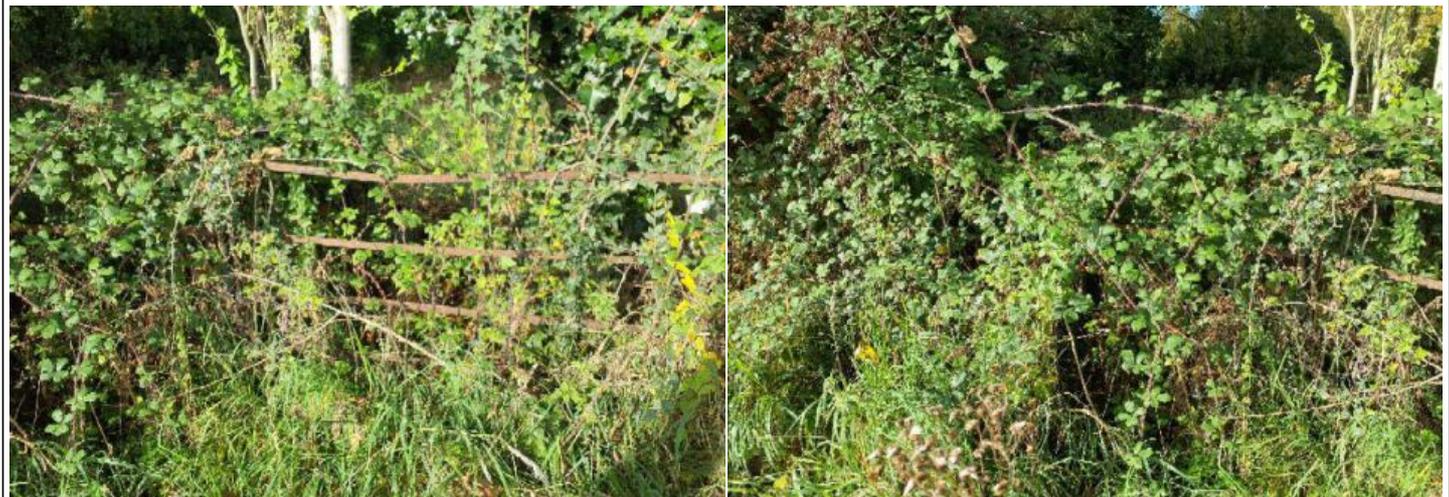
<b>Finding:</b> The adjacent foliage is overhanging	<b>Action:</b> Cut back and maintain
---	--------------------------------------

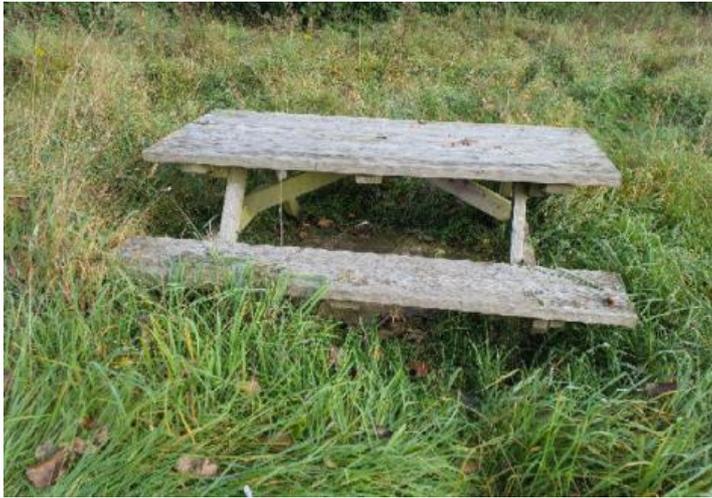
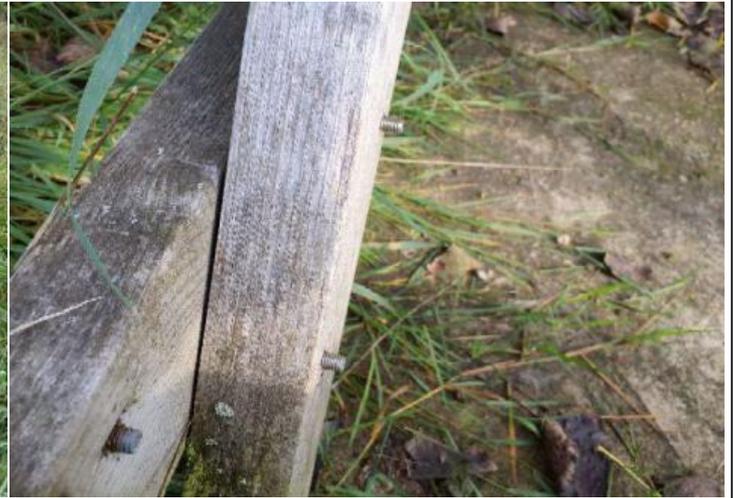
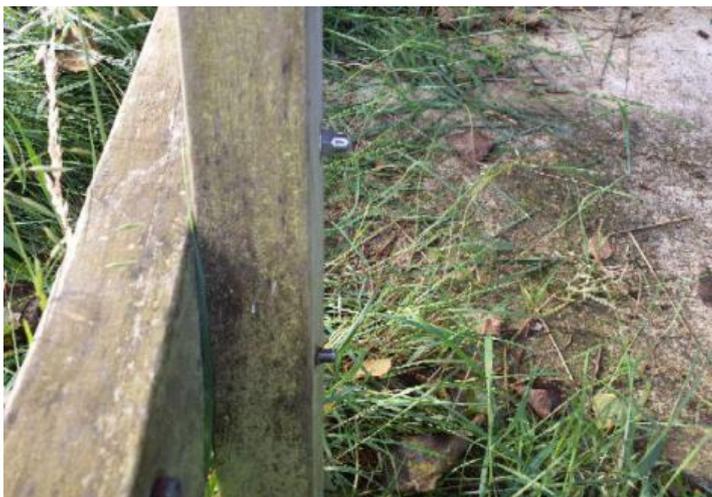
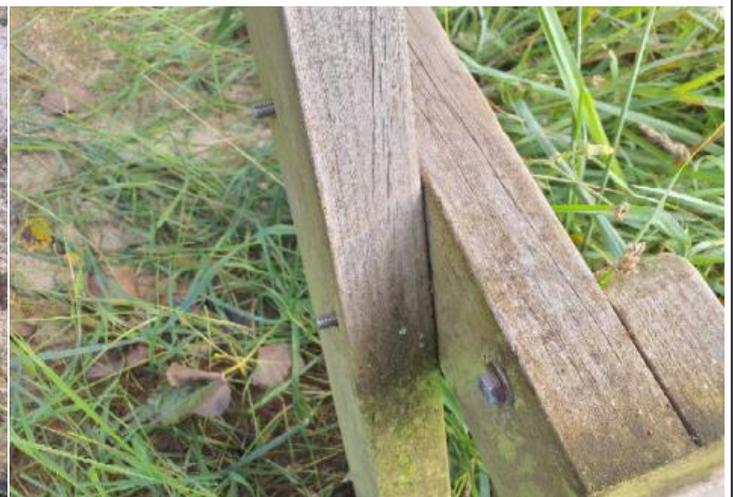
**Finding:** There is or are fixings missing on the item

**Action:** Replace all missing fixings

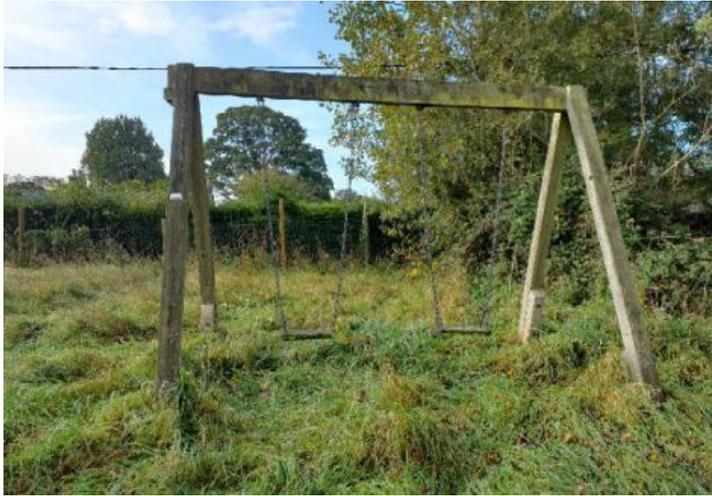
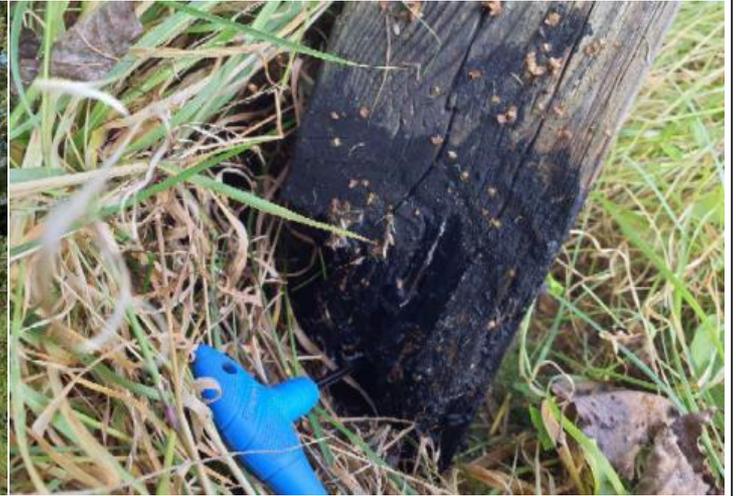
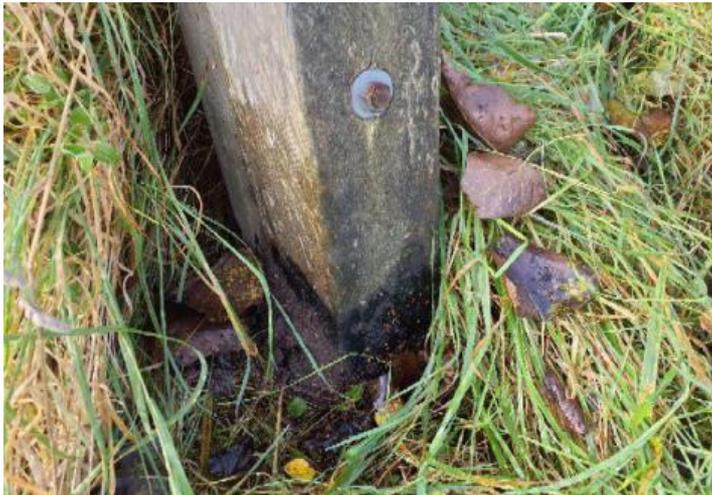
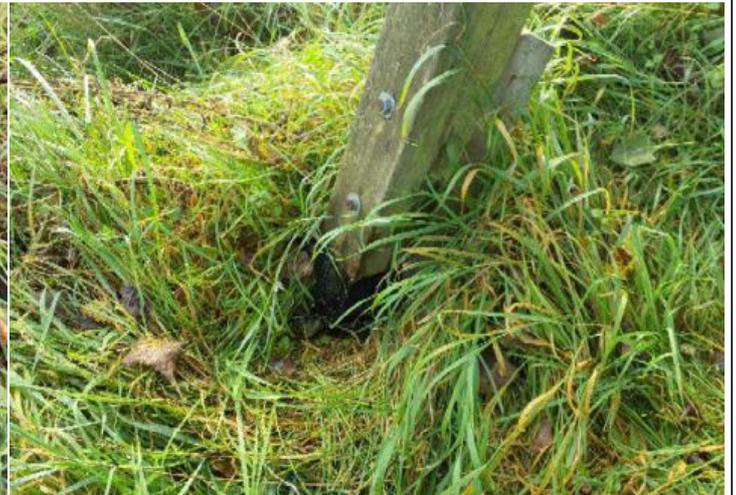
**Finding:** All 4 timber posts on the structure have rotted

**Action:** Replace all affected timbers

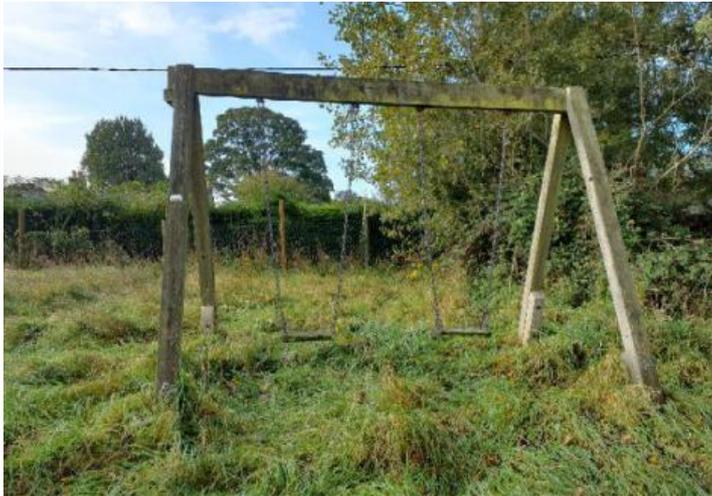
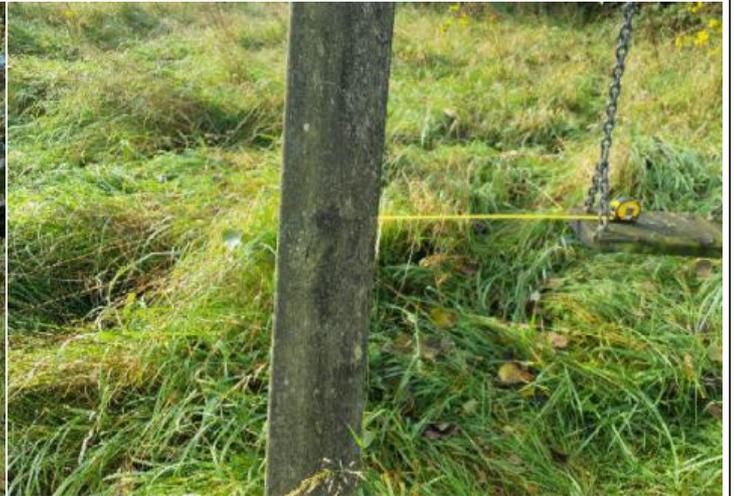
**Finding:** The seats are too close to the frame as defined in BS EN 1176 Part 2; this is a low risk failure and no remedial action is required

**Action:** Monitor - No remedial work recommended

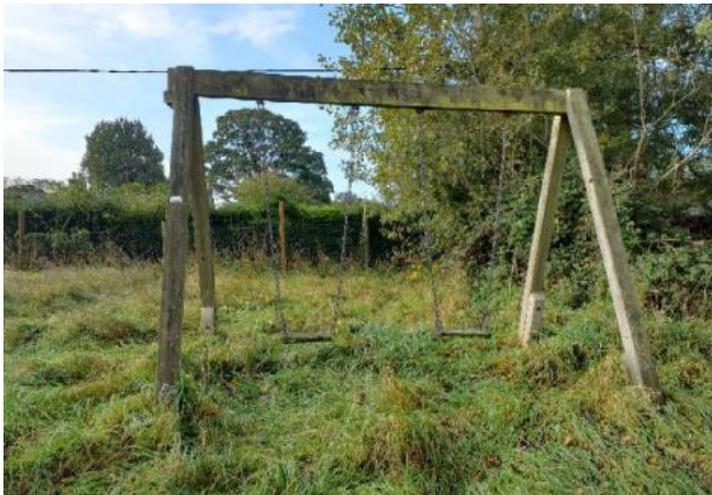
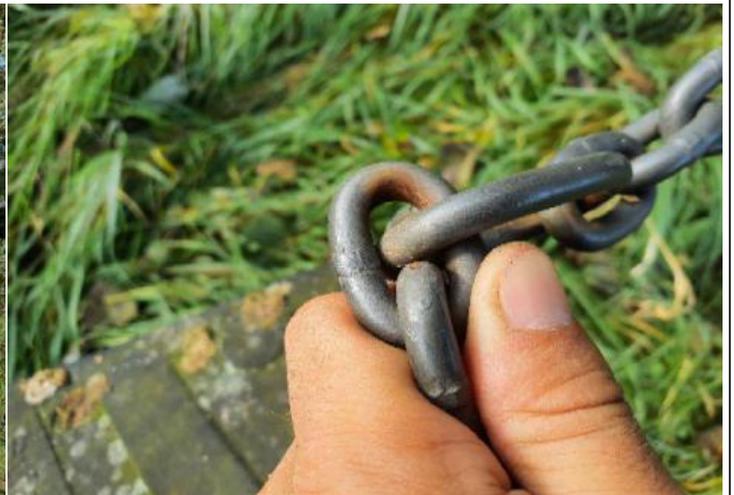
**Finding:** There is some notable evidence of chain wear

**Action:** Monitor for any further deterioration and replace when 40% worn

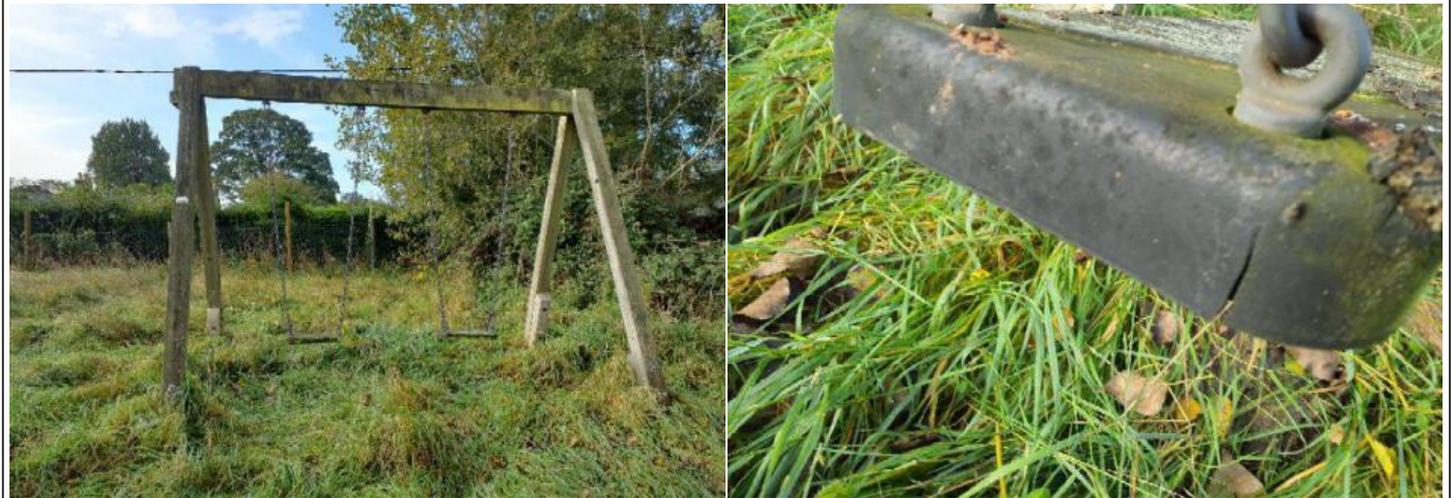
<b>Finding:</b> The seat has minor damage or wear	<b>Action:</b> Monitor for any further deterioration and replace as required
---	--

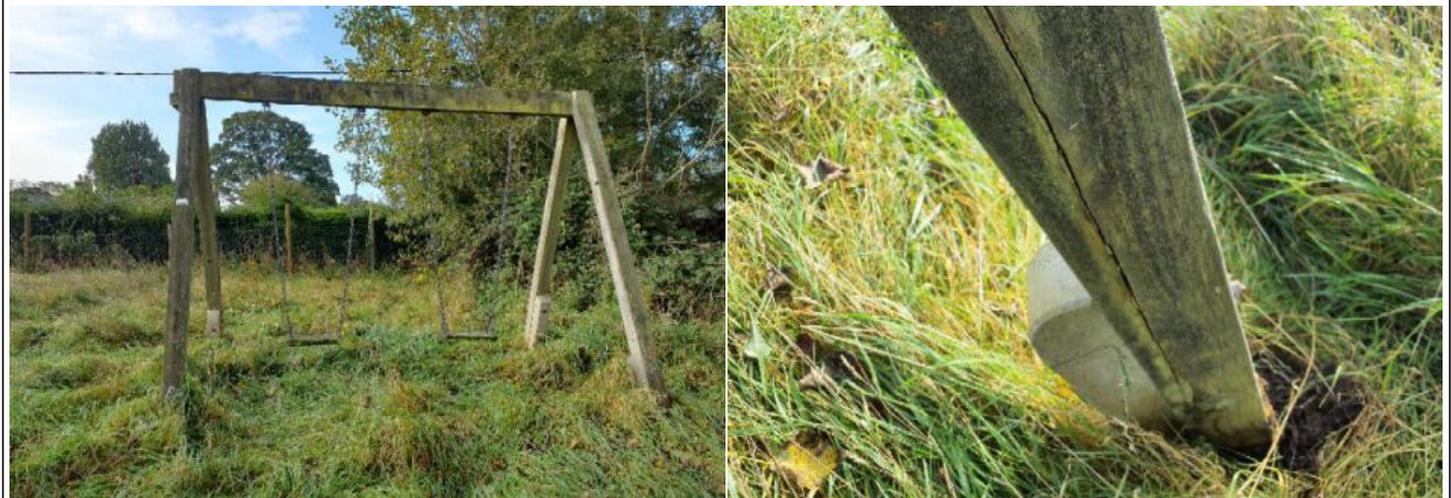
<b>Finding:</b> The timber has a number of splits/shakes or air cracks and this may affect the stability or allow water ingress which will accelerate the rotting process	<b>Action:</b> Monitor to ensure the splits do not cross through fixing points of the structure and/or cause any instability
---	--

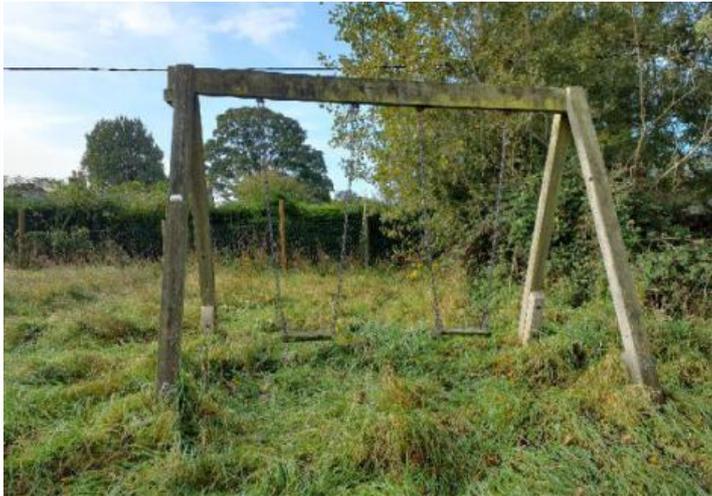
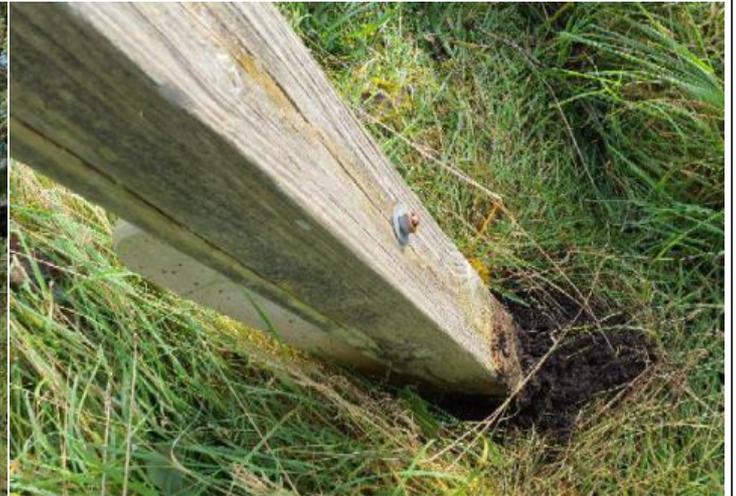
**Finding:** There is/are bolt cap covers missing or damaged on the item

**Action:** Replace missing or damaged bolt cap covers

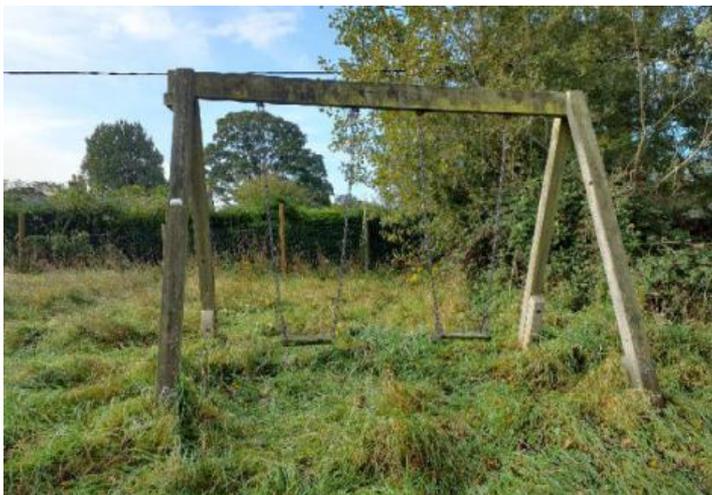
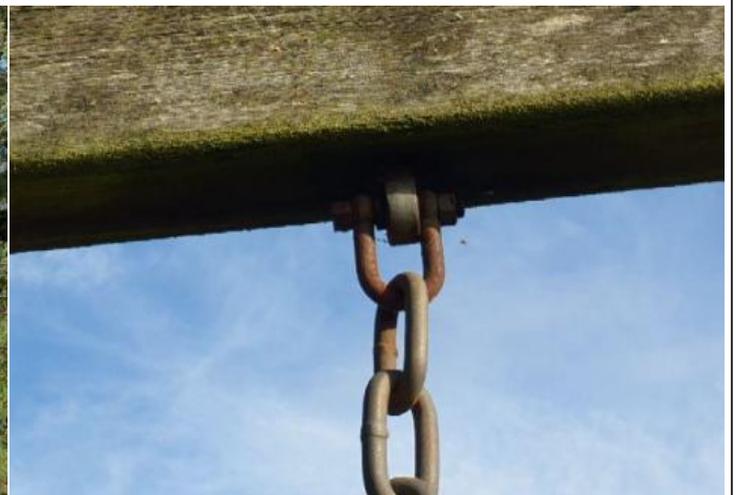
**Finding:** The bushes are showing signs of wear

**Action:** Monitor for any further deterioration and replace as required

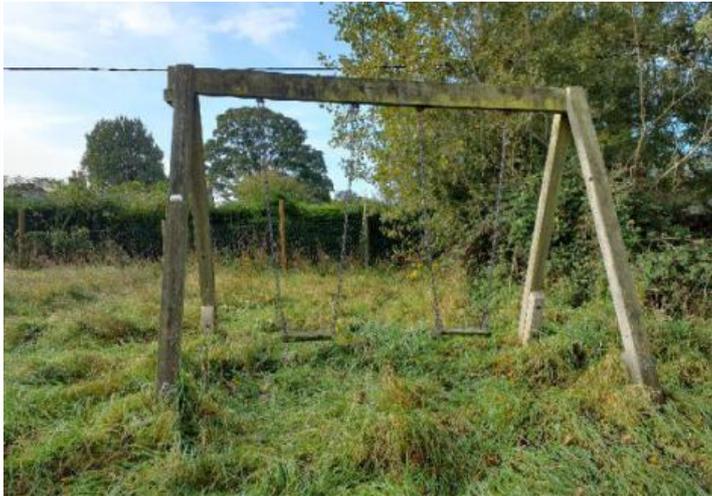
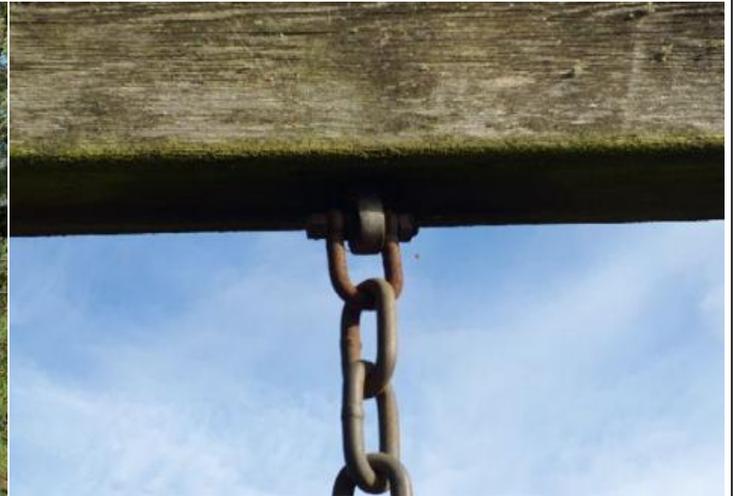
**Finding:** There is some wear to the shackles

**Action:** Monitor for any further deterioration and replace when 40% worn

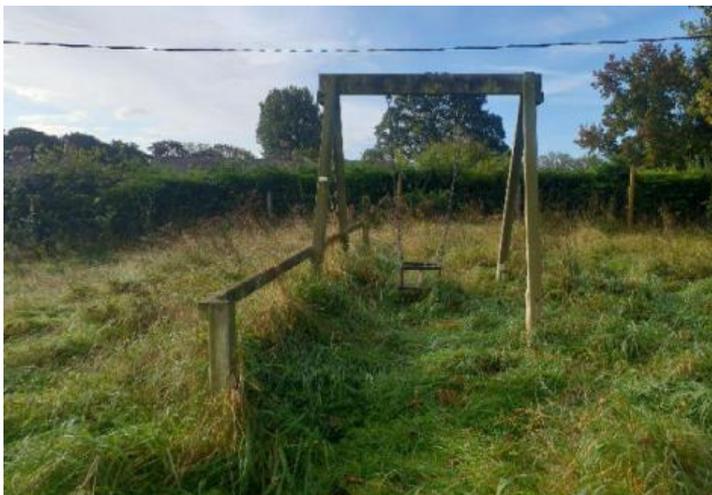
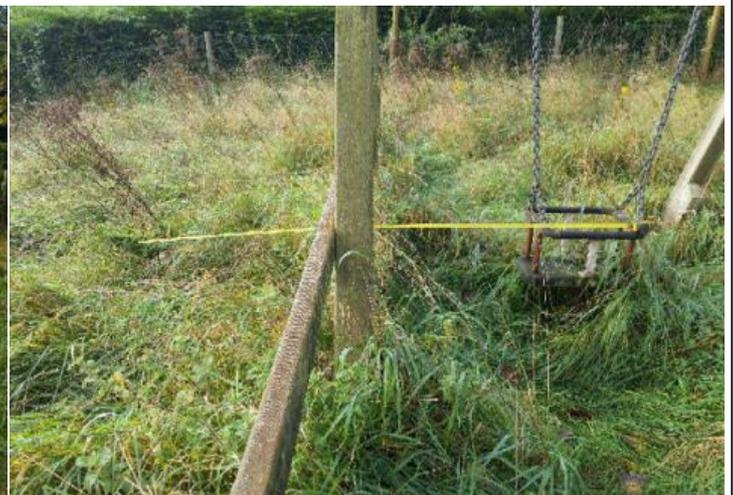
**Finding:** BS EN 1176 Part 2: Annex A makes a recommendation that fences or enclosures should be upto 1.50m from the edges of the swing seat to the sides, and subject to risk assessment, from the edge of the impact area. This is however, a low risk finding and no remedial action is recommended.

**Action:** Monitor - No remedial work recommended

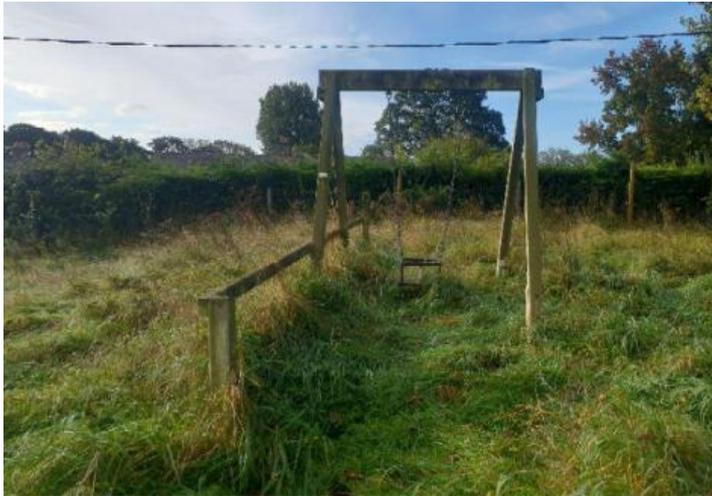
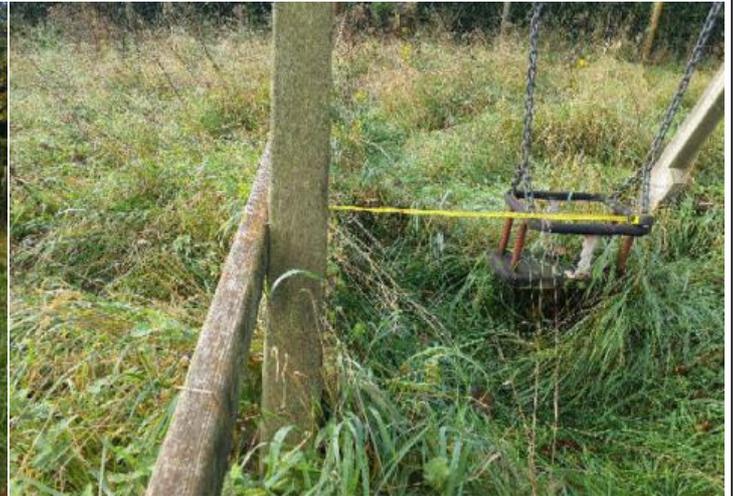
**Finding:** The seats are too close to the frame as defined in BS EN 1176 Part 2; this is a low risk failure and no remedial action is required

**Action:** Monitor - No remedial work recommended

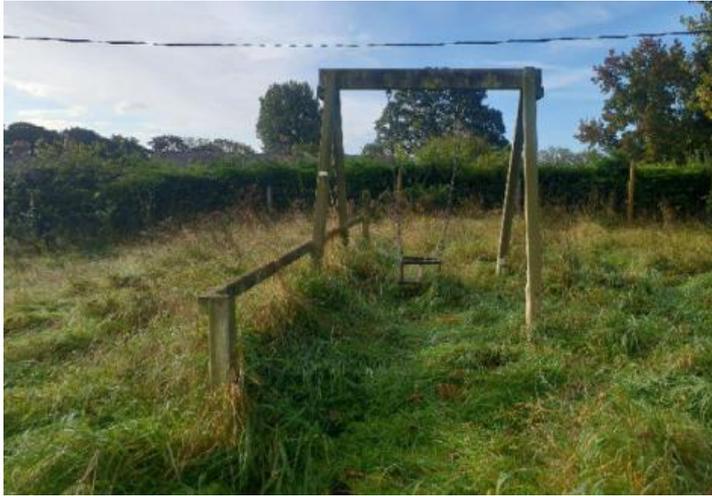
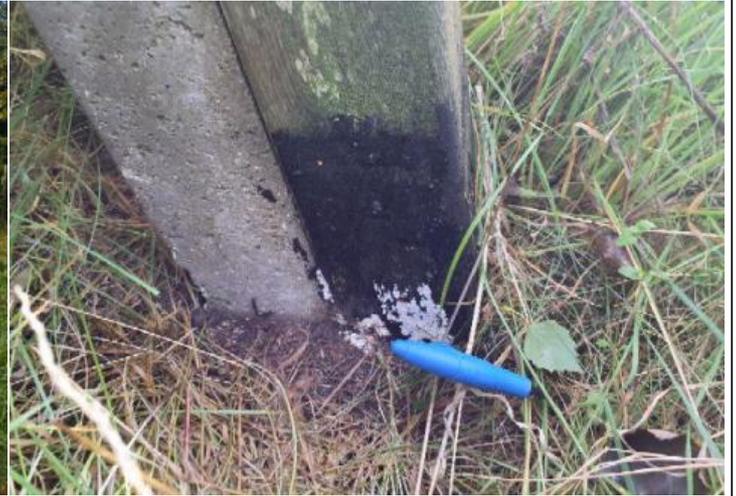
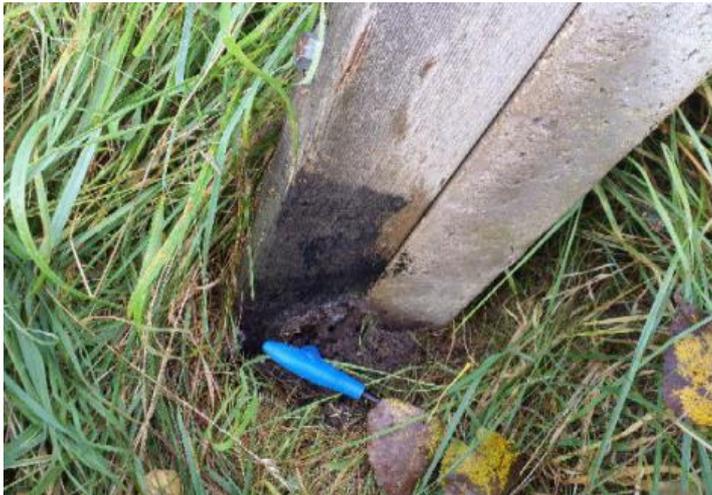
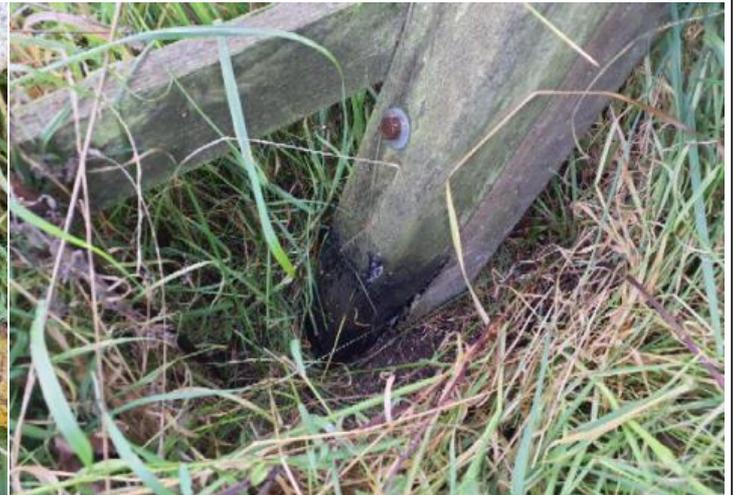
**Finding:** All 4 timber posts on the structure have rotted

**Action:** Replace all affected timbers

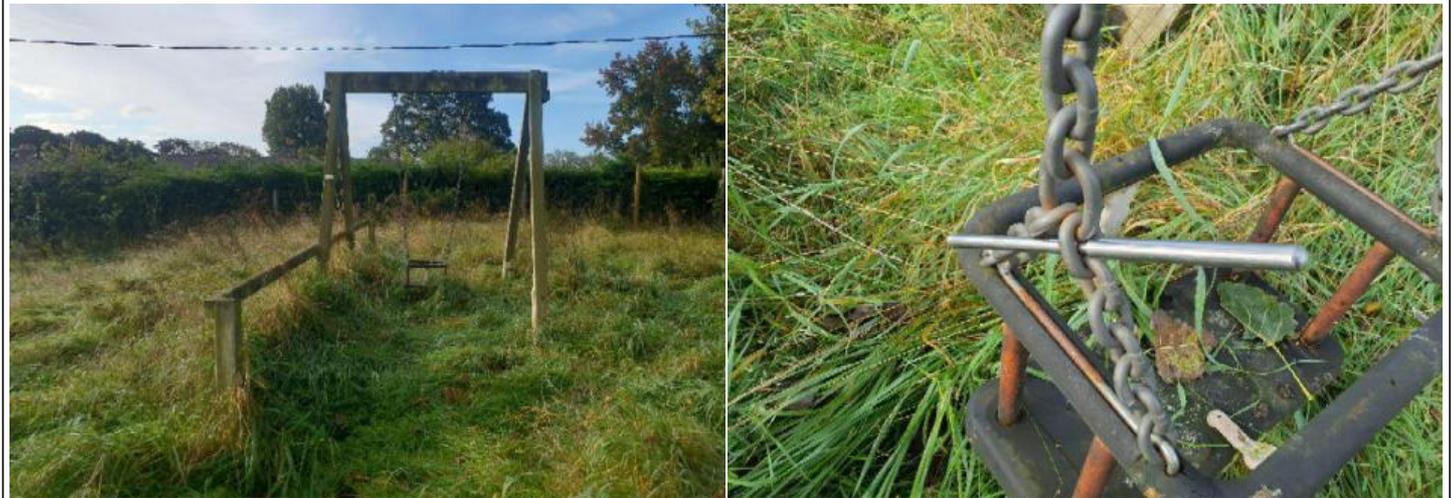
**Finding:** The chain openings are in excess of the 8.6mm as recommended by BS EN 1176  
**Action:** Monitor - No remedial work recommended

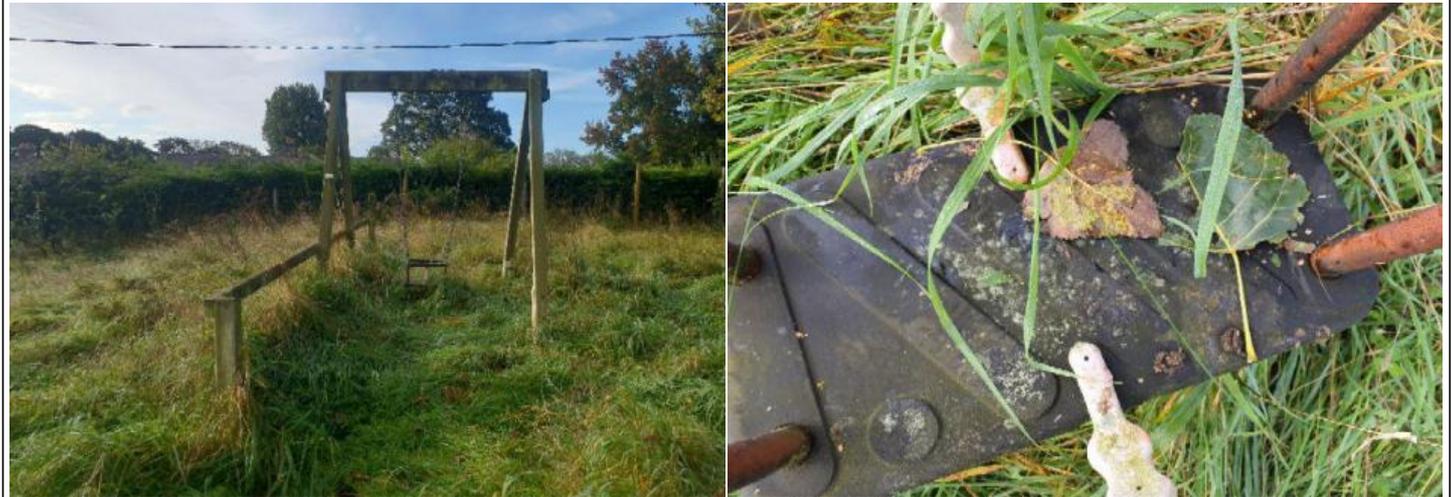
**Finding:** There is algae or moss on the surface of the equipment  
**Action:** Clean and treat appropriately

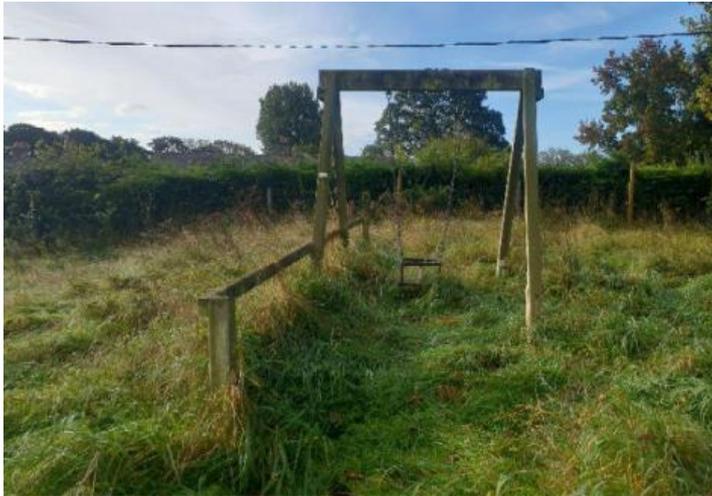
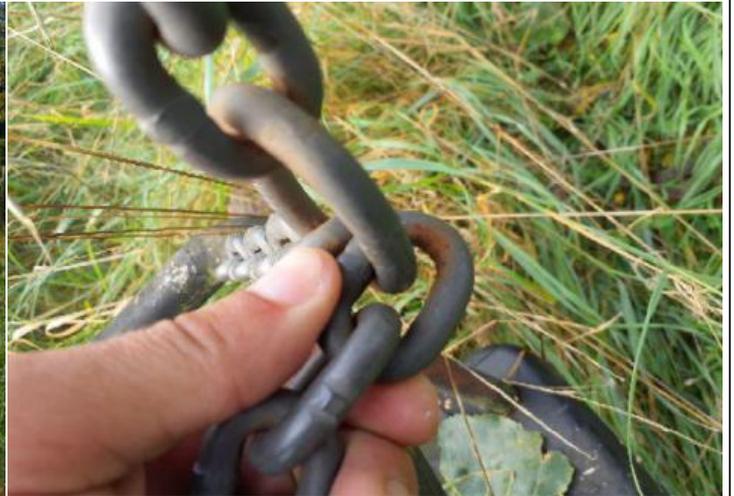
**Finding:** There is some notable evidence of chain wear

**Action:** Monitor for any further deterioration and replace when 40% worn

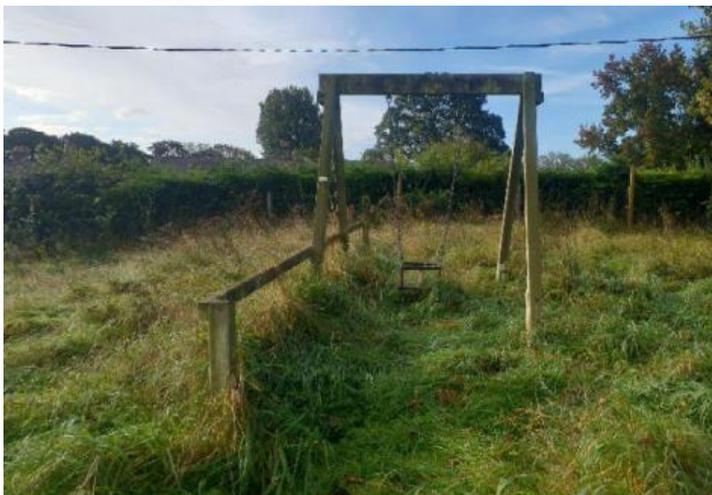
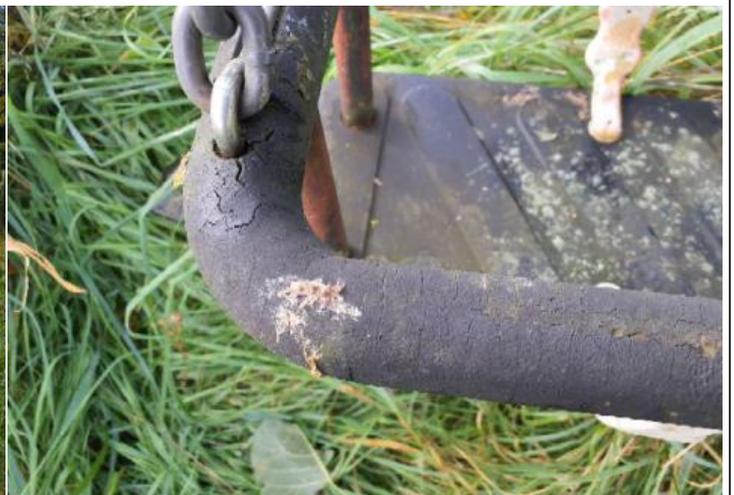
**Finding:** The seat has minor damage or wear

**Action:** Monitor for any further deterioration and replace as required
