# the **play** inspection company

## Annual Inspection

Bockhampton

Bockhampton Lane, Lower Bockhampton, Dorset, DT2  
8PZ

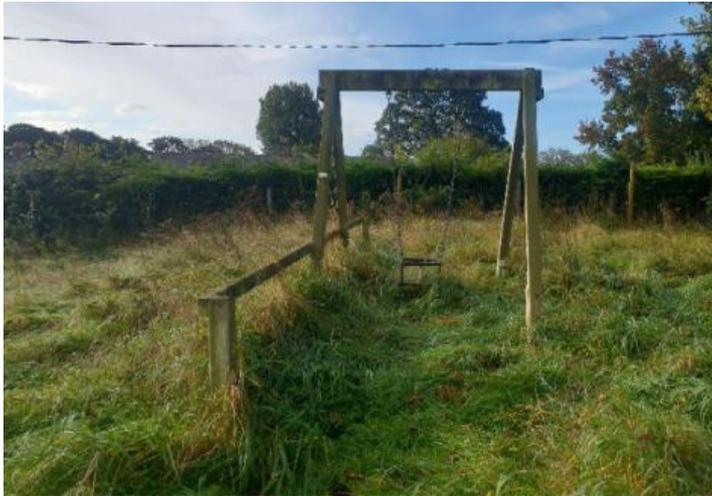
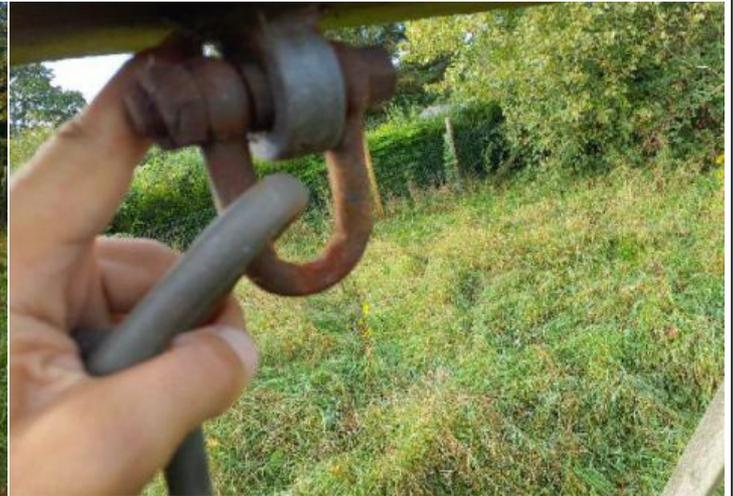
**Finding:** There is some wear to the shackles

**Action:** Monitor for any further deterioration and replace when 40% worn

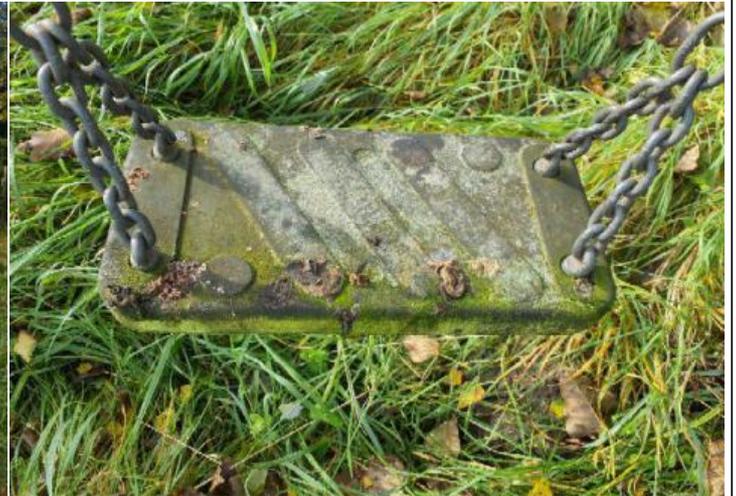
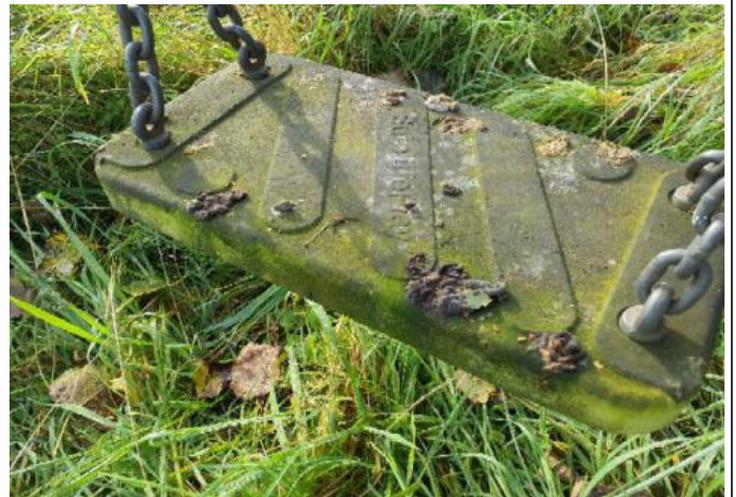
**Finding:** There is algae or moss on the surface of the equipment

**Action:** Clean and treat appropriately

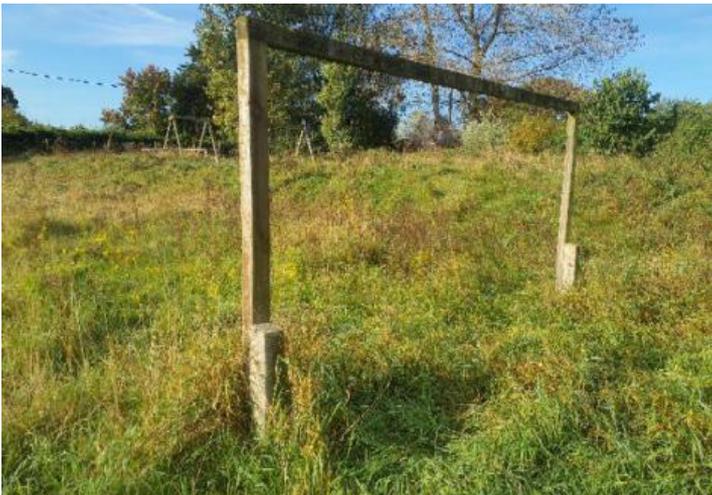
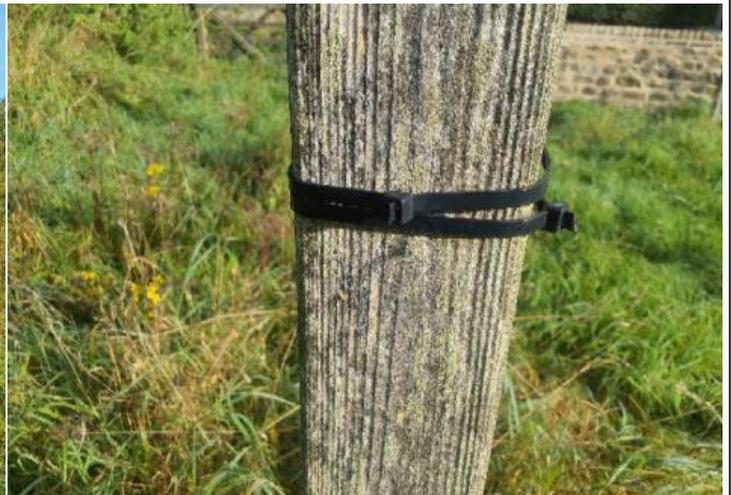
**Finding:** Cable ties have been used on the item and there are sharp projecting ends

**Action:** Remove if not required or replace with a more appropriate alternative fixing method if used as a fixing

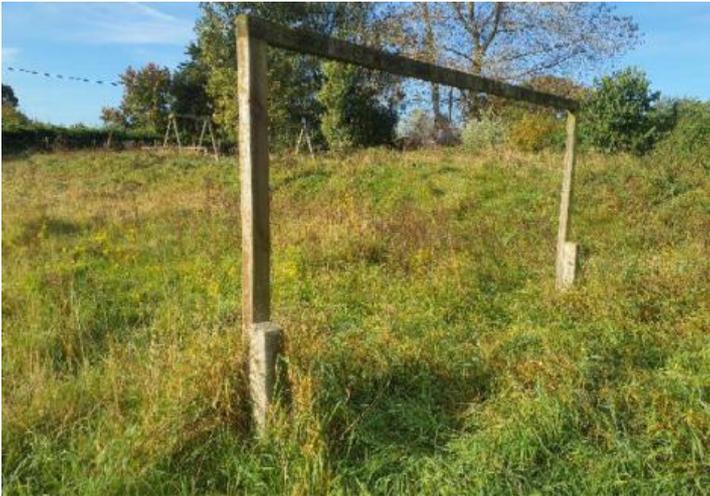
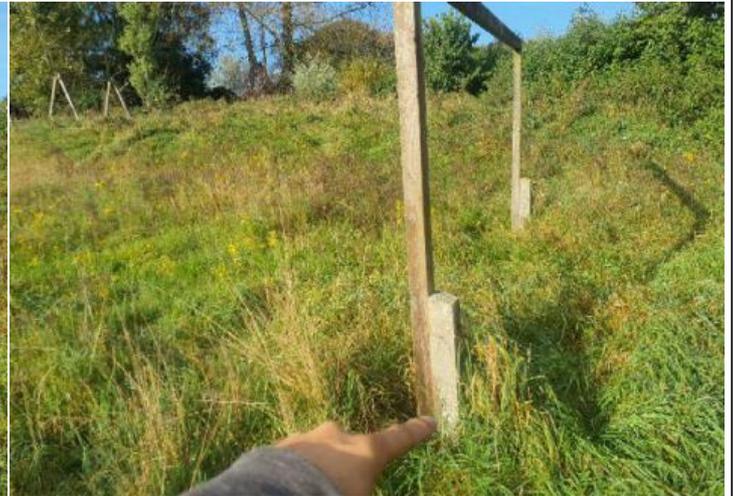
**Finding:** The item is slightly loose in its foundations

**Action:** Monitor for any further deterioration and repair as required

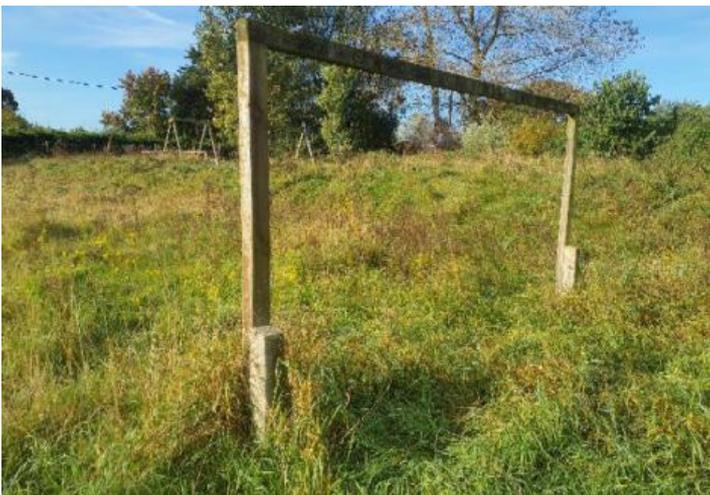
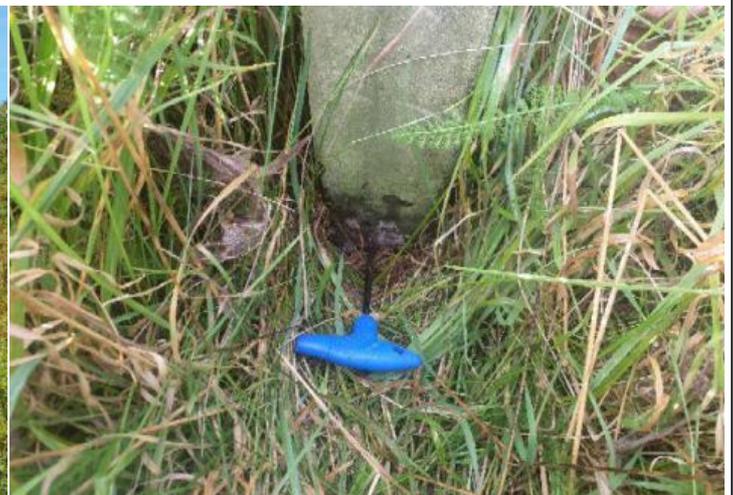
**Finding:** There are areas or parts of the timber on the structure that have rotted

**Action:** Replace all affected timbers

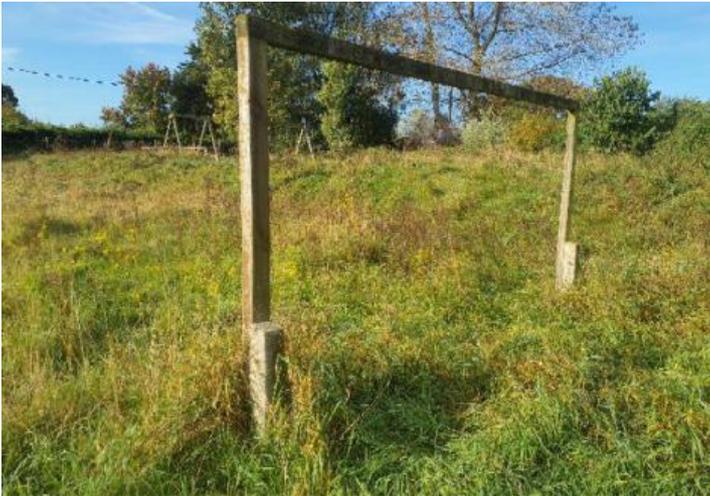
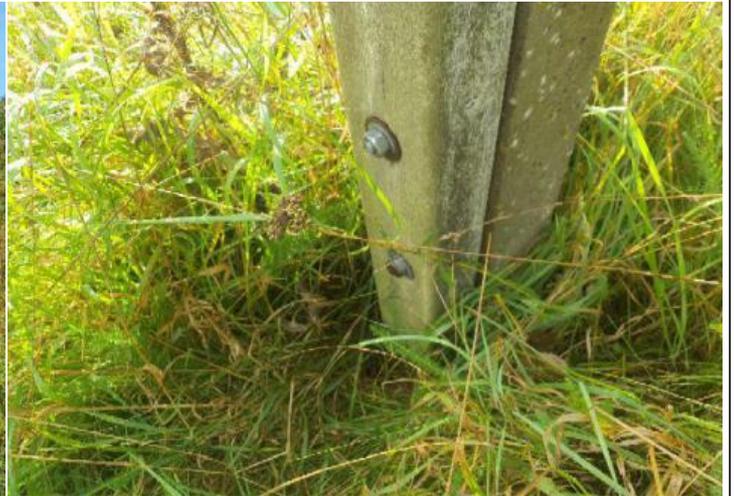
**Finding:** There is/are bolt cap covers missing or damaged on the item

**Action:** Replace missing or damaged bolt cap covers
