## Annual Inspection

Bockhampton

Bockhampton Lane, Lower Bockhampton, Dorset, DT2 8PZ

Annual Inspection - 07 July 2017 at 11:07 Inspector: Leon Pope RPII Annual Inspector

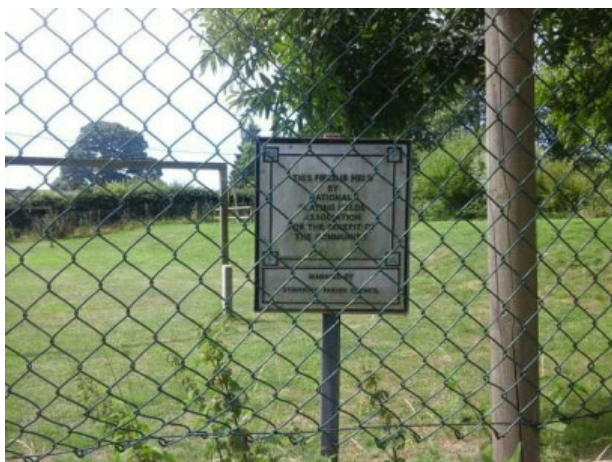
It is recommended that information signs with emergency contact details are installed at each entrance/exit point to the playground - Provide in accordance with the recommendations set out in BS EN 1176

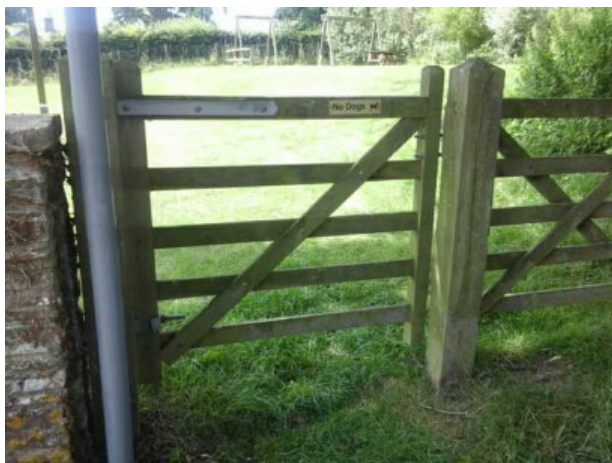
This item is satisfactory - no work required

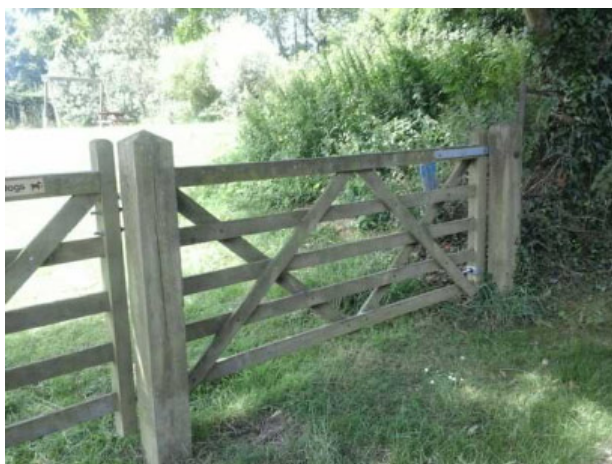
There is no padlock on the maintenance gate - Provide padlock to secure gate

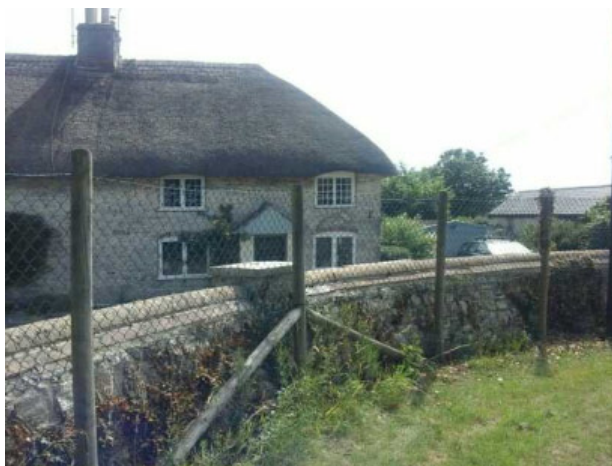
There are a number of loose posts around the fence - Monitor for any further deterioration and reset as required

Parts of the timber are rough or splintered - Remove all rough or sharp edges

There is some evidence of rot in the timber - Monitor for any further deterioration and replace as required

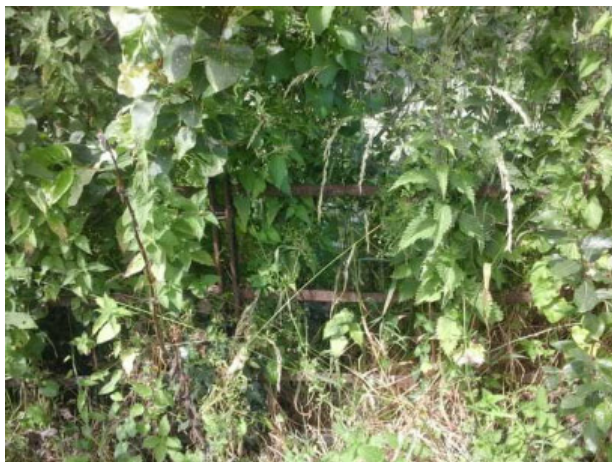
The paintwork on this item has been damaged or worn exposing the metal underneath which is rusting - Treat any rusting components and repaint

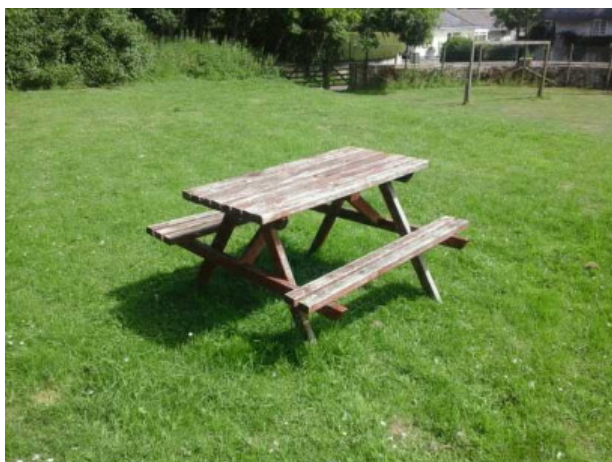
There are missing slats - Repair affected areas

There are areas or parts of the timber on the structure that have rotted - Replace all affected timbers

A number of fixing(s) have worked loose - Secure all loose fixings

Parts of the timber are rough or splintered - Remove all rough or sharp edges

The table is not secured to the ground and there is some potential for the item to be moved within falling spaces of equipment - Secure the item to the ground

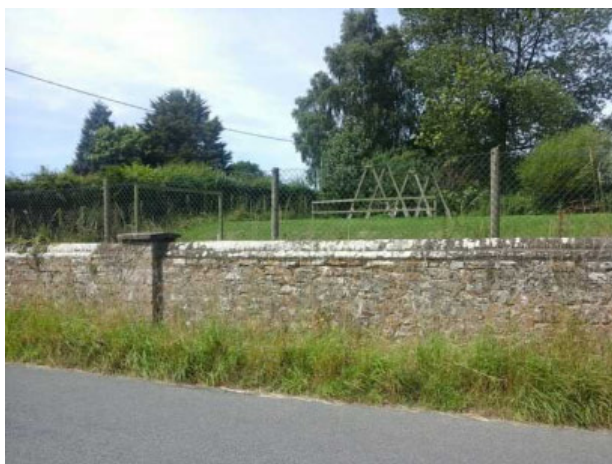
There are stinging nettles/vegetation growth protruding through the fencing surrounding the play area - Cut back and maintain area

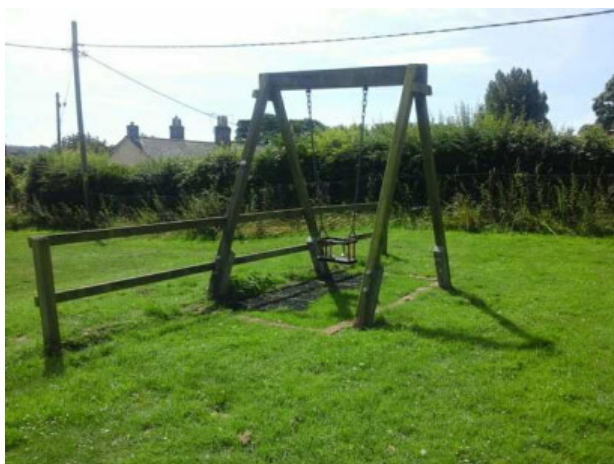
There is some strimmer damage apparent on the posts, this can penetrate the preservative applied to the timber and accelerate the rotting process - Monitor for any deterioration (rot) and replace as required

There is some evidence of rot in the posts - Monitor for any further deterioration and replace as required

There is some evidence of rot in the swing barrier - Monitor for any further deterioration and replace as required

The posts on the swing barrier are slightly loose in the ground - Monitor for any further deterioration and repair as required

Fixing Pins have been installed in the impact areas of the grass mats - Remove pins from impact areas

There are stinging nettles beneath the item - Remove

There is some evidence of rot in the crossbeam - Monitor for any further deterioration and replace as required

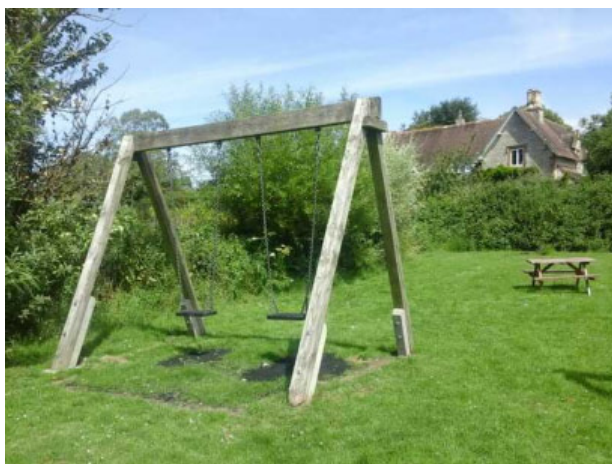
The seats are too close to the frame as defined in BS EN 1176 Part 2; this is a low risk failure and no remedial action is required - Monitor use

There are areas or parts of the posts on the structure that have rotted - Replace all affected timbers

The timber has a number of air cracks apparent, the splits will have penetrated the preservative applied to the timber and allow water ingress to the unprotected areas - Monitor for any deterioration (rot) and replace as required

There is some evidence of rot in the crossbeam - Monitor for any further deterioration and replace as required

Fixing Pins have been installed in the impact areas of the grass mats - Remove pins from impact areas

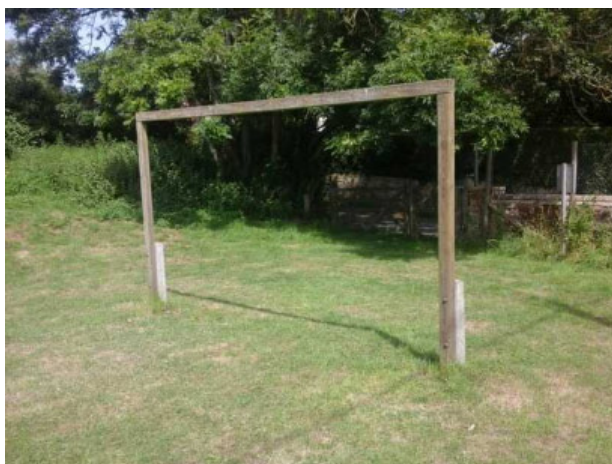
There are areas or parts of the timber on the structure that have rotted - Replace all affected timbers

Parts of the timber are rough or splintered - Remove all rough or sharp edges

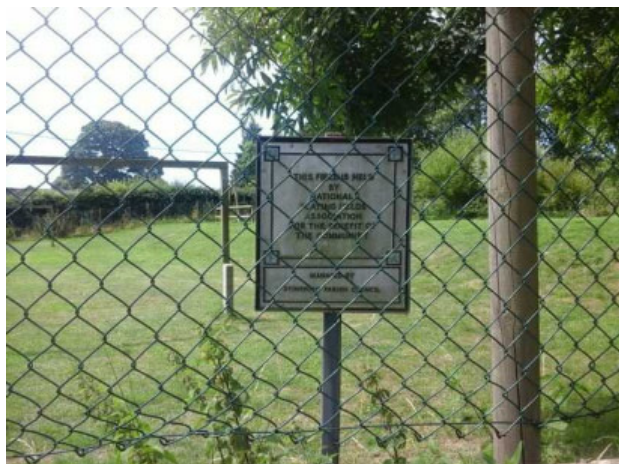
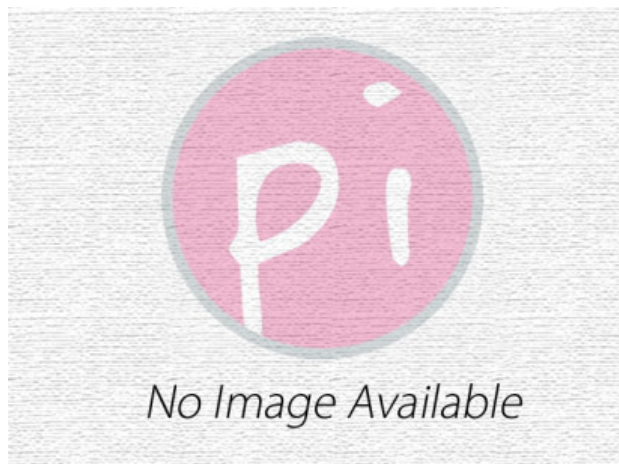
Finding:	It is recommended that information signs with emergency contact details are installed at each entrance/exit point to the playground		
Action:	Provide in accordance with the recommendations set out in BS EN 1176

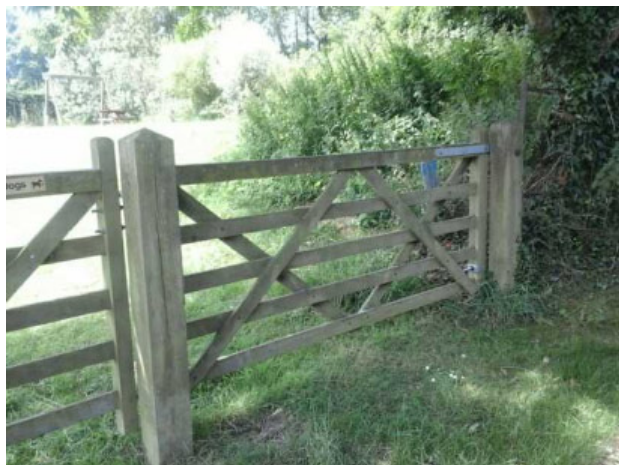
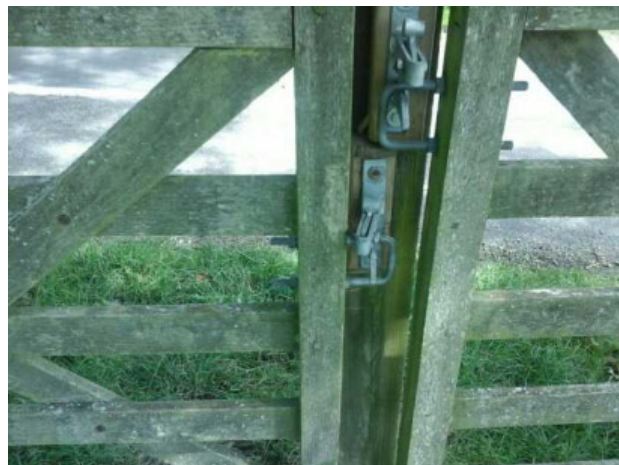
Finding:	There is no padlock on the maintenance gate				
Action:	Provide padlock to secure gate

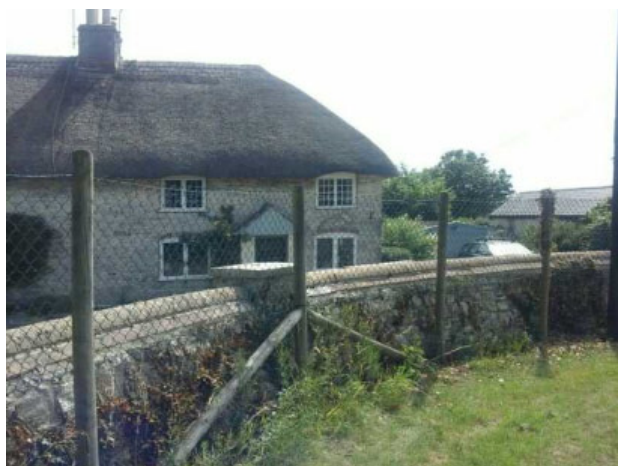
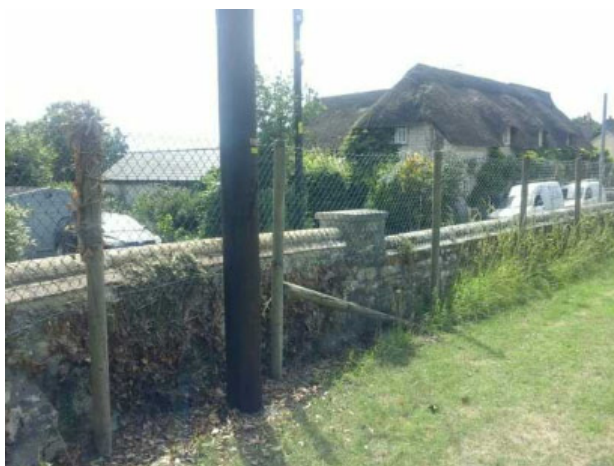
**Finding:** There are a number of loose posts around the fence  
**Action:** Monitor for any further deterioration and reset as required

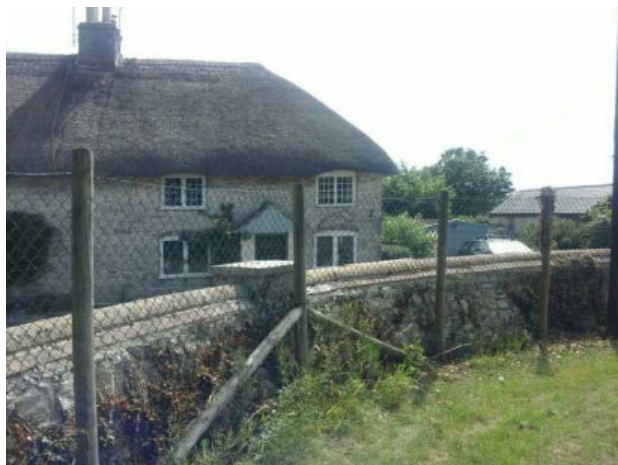
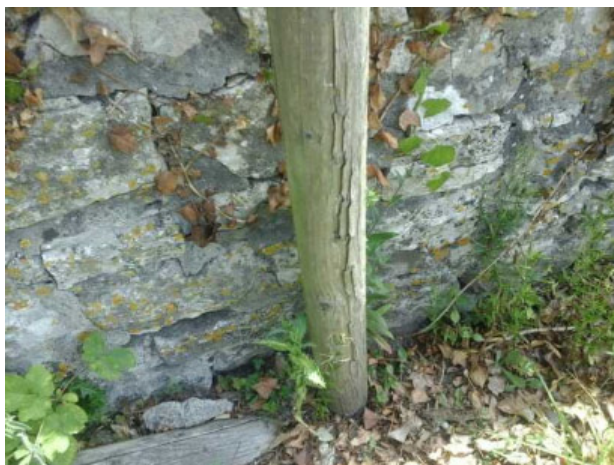
**Finding:** Parts of the timber are rough or splintered  
**Action:** Remove all rough or sharp edges

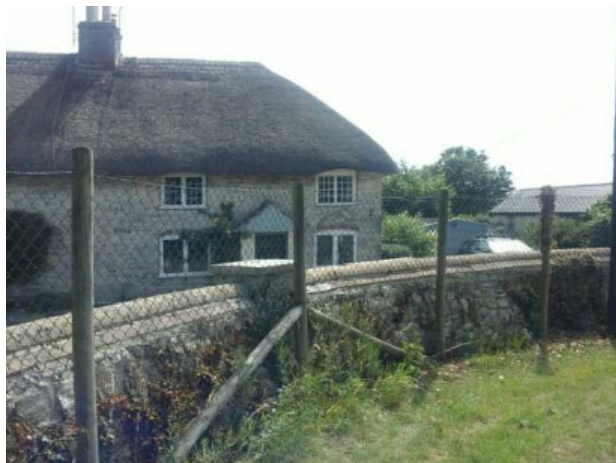
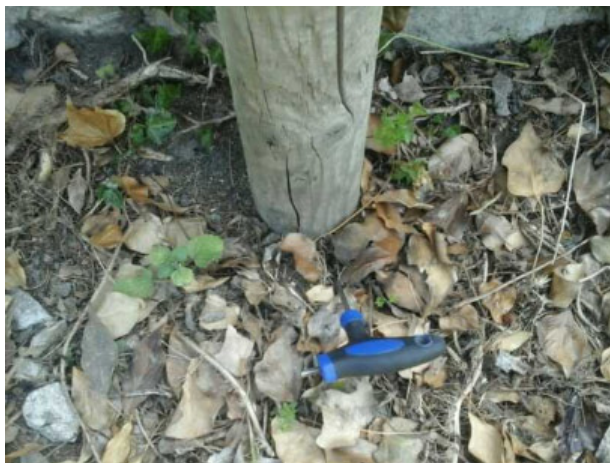
**Finding:** There is some evidence of rot in the timber

**Action:** Monitor for any further deterioration and replace as required

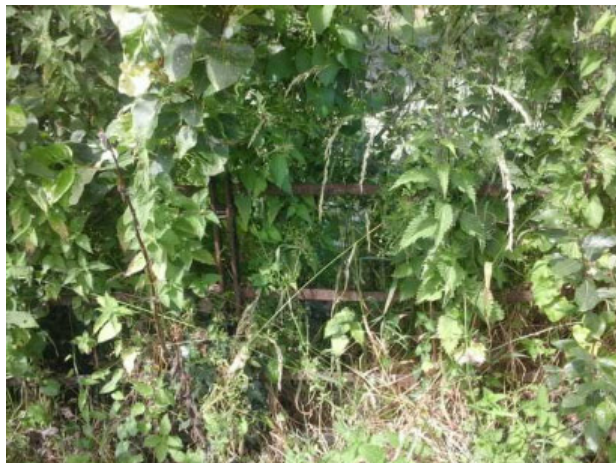
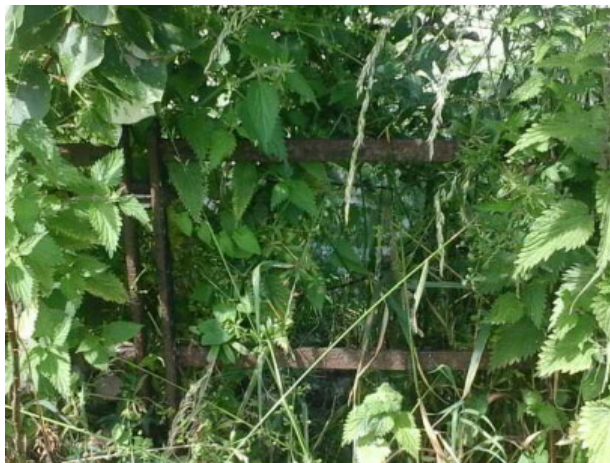
**Finding:** The paintwork on this item has been damaged or worn exposing the metal underneath which is rusting

**Action:** Treat any rusting components and repaint

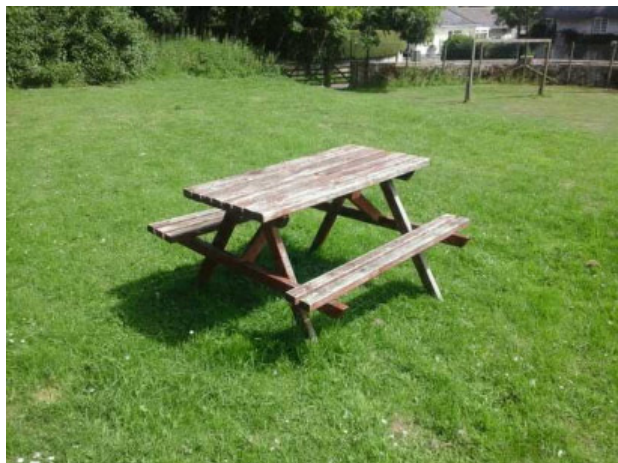
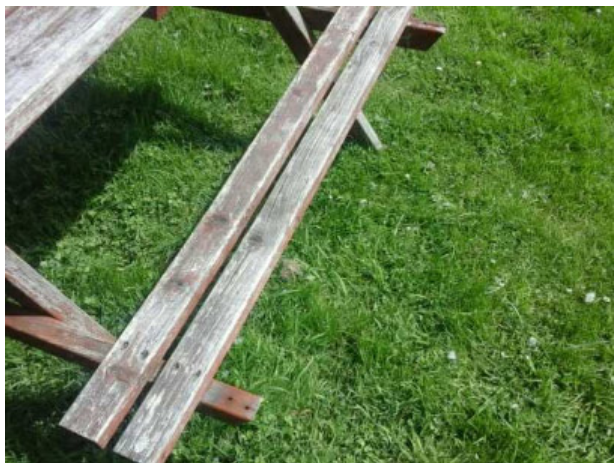
**Finding:** There are missing slats

**Action:** Repair affected areas

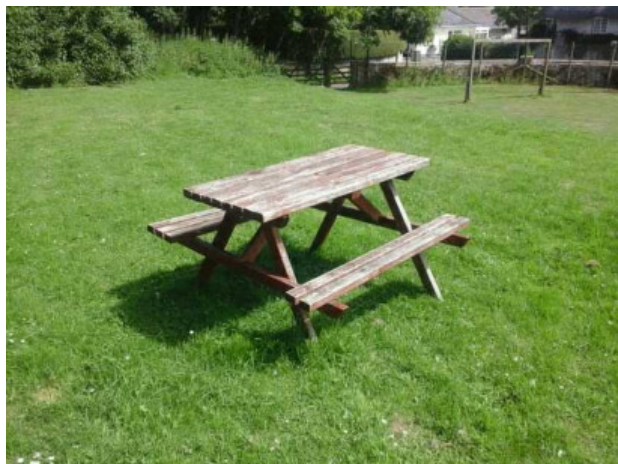
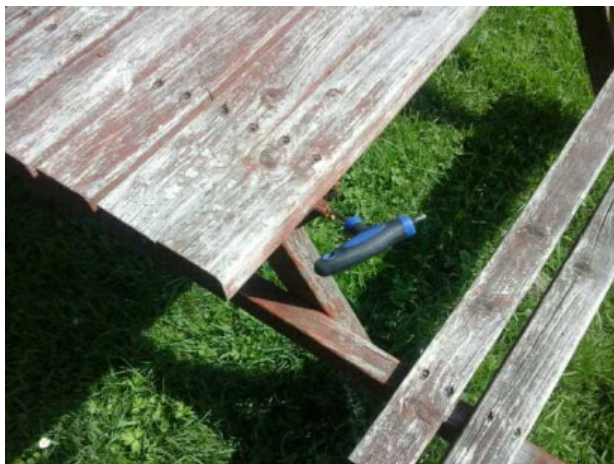
**Finding:** There are areas or parts of the timber on the structure that have rotted

**Action:** Replace all affected timbers

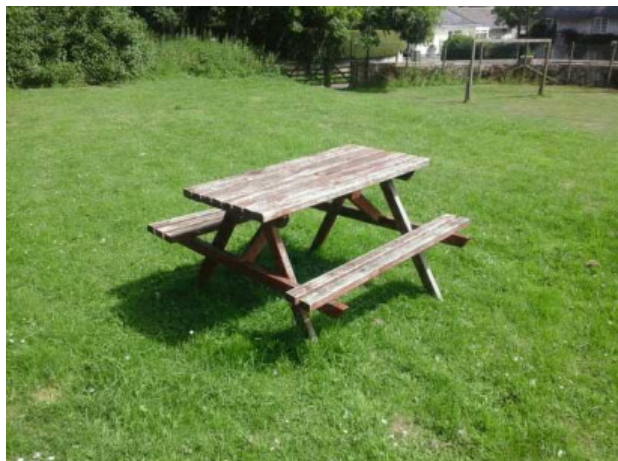
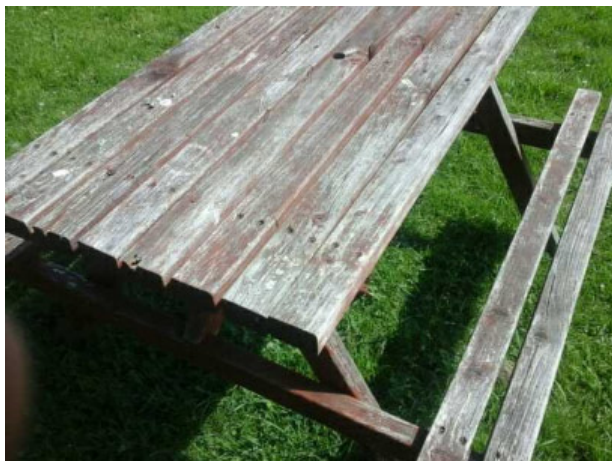
**Finding:** A number of fixing(s) have worked loose

**Action:** Secure all loose fixings

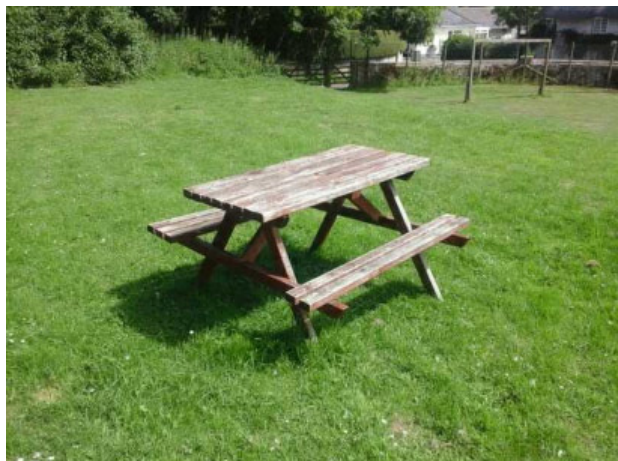
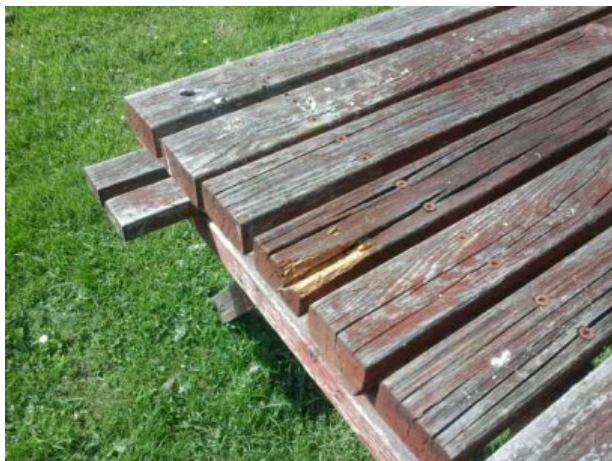
**Finding:** Parts of the timber are rough or splintered

**Action:** Remove all rough or sharp edges

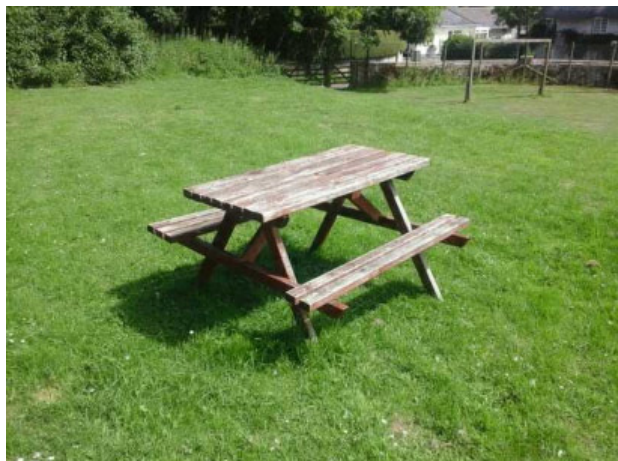
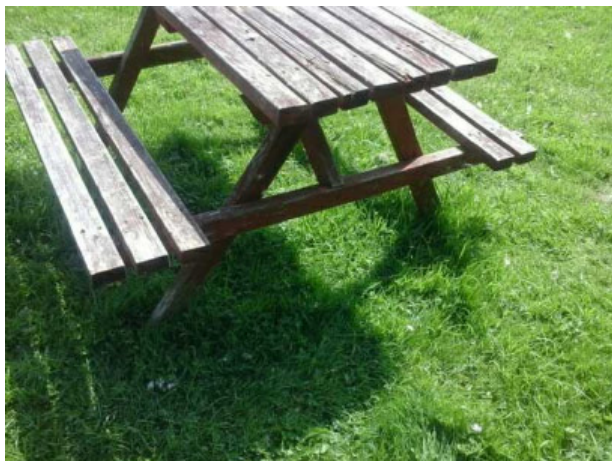
**Finding:** The table is not secured to the ground and there is some potential for the item to be moved within falling spaces of equipment

**Action:** Secure the item to the ground

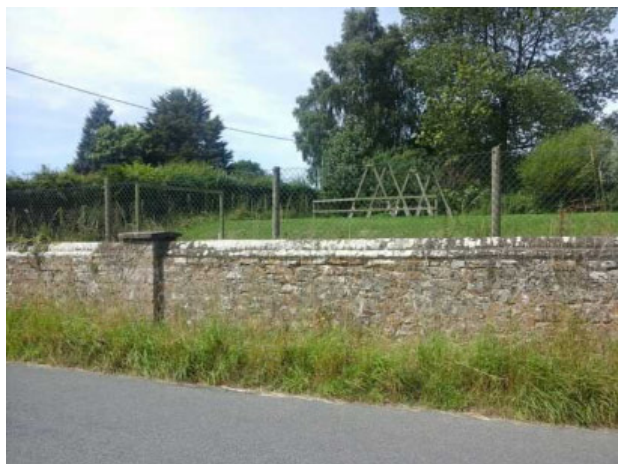
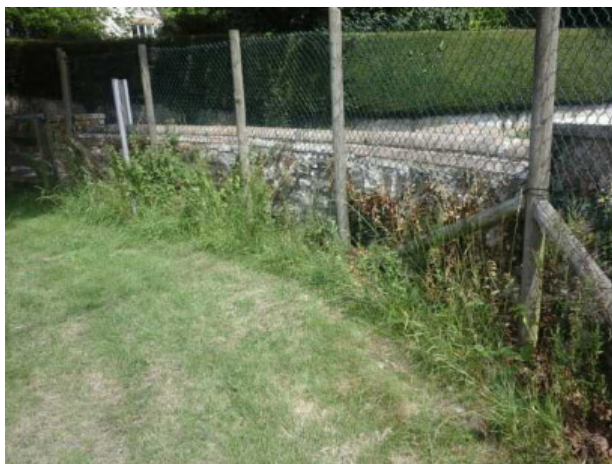
**Finding:** There are stinging nettles/vegetation growth protruding through the fencing surrounding the play area

**Action:** Cut back and maintain area

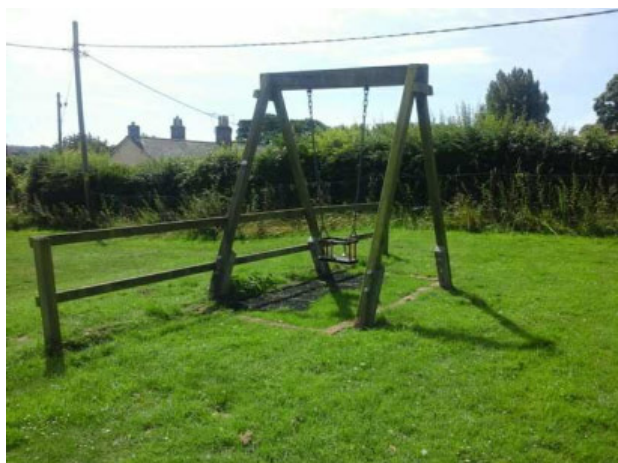
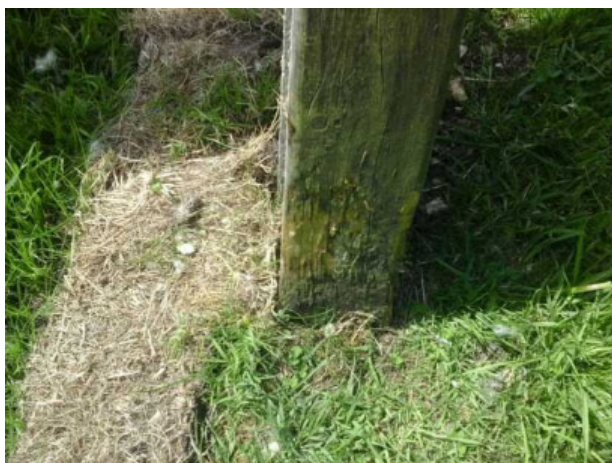
**Finding:** There is some strimmer damage apparent on the posts, this can penetrate the preservative applied to the timber and accelerate the rotting process

**Action:** Monitor for any deterioration (rot) and replace as required

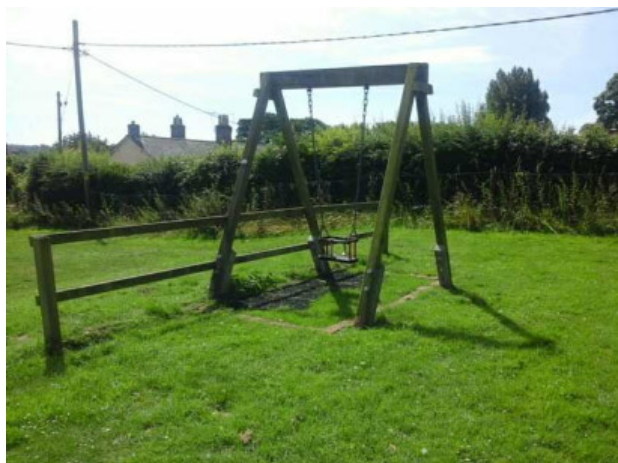
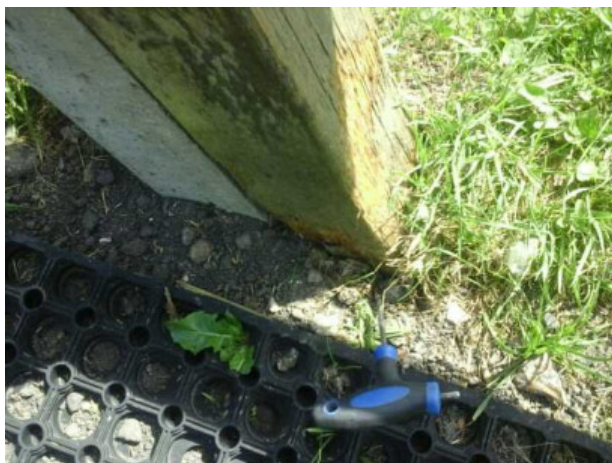
**Finding:** There is some evidence of rot in the posts

**Action:** Monitor for any further deterioration and replace as required

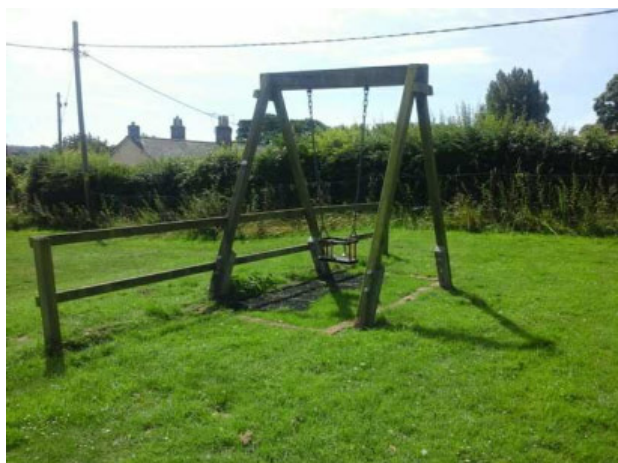
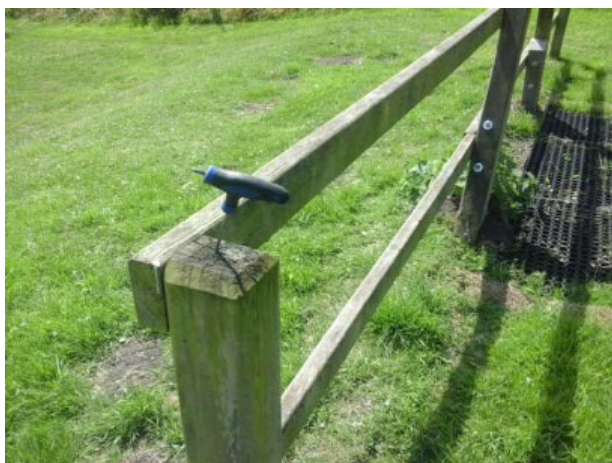
**Finding:** There is some evidence of rot in the swing barrier

**Action:** Monitor for any further deterioration and replace as required

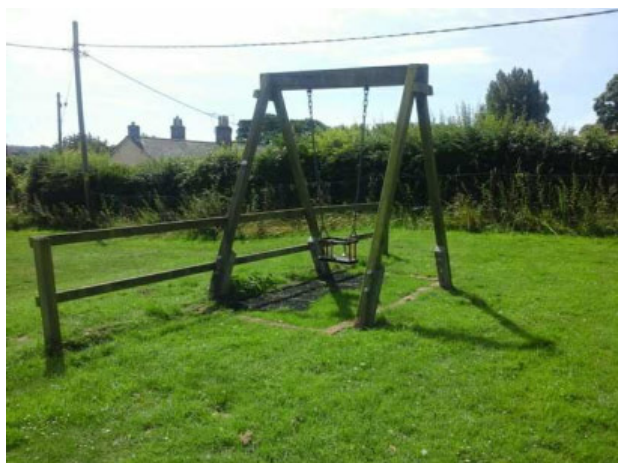
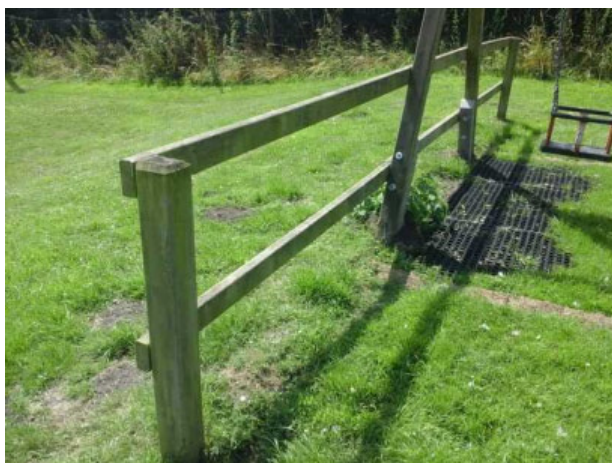
**Finding:** The posts on the swing barrier are slightly loose in the ground

**Action:** Monitor for any further deterioration and repair as required

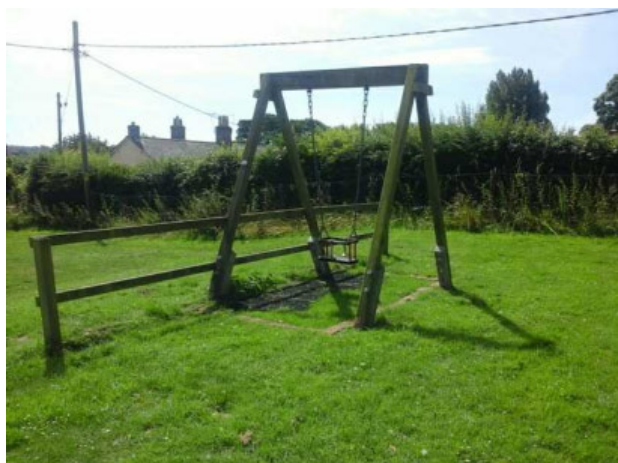
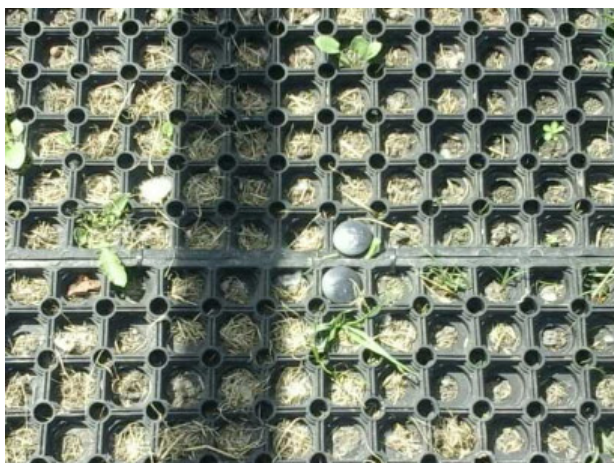
**Finding:** Fixing Pins have been installed in the impact areas of the grass mats

**Action:** Remove pins from impact areas

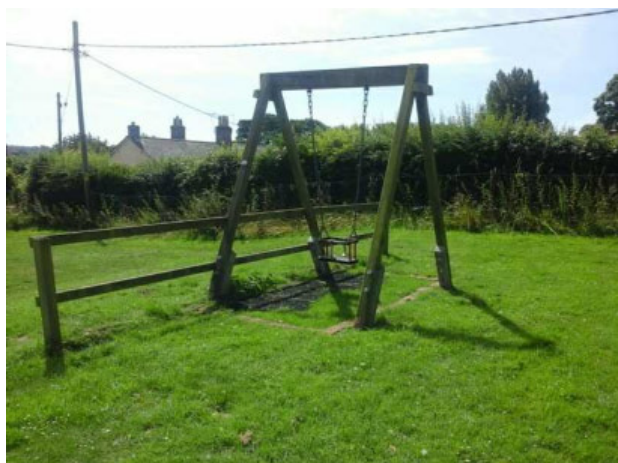
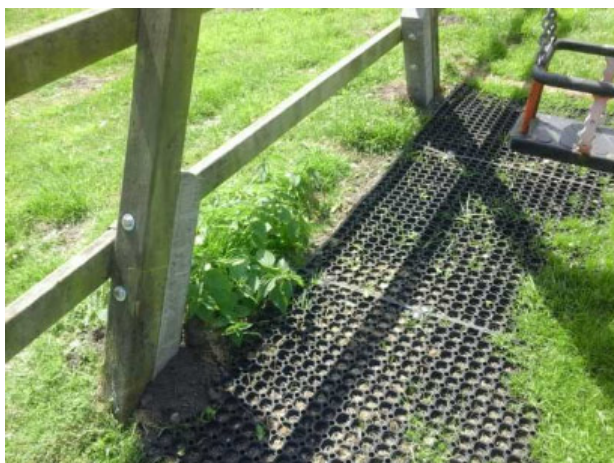
**Finding:** There are stinging nettles beneath the item

**Action:** Remove

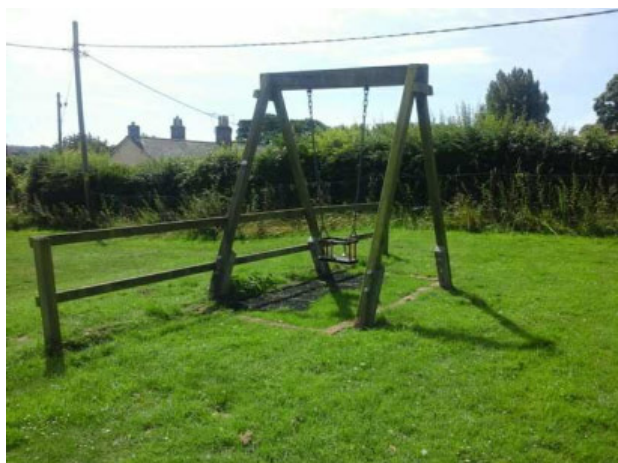
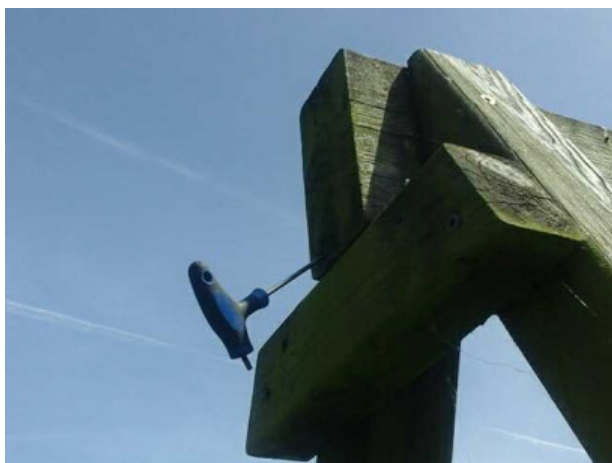
**Finding:** There is some evidence of rot in the crossbeam

**Action:** Monitor for any further deterioration and replace as required

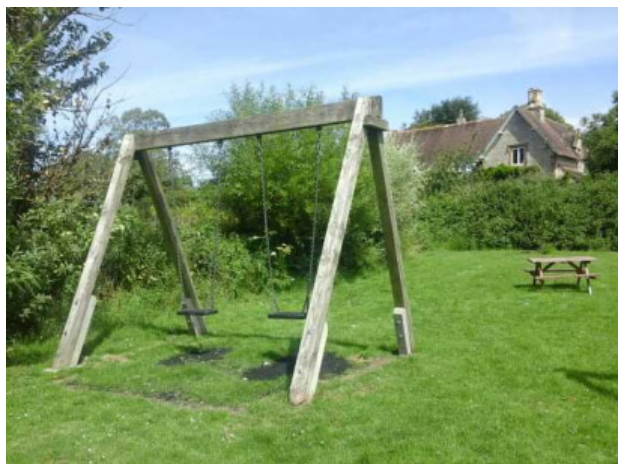
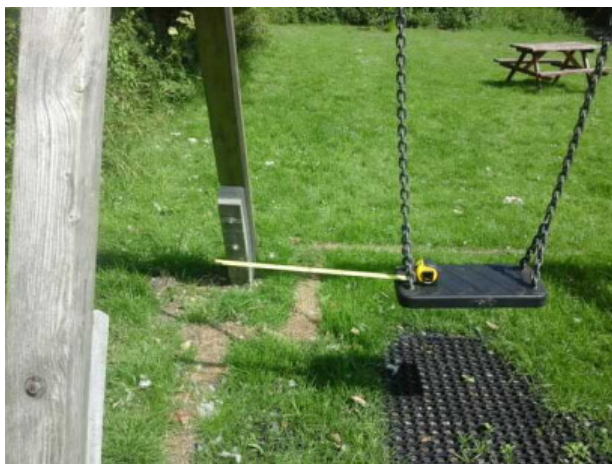
**Finding:** The seats are too close to the frame as defined in BS EN 1176 Part 2; this is a low risk failure and no remedial action is required

**Action:** Monitor use

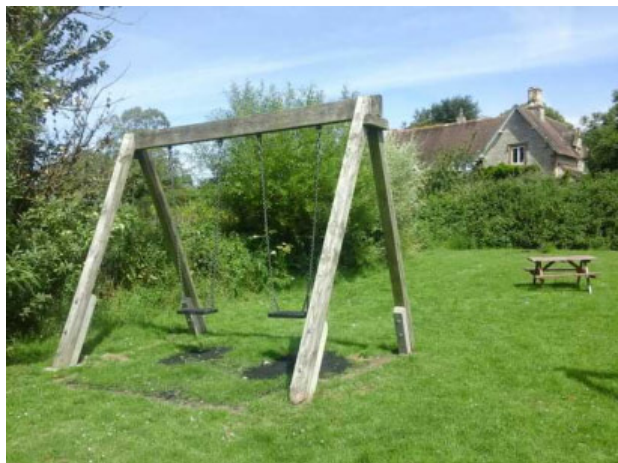
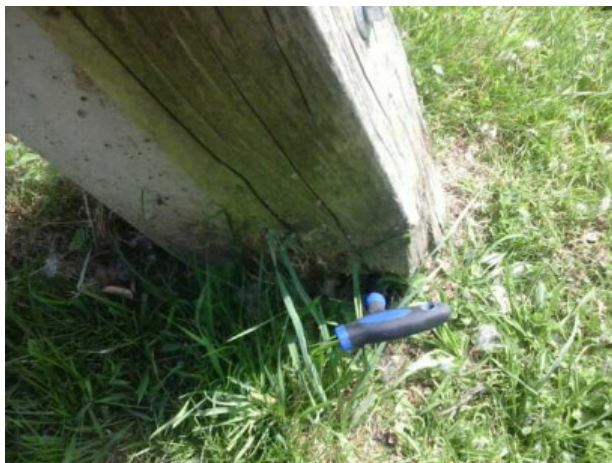
**Finding:** There are areas or parts of the posts on the structure that have rotted

**Action:** Replace all affected timbers

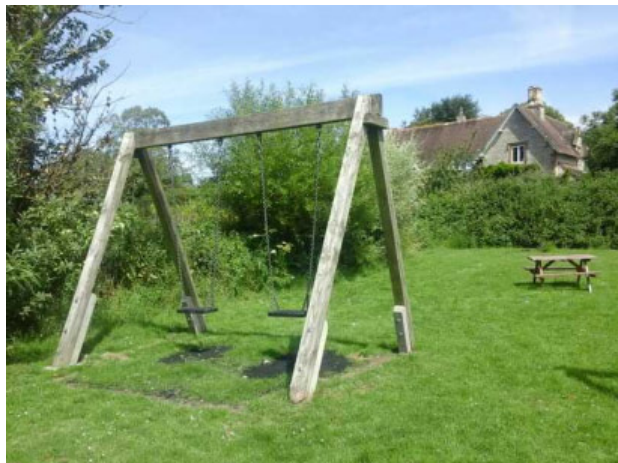
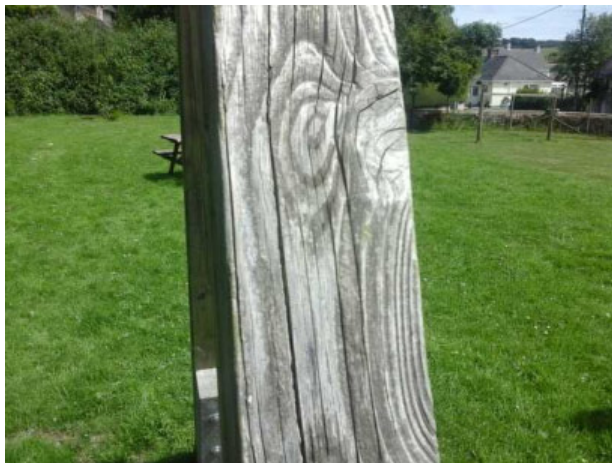
**Finding:** The timber has a number of air cracks apparent, the splits will have penetrated the preservative applied to the timber and allow water ingress to the unprotected areas

**Action:** Monitor for any deterioration (rot) and replace as required

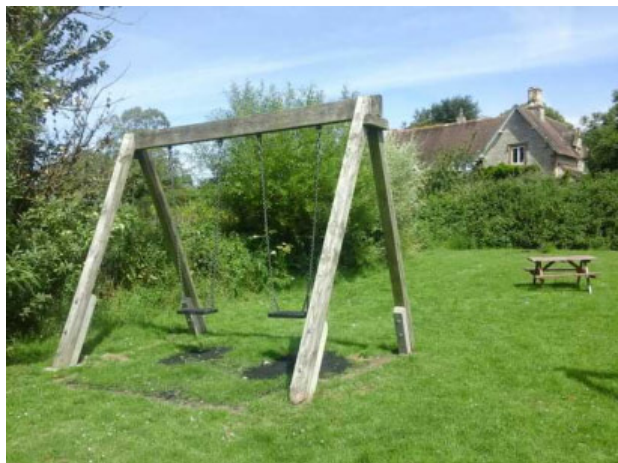
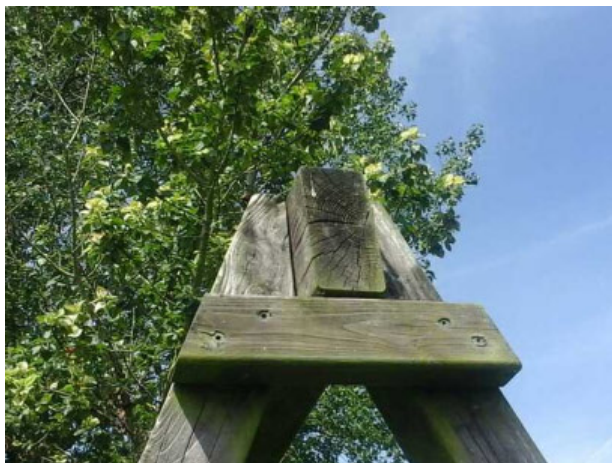
**Finding:** There is some evidence of rot in the crossbeam

**Action:** Monitor for any further deterioration and replace as required

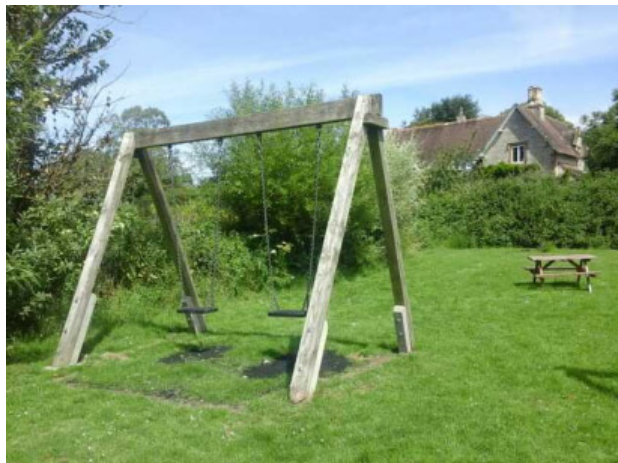
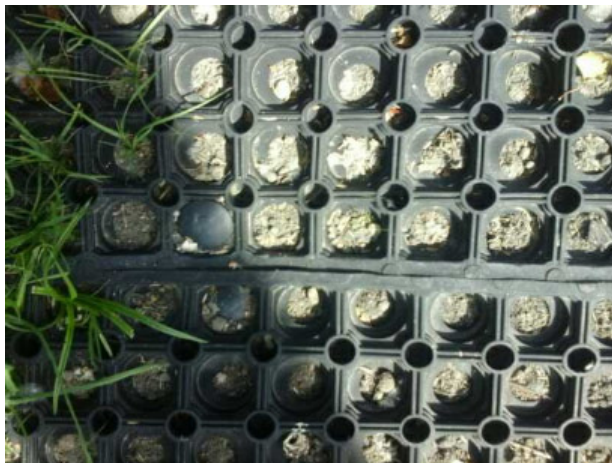
**Finding:** Fixing Pins have been installed in the impact areas of the grass mats

**Action:** Remove pins from impact areas

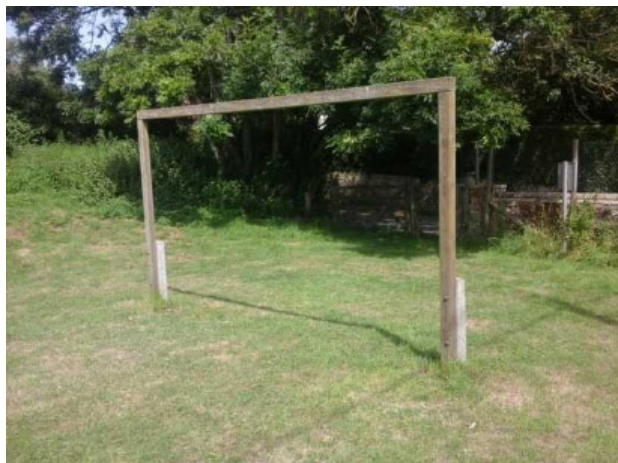
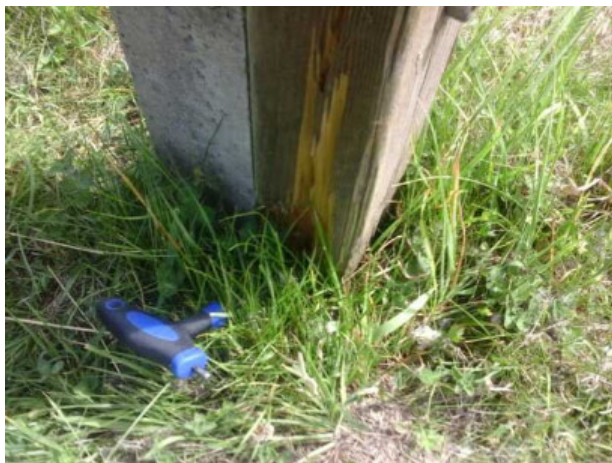
**Finding:** There are areas or parts of the timber on the structure that have rotted

**Action:** Replace all affected timbers

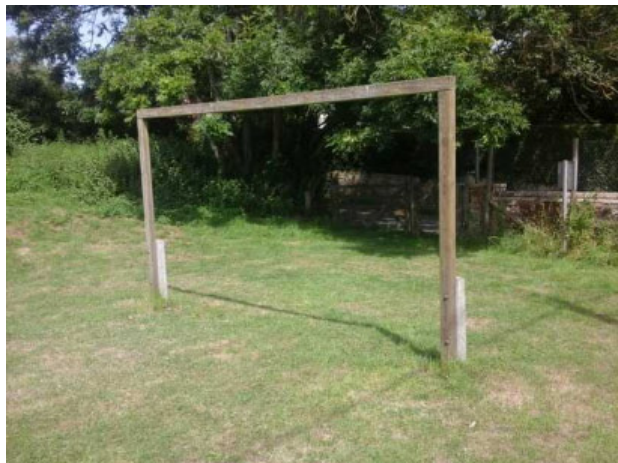
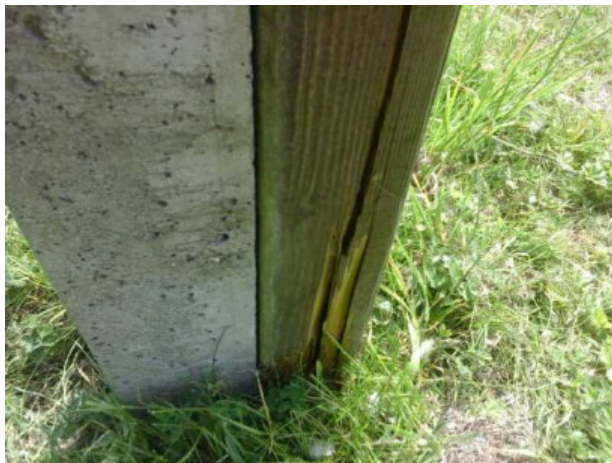
**Finding:** Parts of the timber are rough or splintered

**Action:** Remove all rough or sharp edges
