## Annual Inspection

Bockhampton

Bockhampton Lane, Lower Bockhampton, Dorset, DT2  
8PZ

Inspection Ref: 1509630

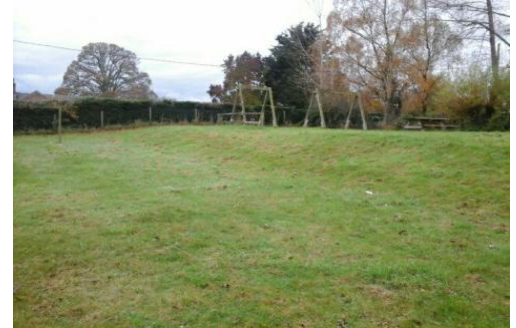
**Item:** Site General  
**Manufacturer:** Owner/Operator  
**Surface Type:** N/A  
**Item Quantity:** 1  
**Equipment Compliance:** N/A  
**Surface Area Compliance:** N/A

There are a number of molehills within the area and these may present unforeseen hazards for users - Remove moles by appropriate means, reinstate surfaces to level and maintain the area

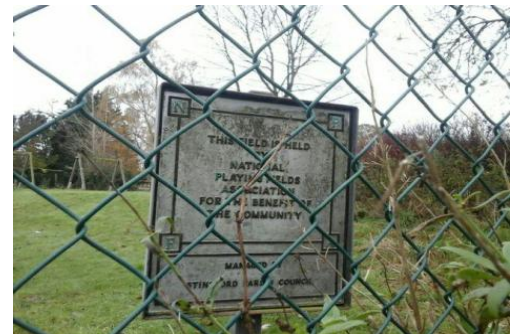
**Item:** Sign  
**Manufacturer:** Owner/Operator  
**Surface Type:** N/A  
**Item Quantity:** 1  
**Equipment Compliance:** N/A  
**Surface Area Compliance:** N/A

BS EN 1176 Part 7 recommends that signage shall include emergency contact details and contact details of owner / operator for reporting maintenance issues - Provide additional information

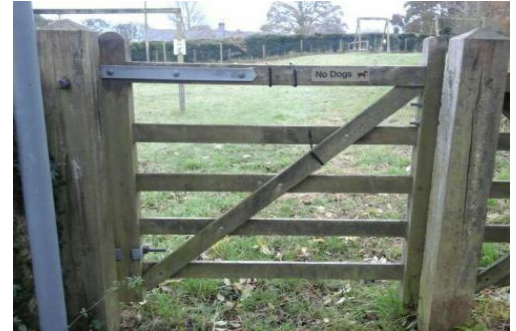
**Item:** Gate  
**Manufacturer:** Owner/Operator  
**Surface Type:** N/A  
**Item Quantity:** 1  
**Equipment Compliance:** N/A  
**Surface Area Compliance:** N/A

There are projecting bolt thread(s) present - Remove excess thread length and deburr or provide cap

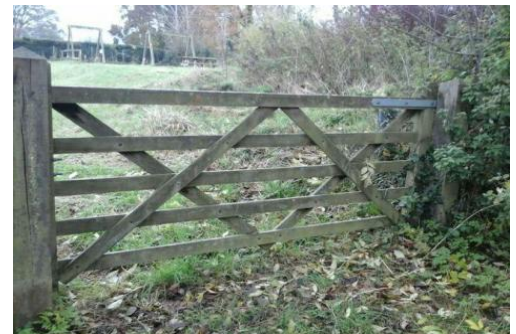
**Item:** Gate - Maintenance  
**Manufacturer:** Owner/Operator  
**Surface Type:** N/A  
**Item Quantity:** 1  
**Equipment Compliance:** N/A  
**Surface Area Compliance:** N/A

There is no padlock on the maintenance gate - Provide a padlock to secure the gate

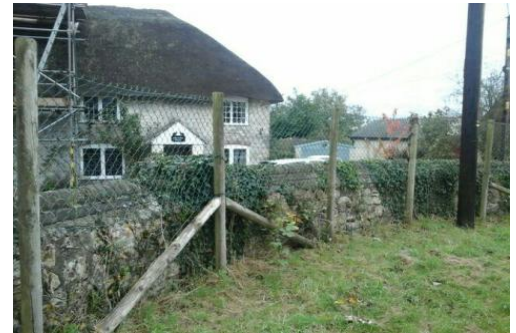
**Item:** Fence - Chainlink  
**Manufacturer:** Owner/Operator  
**Surface Type:** N/A  
**Item Quantity:** 1  
**Equipment Compliance:** N/A  
**Surface Area Compliance:** N/A

There are projecting bolt thread(s) present - Remove excess thread length and deburr or provide cap

Numerous posts have rotted at ground level - Replace posts

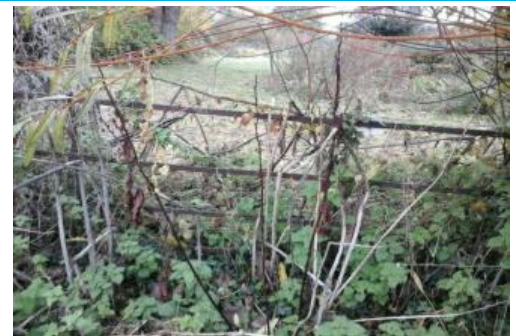
**Item:** Fencing - Post & Rail  
**Manufacturer:** Owner/Operator  
**Surface Type:** N/A  
**Item Quantity:** 1  
**Equipment Compliance:** N/A  
**Surface Area Compliance:** N/A

This item is satisfactory - no work required -

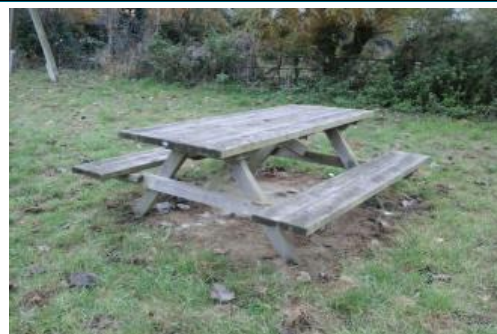
**Item:** Picnic Table  
**Manufacturer:** Owner/Operator  
**Surface Type:** Concrete  
**Item Quantity:** 1  
**Equipment Compliance:** N/A  
**Surface Area Compliance:** N/A

This item is satisfactory - no work required -

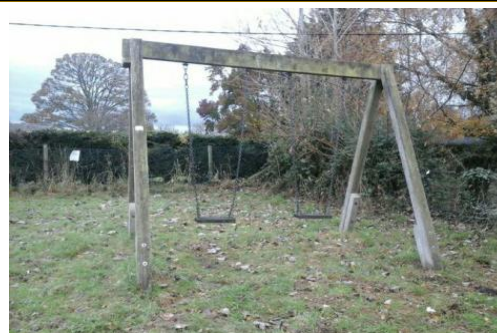
**Item:** 1 Bay 2 Seat (Flat)  
**Manufacturer:** Playline Design  
**Surface Type:** Grass  
**Item Quantity:** 1  
**Equipment Compliance:** No  
**Surface Area Compliance:** Yes

There is some wear to the shackles. - Monitor for any further deterioration and replace when 40% worn

There are areas or parts of the timber on the structure that have rotted - Replace all affected timbers

A number of fixing(s) have worked loose, the cross bar moves when in use - Secure all loose fixings

The seats are too close to the frame as defined in BS EN 1176 Part 2; this is a low risk failure and no remedial action is required - Monitor - No remedial work recommended

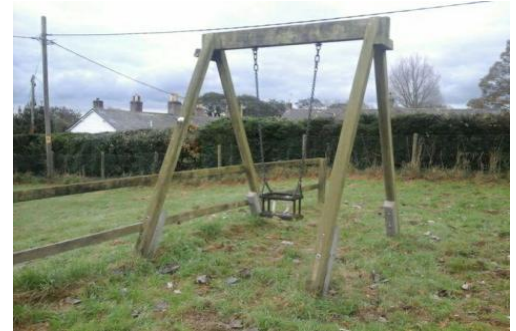
**Item:** 1 Bay 1 Seat (Cradle) - Type 1  
**Manufacturer:** Playline Design  
**Surface Type:** Grass  
**Item Quantity:** 1  
**Equipment Compliance:** No  
**Surface Area Compliance:** Yes

BS EN 1176 Part 2: Annex A makes a recommendation that fences or enclosures should be up to 1.50m from the edges of the swing seat to the sides, and subject to risk assessment, from the edge of the impact area. This is however, a low risk finding and no remedial action is recommended. - Monitor - No remedial work recommended

There is some strimmer / machinery damage apparent on the posts, this can penetrate the preservative applied to the timber and accelerate the rotting process - Monitor for any deterioration (rot) and replace as required

The seats are too close to the frame as defined in BS EN 1176 Part 2; this is a low risk failure and no remedial action is required - Monitor - No remedial work recommended

There are areas or parts of the timber on the structure that have rotted - Replace all affected timbers

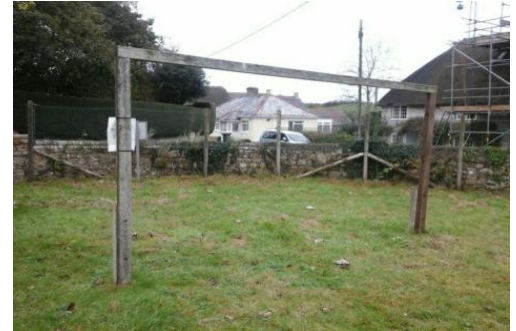
**Item:** Goal End  
**Manufacturer:** Playline Design  
**Surface Type:** Grass  
**Item Quantity:** 2  
**Equipment Compliance:** N/A  
**Surface Area Compliance:** N/A

NB: We have undertaken a maintenance inspection only of the football goal(s); full load testing falls outside the scope of our inspection. - Implement load testing as required

There is some strimmer / machinery damage apparent on the posts, this can penetrate the preservative applied to the timber and accelerate the rotting process - Monitor for any deterioration (rot) and replace as required
