# the **play** inspection company

## Annual Inspection

Bockhampton

Bockhampton Lane, Lower Bockhampton, Dorset, DT2  
8PZ

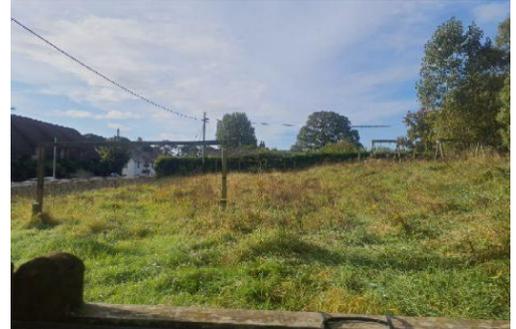
<b>Item:</b>	Site General
<b>Manufacturer:</b>	Owner/Operator
<b>Surface Type:</b>	N/A
<b>Item Quantity:</b>	1
<b>Equipment Compliance:</b>	N/A
<b>Surface Area Compliance:</b>	N/A
<b>Total Findings:</b>	4

<b>Finding 1</b> The grass is overgrown within the play area and may hide hazards - Reduce the length of grass to an acceptable height and maintain	<b>Finding 2</b> There is weed / vegetation growth on, between, or around the edges of the surfacing - Remove weed / vegetation growth
<b>Finding 3</b> The inspector was unable to check the surfacing below the items due to the sheer volume of vegetation - Check surfacing when the vegetation has been removed	<b>Finding 4</b> There are redundant / damaged posts - Remove

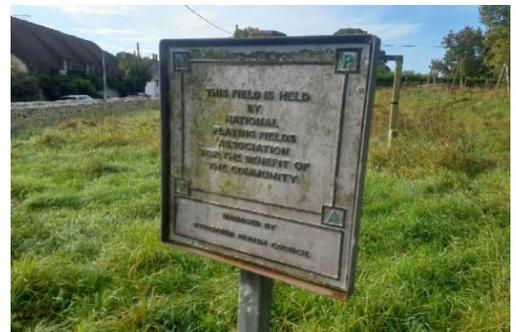
<b>Item:</b>	Sign
<b>Manufacturer:</b>	Owner/Operator
<b>Surface Type:</b>	Grass
<b>Item Quantity:</b>	1
<b>Equipment Compliance:</b>	N/A
<b>Surface Area Compliance:</b>	N/A
<b>Total Findings:</b>	1

<b>Finding 1</b> It is recommended that signage, with information including the site address, contact information for maintenance issues and emergency contact details are provided for the facility - Provide in accordance with the recommendations
--

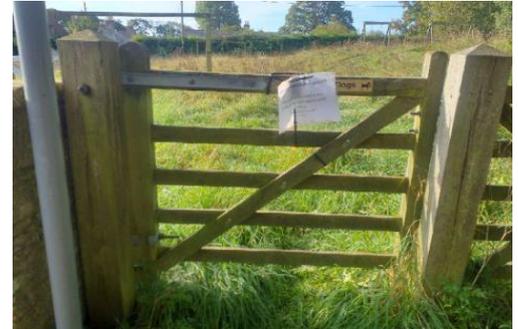
**Item:** Gate  
**Manufacturer:** Not Identified  
**Surface Type:** Grass  
**Item Quantity:** 1  
**Equipment Compliance:** N/A  
**Surface Area Compliance:** N/A

Cable ties have been used on the item and there are sharp projecting ends - Remove if not required or replace with a more appropriate alternative fixing method if used as a fixing

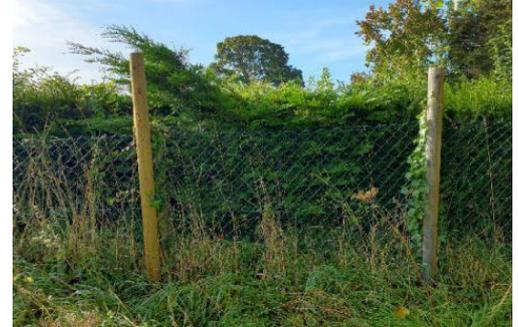
**Item:** Fence - Chainlink  
**Manufacturer:** Owner/Operator  
**Surface Type:** Grass  
**Item Quantity:** 1  
**Equipment Compliance:** N/A  
**Surface Area Compliance:** N/A

There are areas or parts of the timber on the structure that have rotted - Replace all affected timbers

There are a number of loose posts around the fence - Monitor for any further deterioration and reset as required

Loose timber posts and mesh (fencing materials) are being stored in the area - Remove

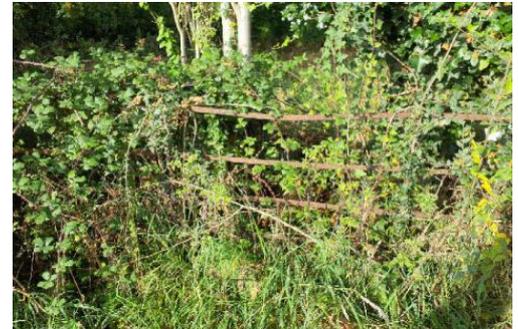
**Item:** Fencing - Post & Rail  
**Manufacturer:** Not Identified  
**Surface Type:** Grass  
**Item Quantity:** 1  
**Equipment Compliance:** N/A  
**Surface Area Compliance:** N/A

The paintwork on this item has been damaged or worn exposing the metal underneath which is rusting / corroding - Treat affected areas and repaint

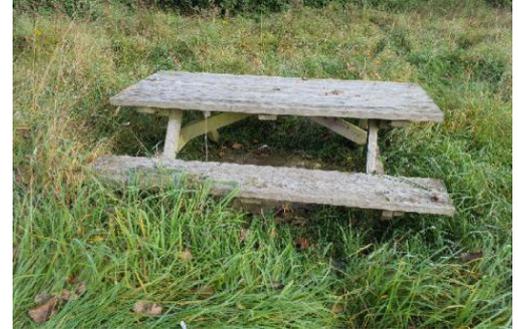
**Item:** Picnic Table  
**Manufacturer:** Not Identified  
**Surface Type:** Concrete  
**Item Quantity:** 1  
**Equipment Compliance:** N/A  
**Surface Area Compliance:** N/A

There is or are fixings missing on the item - Replace all missing fixings

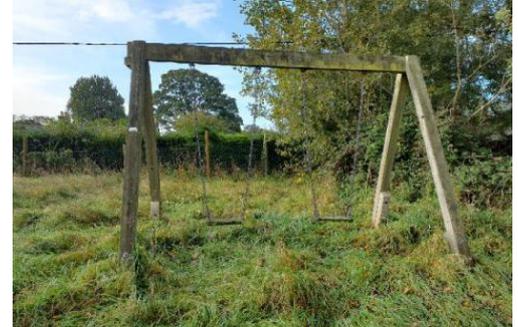
**Item:** 1 Bay 2 Seat (Flat)  
**Manufacturer:** Playline Design  
**Surface Type:** Grass Matrix Tiles  
**Item Quantity:** 1  
**Equipment Compliance:** No  
**Surface Area Compliance:** Yes

All 4 timber posts on the structure have rotted - Replace all affected timbers

The seats are too close to the frame as defined in BS EN 1176 Part 2; this is a low risk failure and no remedial action is required - Monitor - No remedial work recommended

There is some notable evidence of chain wear - Monitor for any further deterioration and replace when 40% worn

The seat has minor damage or wear - Monitor for any further deterioration and replace as required

The timber has a number of splits/shakes or air cracks and this may affect the stability or allow water ingress which will accelerate the rotting process - Monitor to ensure the splits do not cross through fixing points of the structure and/or cause any instability

There is/are bolt cap covers missing or damaged on the item - Replace missing or damaged bolt cap covers

The bushes are showing signs of wear - Monitor for any further deterioration and replace as required

There is some wear to the shackles - Monitor for any further deterioration and replace when 40% worn

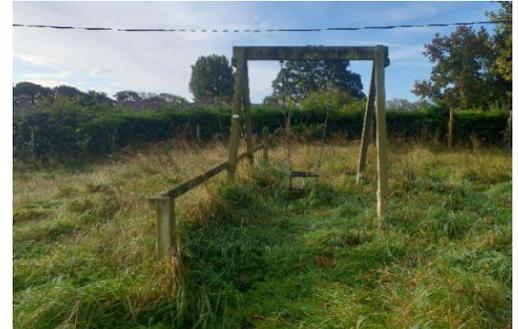
**Item:** 1 Bay 1 Seat (Cradle) - Type 1  
**Manufacturer:** Playline Design  
**Surface Type:** Grass  
**Item Quantity:** 1  
**Equipment Compliance:** No  
**Surface Area Compliance:** Yes

BS EN 1176 Part 2: Annex A makes a recommendation that fences or enclosures should be upto 1.50m from the edges of the swing seat to the sides, and subject to risk assessment, from the edge of the impact area. This is however, a low risk finding and no remedial action is recommended. - Monitor - No remedial work recommended

The seats are too close to the frame as defined in BS EN 1176 Part 2; this is a low risk failure and no remedial action is required - Monitor - No remedial work recommended

All 4 timber posts on the structure have rotted - Replace all affected timbers

The chain openings are in excess of the 8.6mm as recommended by BS EN 1176 - Monitor - No remedial work recommended

There is some notable evidence of chain wear - Monitor for any further deterioration and replace when 40% worn

The seat has minor damage or wear - Monitor for any further deterioration and replace as required

There is some wear to the shackles - Monitor for any further deterioration and replace when 40% worn

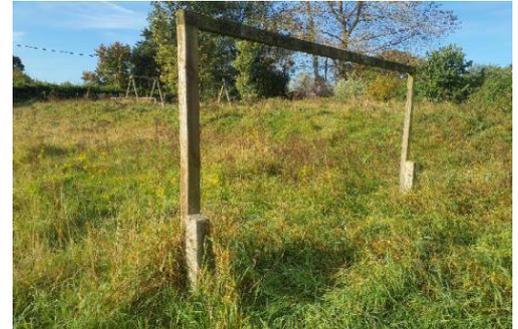
**Item:** Football Goal  
**Manufacturer:** Playline Design  
**Surface Type:** Grass  
**Item Quantity:** 2  
**Equipment Compliance:** N/A  
**Surface Area Compliance:** N/A

NB: We have undertaken a maintenance inspection only of the football goal(s); full load testing falls outside the scope of our inspection. - Implement load testing as required

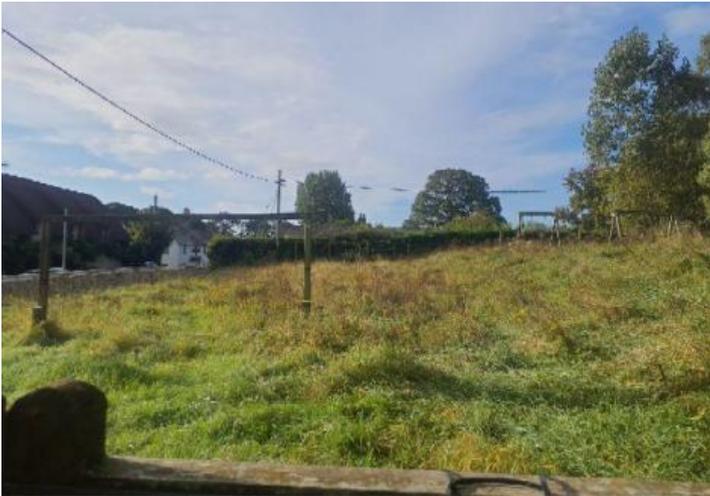
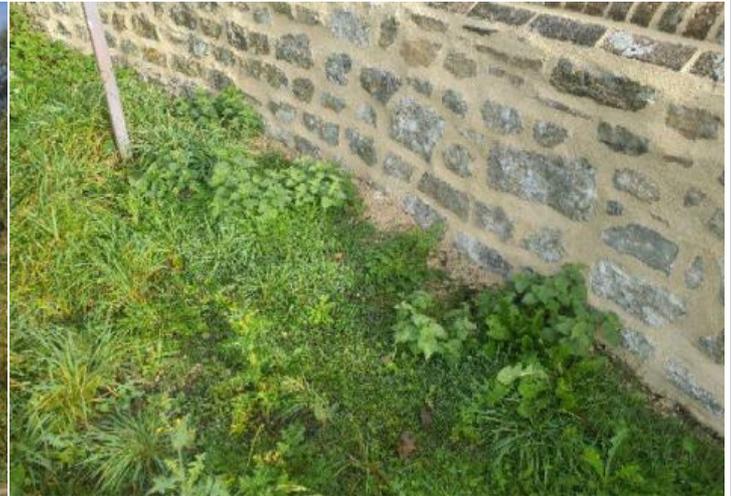
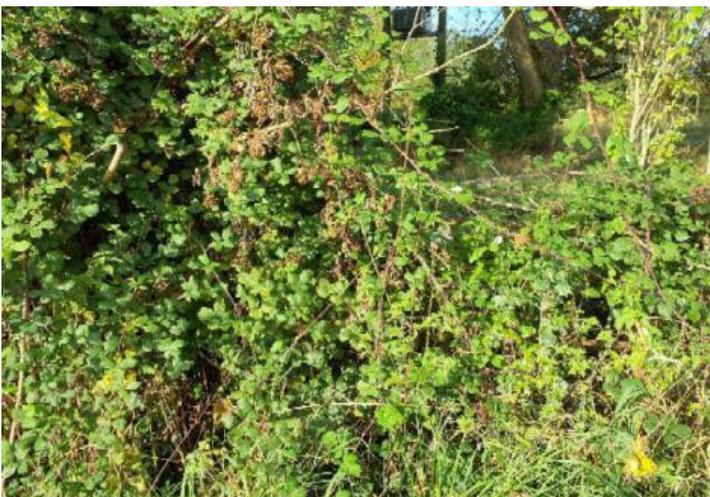
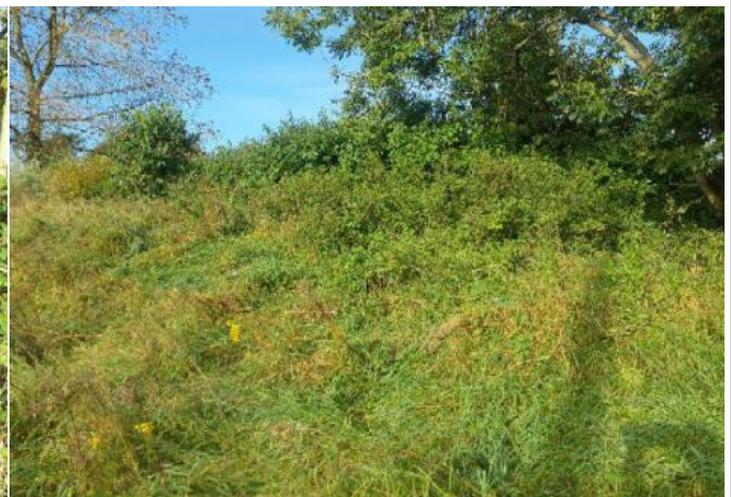
<b>Item:</b>	Ancillary Items - Site General	<b>Risk Level:</b>	L - Low Risk
<b>Manufacturer:</b>	Owner/Operator	<b>Surface:</b>	N/A

**Finding:** There is weed / vegetation growth on, between, or around the edges of the surfacing **Action:** Remove weed / vegetation growth

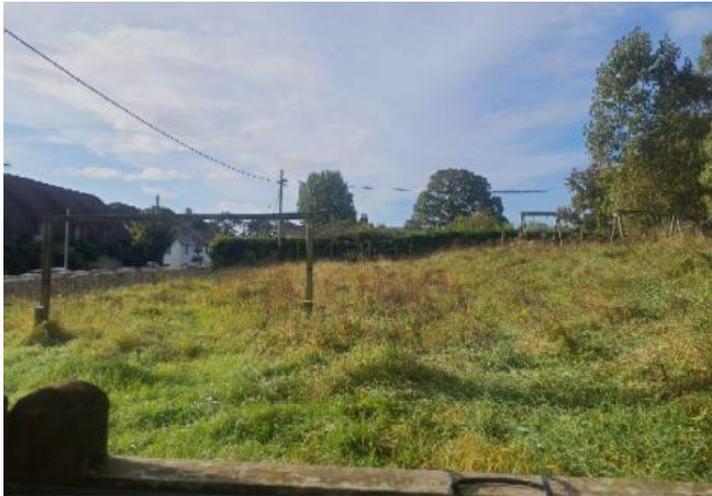
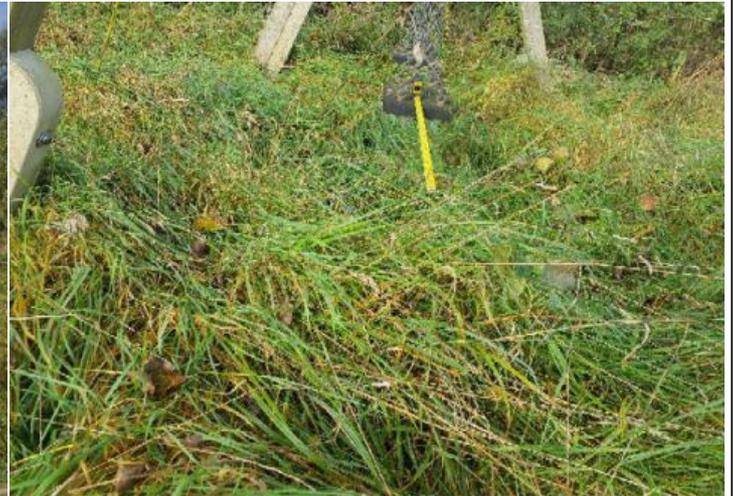
**Item:** Ancillary Items - Site General  
**Manufacturer:** Owner/Operator

**Finding:** The inspector was unable to check the surfacing below the items due to the sheer volume of vegetation

**Action:** Check surfacing when the vegetation has been removed

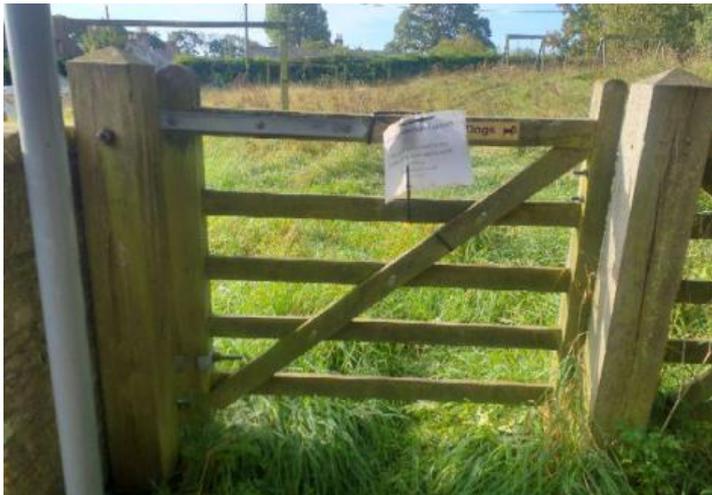
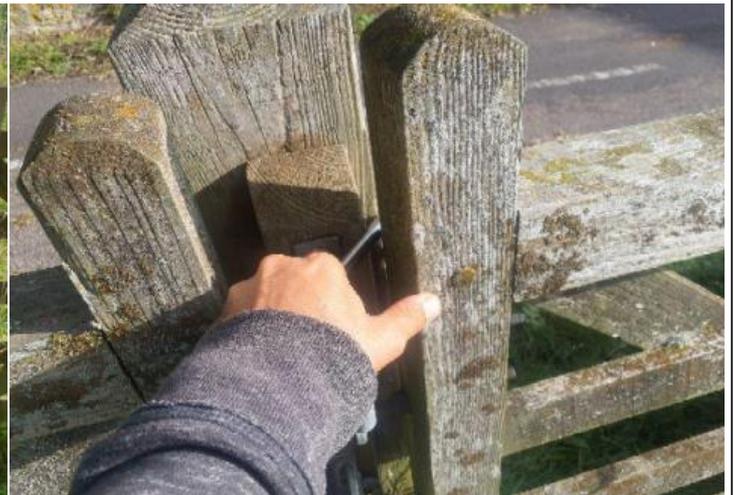
**Item:** Gates - Gate  
**Manufacturer:** Not Identified

**Finding:** There are openings that are less than 12mm that could trap or crush fingers

**Action:** Provide a 12mm gap throughout full range of motion at both sides of gate

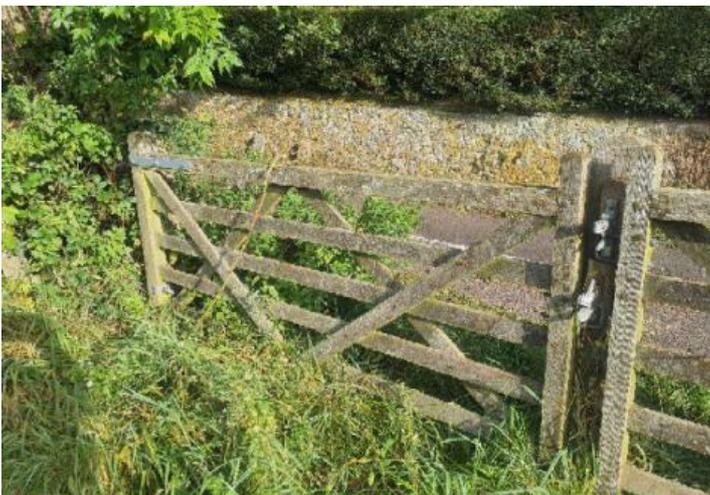
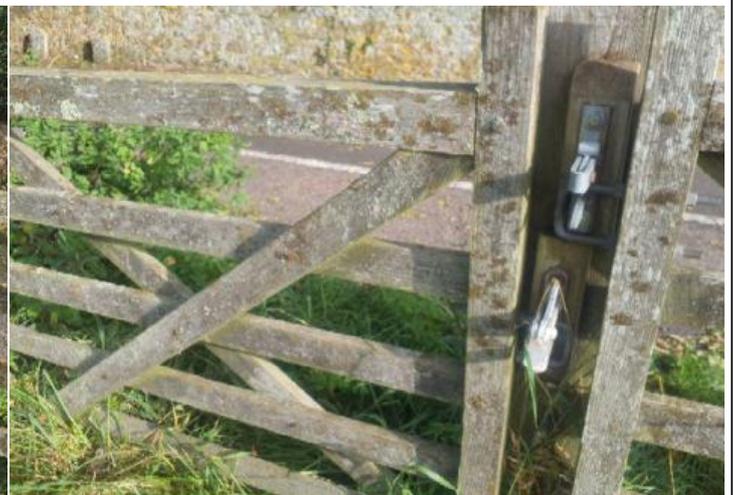
**Item:** Gates - Gate - Maintenance  
**Manufacturer:** Not Identified

**Finding:** There is no padlock on the maintenance gate

**Action:** Provide a padlock to secure the gate

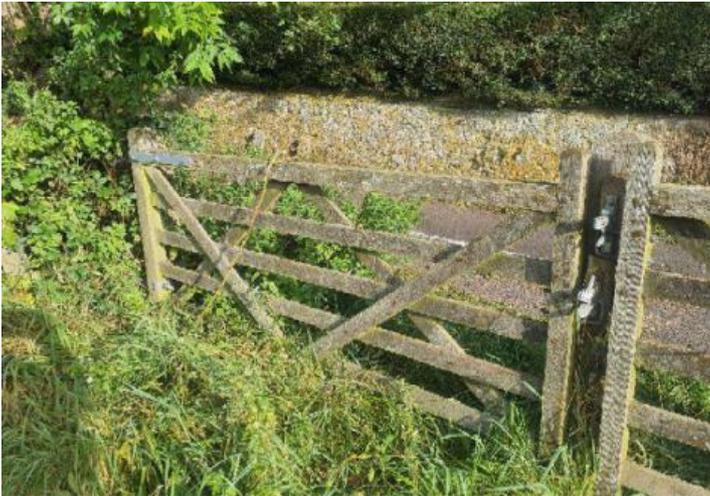
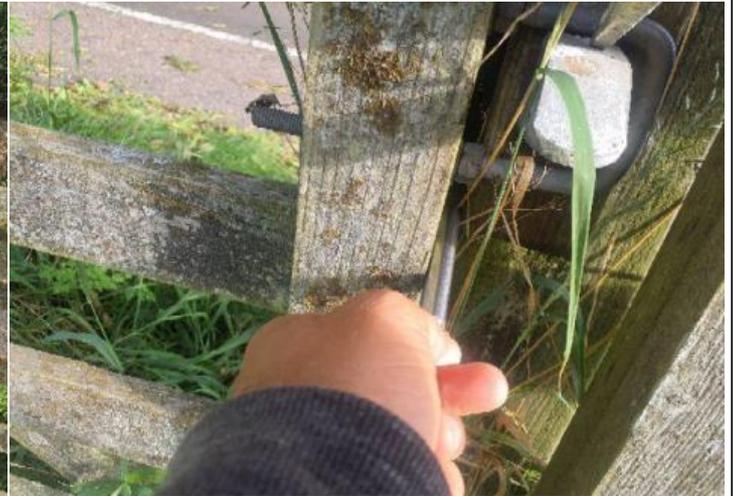
**Item:** Gates - Gate - Maintenance  
**Manufacturer:** Not Identified

**Finding:** There are openings that are less than 12mm that could trap or crush fingers

**Action:** Provide a 12mm gap throughout full range of motion at both sides of gate

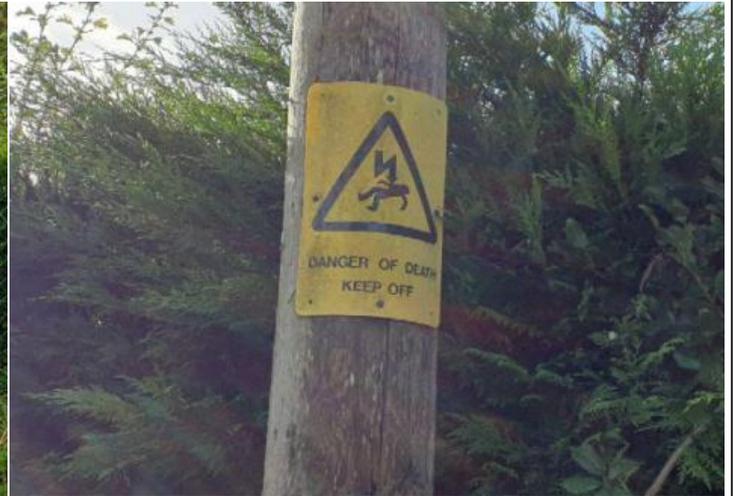
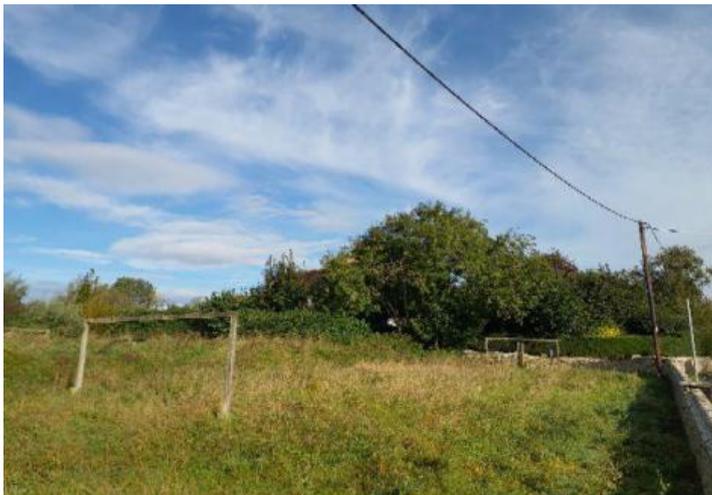
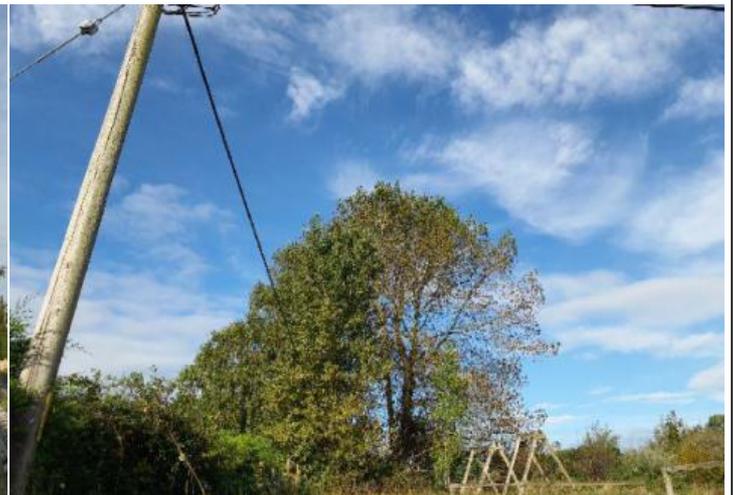
**Item:** Fences - Fence - Chainlink  
**Manufacturer:** Owner/Operator

**Finding:** NOTE - There are power lines in and above the play area

**Action:** Ensure there is a suitable risk assessment in place and review regularly

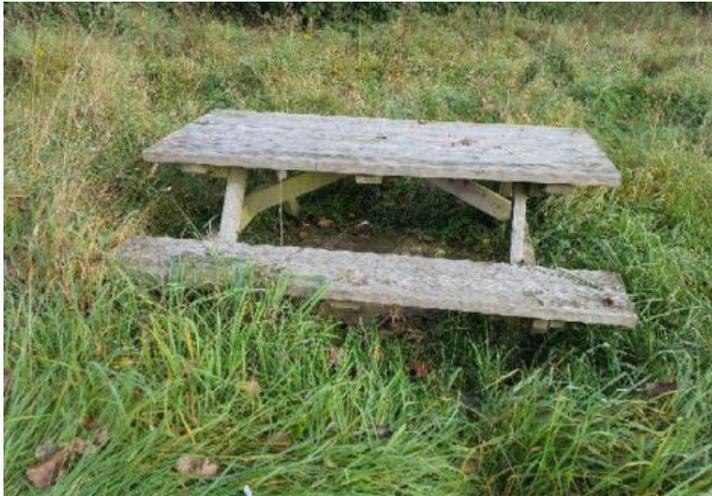
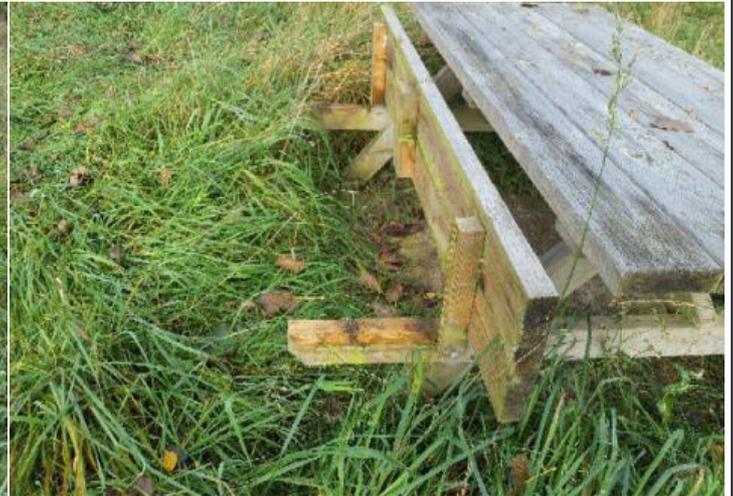
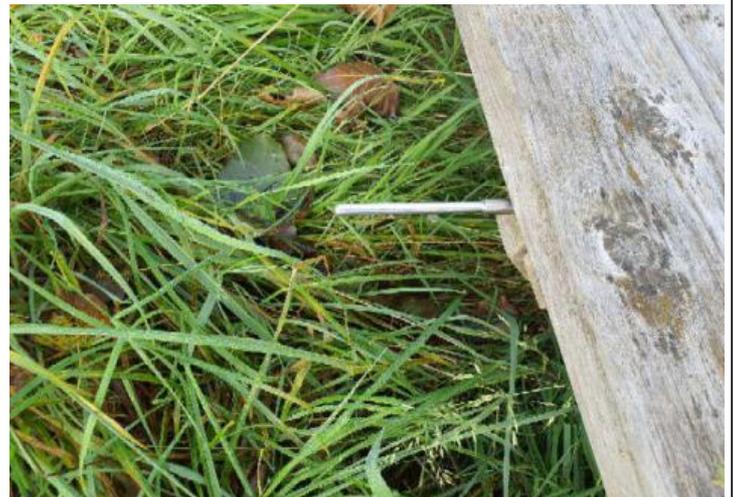
<b>Item:</b>	Ancillary Items - Picnic Table	<b>Risk Level:</b>	N - Risk Assessment not Undertaken
<b>Manufacturer:</b>	Not Identified	<b>Surface:</b>	Concrete

**Finding:** The seats are not secured and there is a potential crush point where they close

**Action:** Consider securing the seats

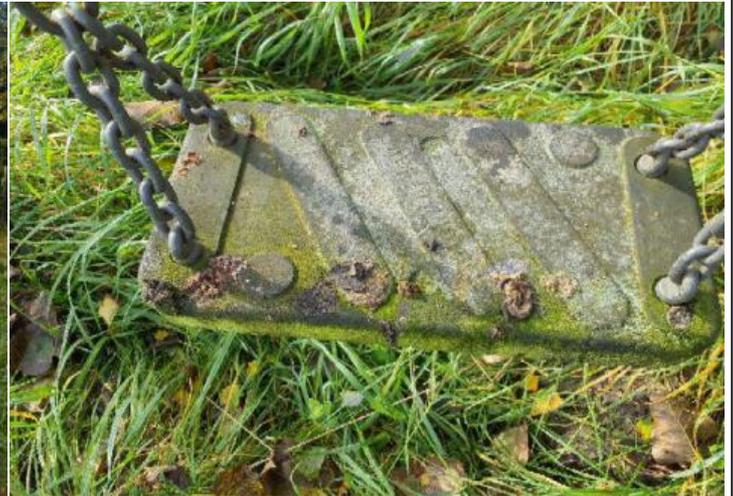
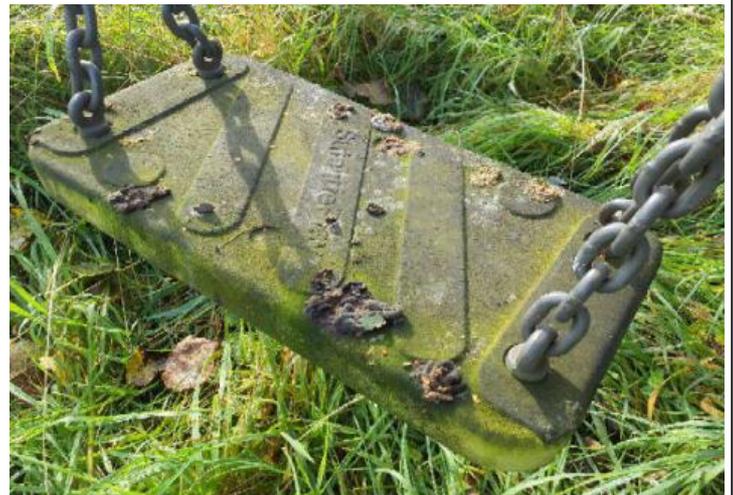
**Item:** Swings - 1 Bay 1 Seat (Cradle) - Type 1  
**Manufacturer:** Playline Design

**Finding:** The seats are covered in bird droppings

**Action:** Clean and maintain. Consider using upturned cable ties to deter birds

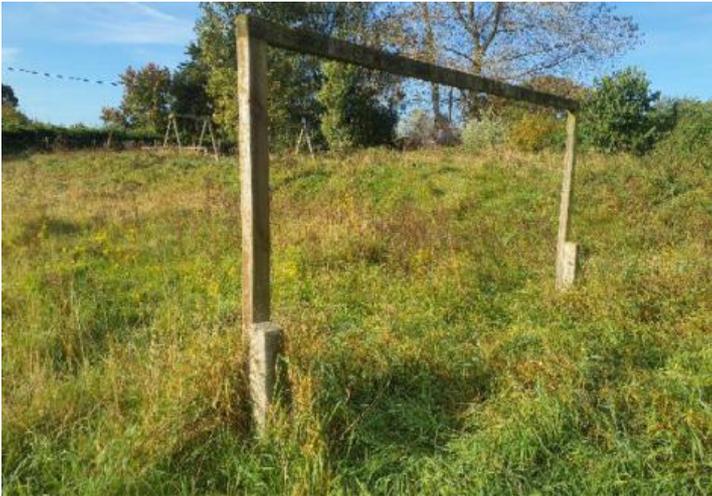
**Item:** Multi Use Games Area - Football Goal  
**Manufacturer:** Playline Design

**Finding:** NB: We have undertaken a maintenance inspection only of the football goal(s); full load testing falls outside the scope of our inspection.

**Action:** Implement load testing as required

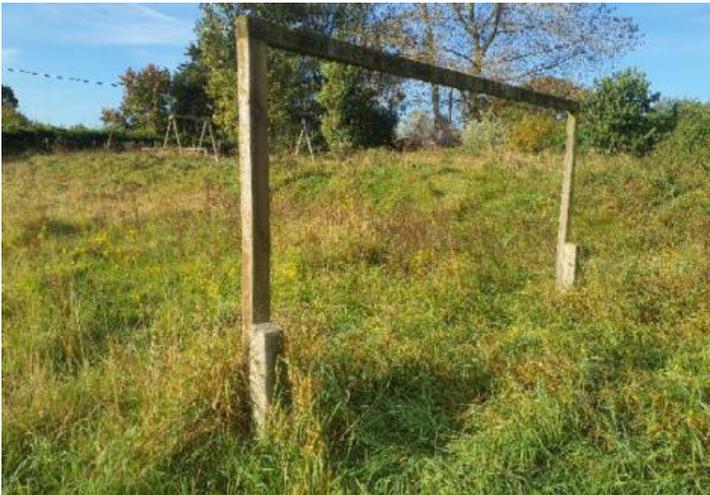
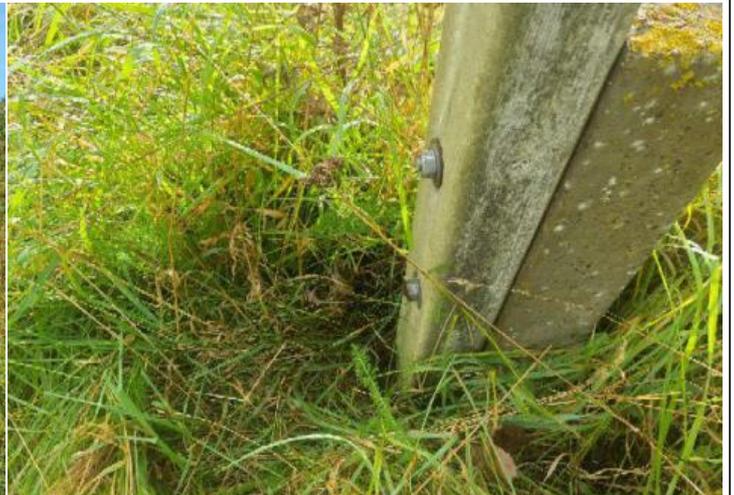
**Item:** Multi Use Games Area - Football Goal  
**Manufacturer:** Playline Design

**Finding:** There are fixings protruding from the front of the goal posts

**Action:** Consider altering the design
